WESTFIELD STREET (ROUTE 20)

SAFETY STUDY

(SIBLEY AVENUE TO KINGS HIGHWAY)

WEST SPRINGFIELD, MA

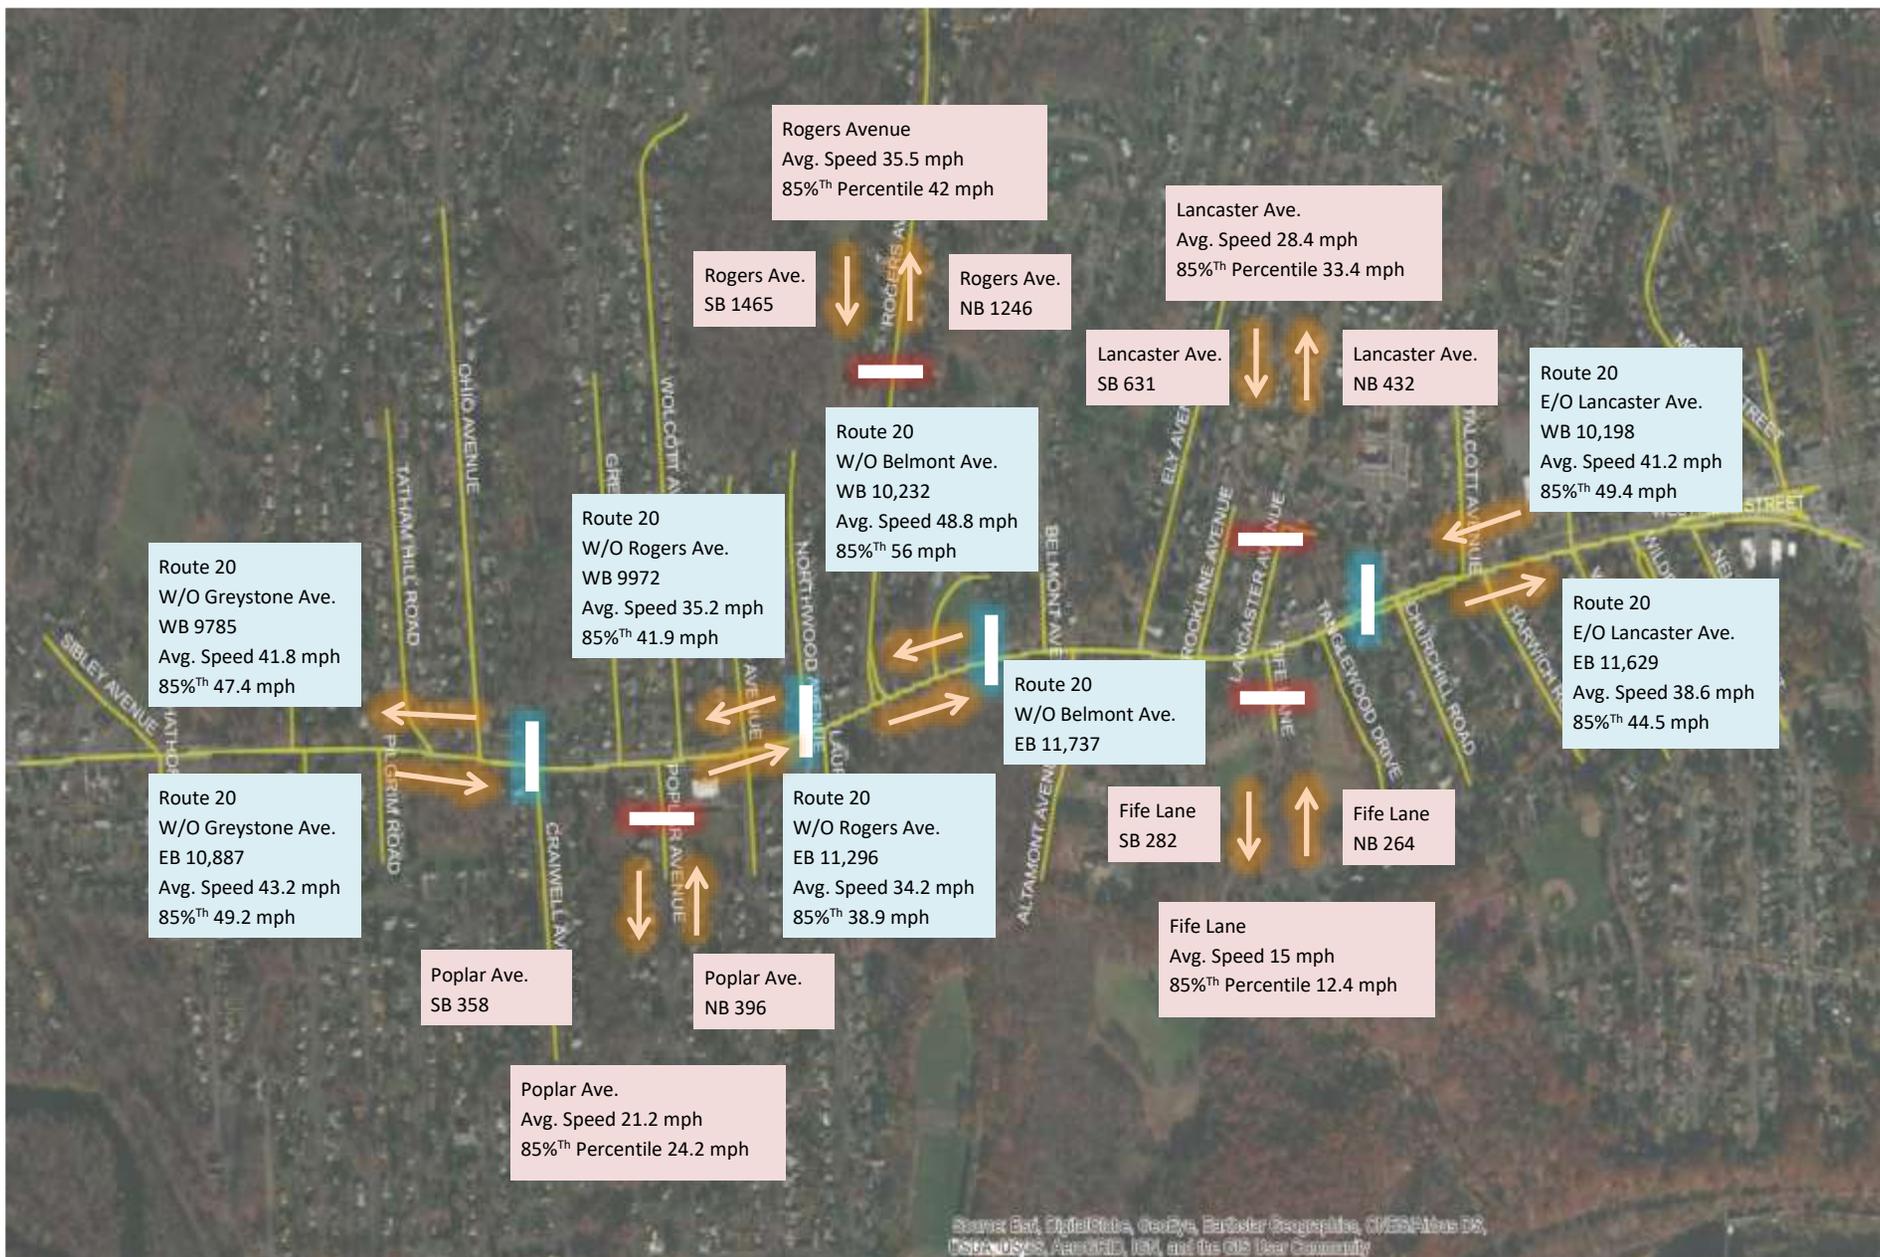
Figure 2: 2021 Traffic Volumes (Annual Daily Traffic – ADT) and Speed in miles per hour (mph)

Figure 2 depicts the average speeds and the 85th percentile speeds of vehicles travelling eastbound and westbound along Route 20 at 4 different locations. The PVPC could only collect speed data in the westbound direction in the vicinity of Belmont Avenue because of an equipment malfunction.

The 85th percentile speed denotes the speed at which 85% of all the vehicles travel at or below on that road. The 85th percentile speed along Route 20 is consistently higher than the posted speed limit in both directions. The travel speed data collected on Route 20 in the vicinity of Rogers Avenue is lower than other areas due to the impact of the traffic signal at this intersection. [Appendix 2](#) presents detailed speed data at each of the surveyed locations in the study area.

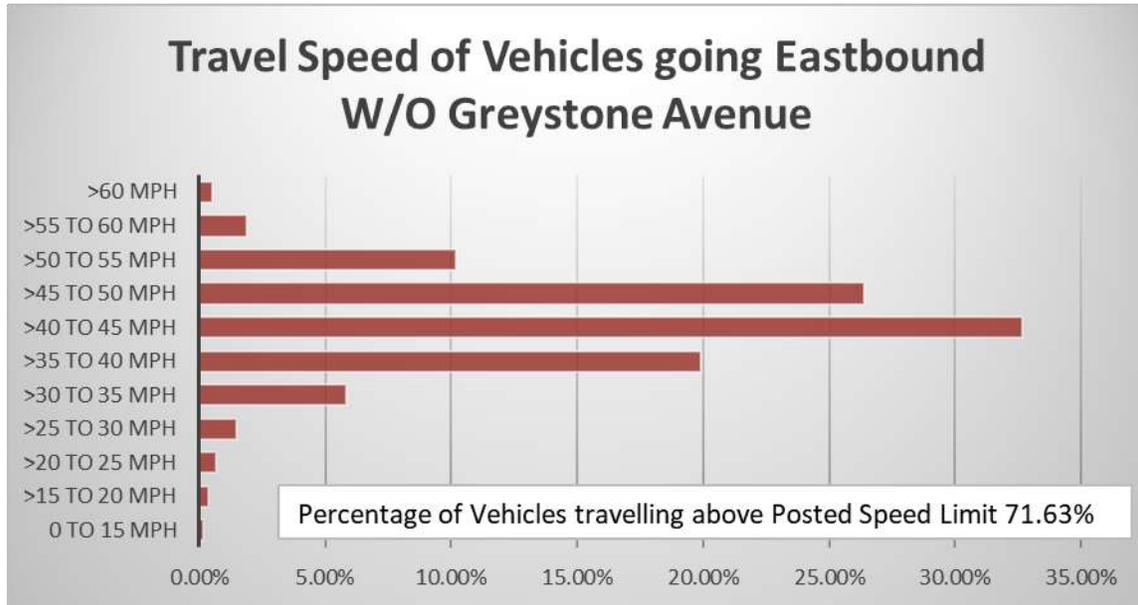
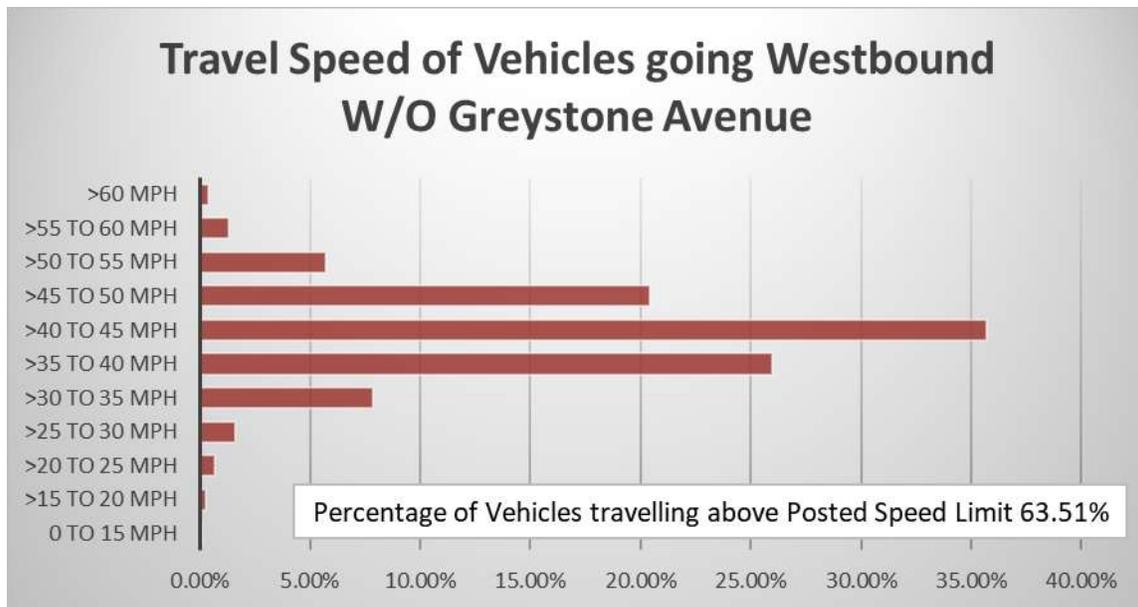
Figure 3: Travel Speed of Vehicles W/O Greystone Avenue

To further analyze the extent of speeding along the road, the PVPC distributed the travel speed data into 5 mph increments or “bins” at the three locations. The location in the vicinity of Rogers Avenue was influenced by the proximity of the traffic signal, therefore it was not included in the speed bin analysis. *Figures 3, 4 and 5* depict the percentages of vehicles travelling at different speeds and the total percentage of vehicles travelling above the posted speed limit. It is noteworthy that a higher number of westbound vehicles are travelling above speed limit than eastbound vehicles. Over 25% of vehicles travel more than 5 mph over the posted speed limit in the vicinity of Greystone Avenue. Westbound traffic in the vicinity of Belmont Avenue travels almost 10 mph more than the posted speed limit. Figure 5 further depicts that nearly 40% of the vehicles at this location travel at speeds greater than 50 mph.

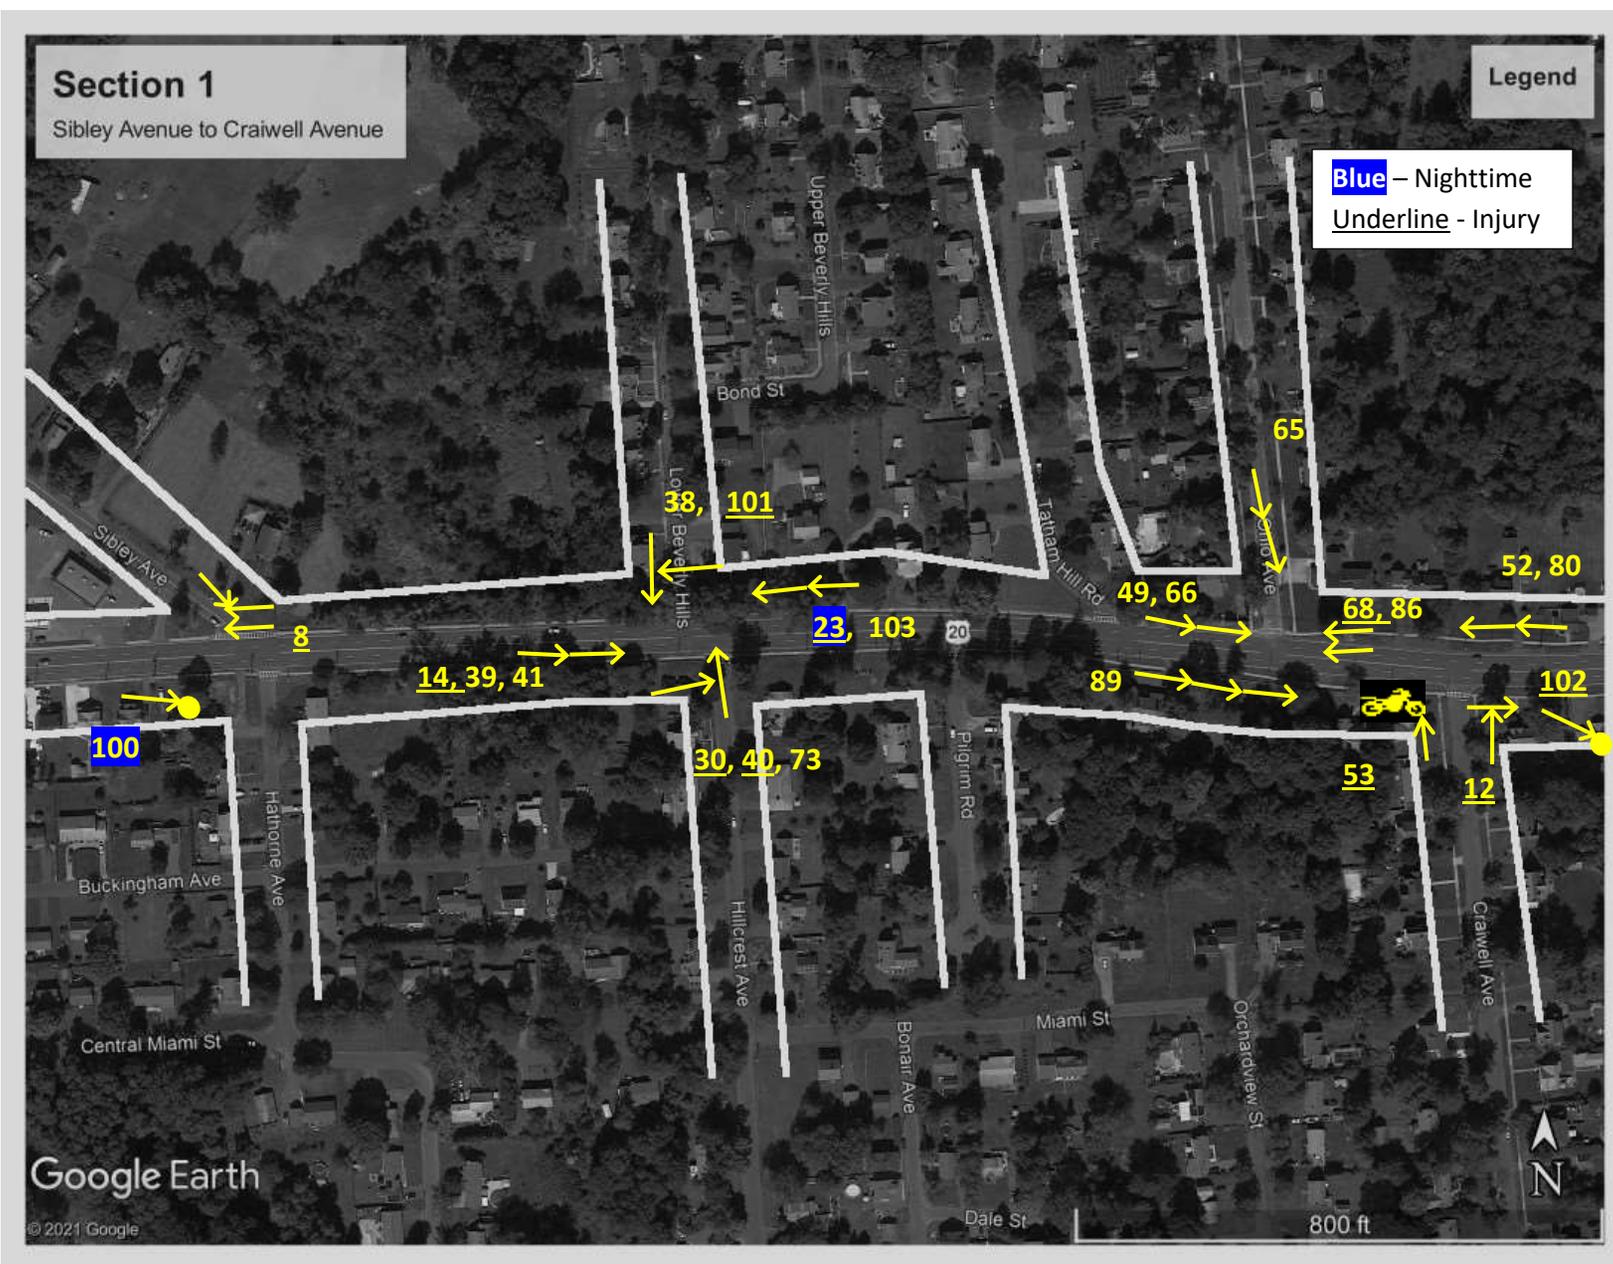
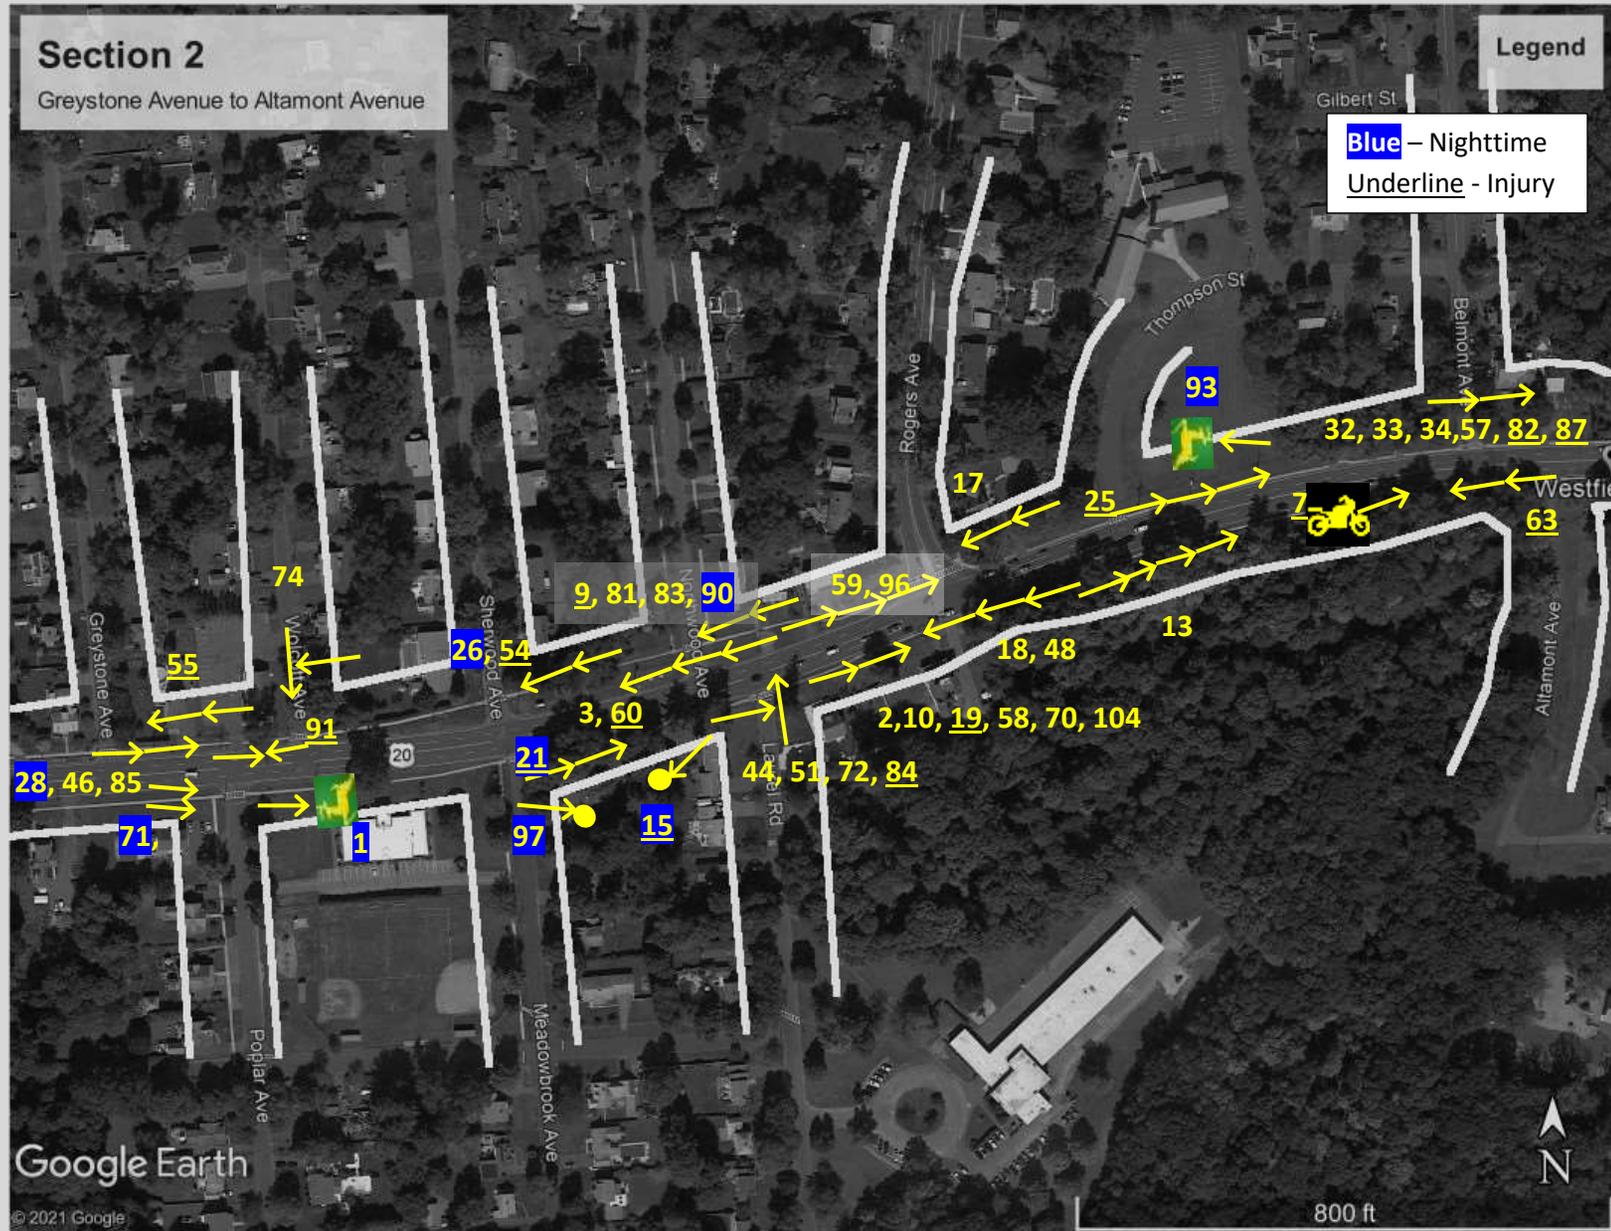
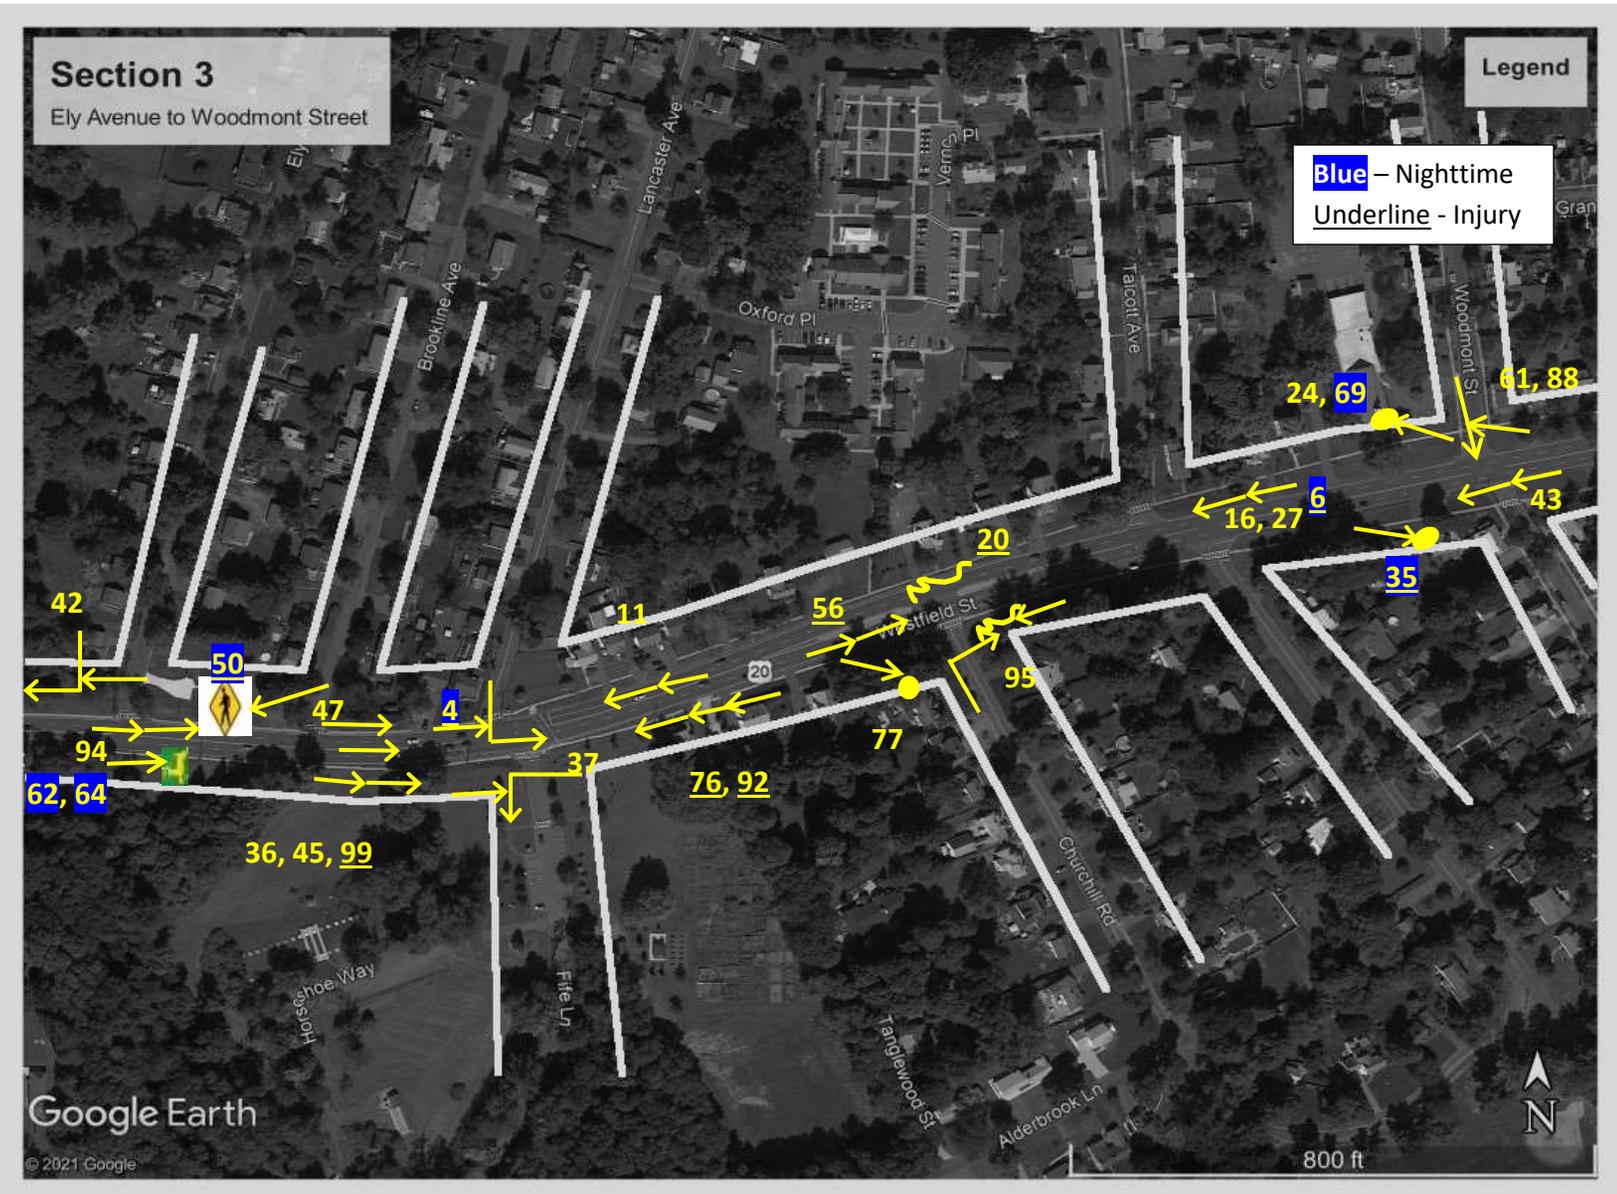
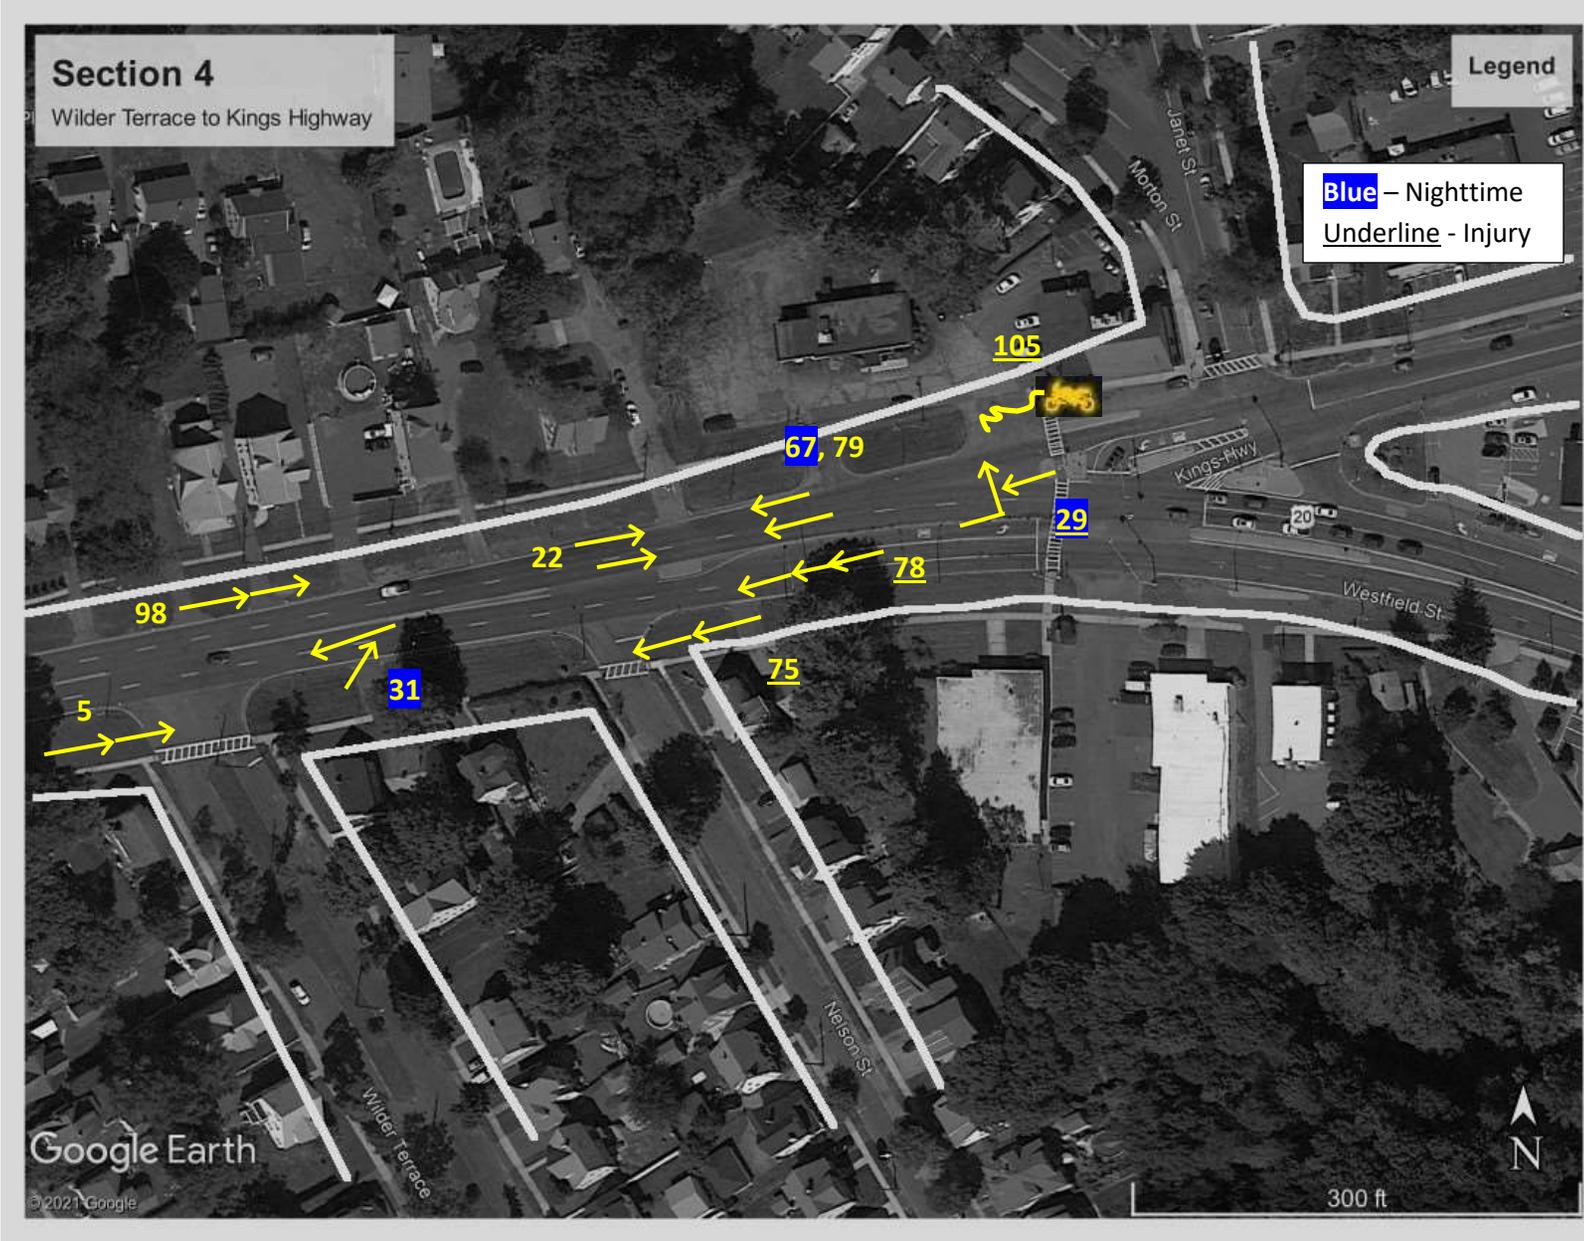
A total of 94 crashes occurred within these three years. To study these crashes in detail, the roadway was divided into 4 sections going eastbound: Section 1: Sibley Avenue to Craiwell Avenue, Section 2 Greystone Avenue to Altamont Avenue, Section 3: Ely Avenue to Woodmont Street, and Section 4: Wilder Terrace to King’s Highway (the King’s Highway Intersection is not included as a part of study area). These crashes are depicted in the four figures below and detailed information about each crash is provided in Appendix 5. This information corresponds to the crash number in the diagrams. Sections 2 (42 crashes) and 3 (26 crashes) are longer in length and have a higher number of crashes when compared to sections 1 (19 crashes) and 4 (7 crashes).

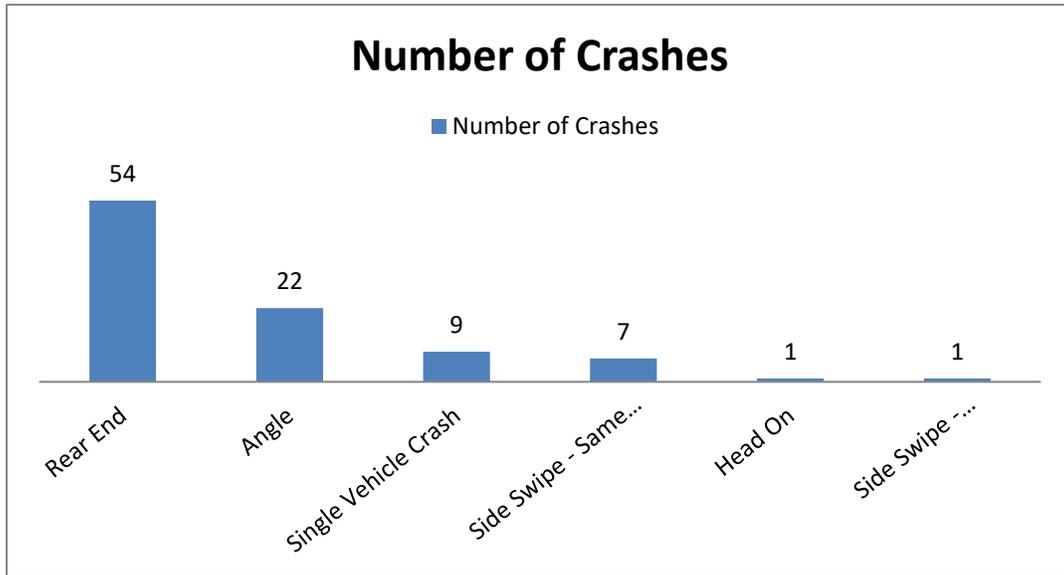
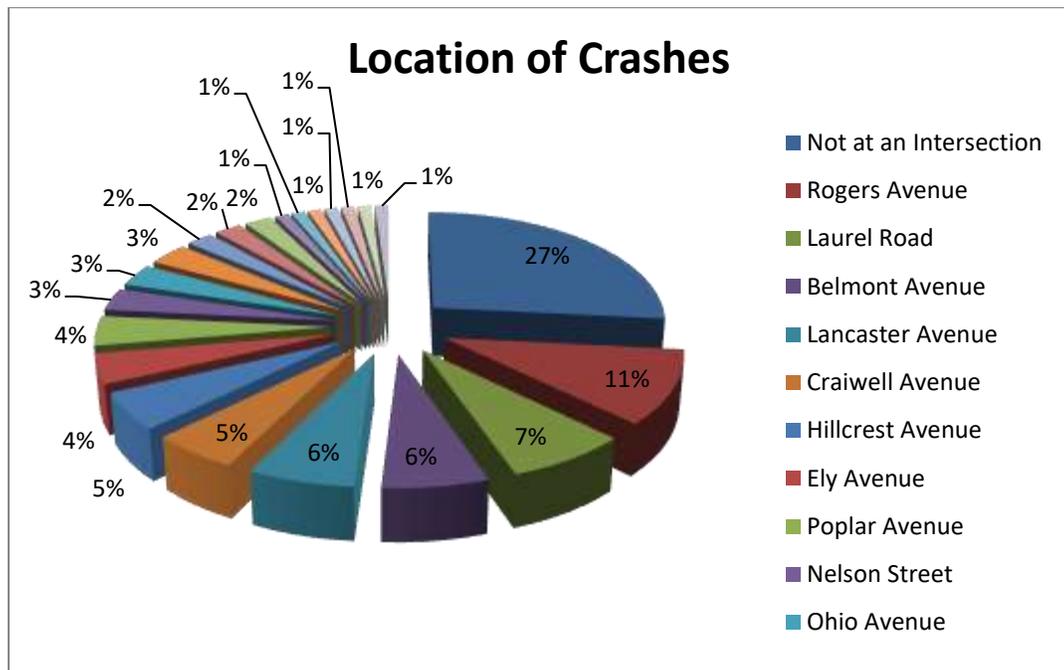
7. Higher traffic during the afternoon creates more potential for crashes. A higher volume of traffic is observed travelling westbound along Route 20 during the afternoon peak hour. A significant number of rear end crashes were observed in this direction in the afternoon.
