Carew Street (Route 20A) / Liberty Street / Banbury Street / Grover Street / Kendall Street / Libcar Street / Penacook Street / Stockman Street

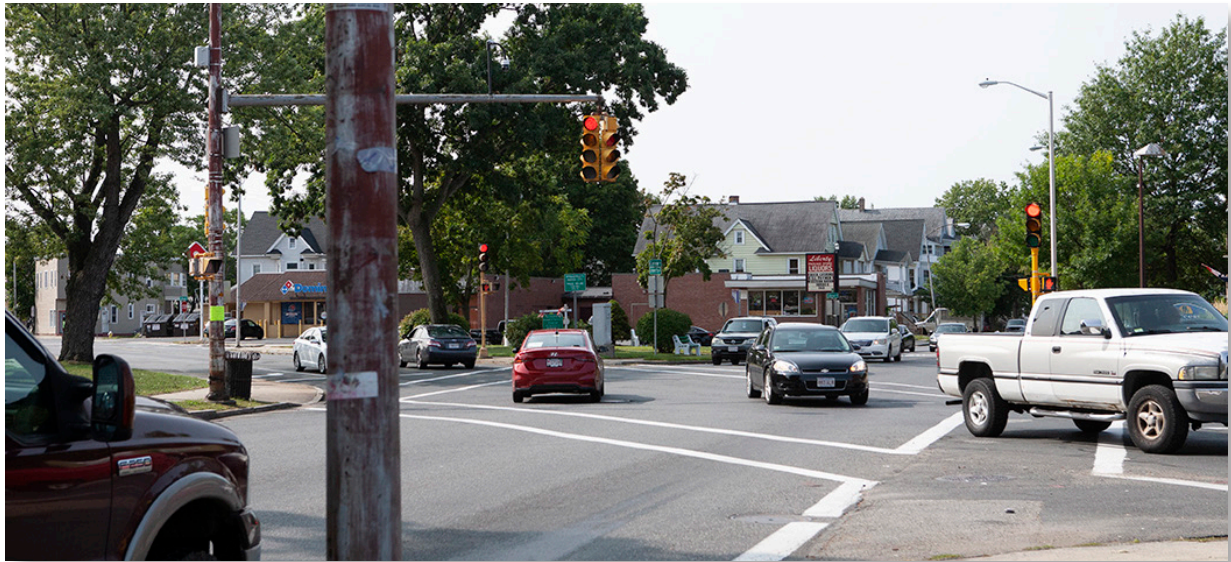
- Unusual geometry, close proximity of the streets, high traffic volumes, acute angle of approaches, and outdated equipment are some of the factors that possibly contribute to higher crashes along this location

- Pedestrian signal head for crosswalk across Liberty Street southbound approach was not aligned along with the crosswalk markings.
- Signal Heads do not have back plates

- Overgrown Landscaping along the northeast corner of the intersection of Carew Street with Liberty Street obstructs visibility for the drivers along the Liberty Street southbound approach

- Left Turn Only sign for Carew Street southwest bound approach is not clearly visible because of trees and their shade in the vicinity of the mast arm

- The Cumberland Farms driveway in the northeast corner of the intersection of Liberty Street and Carew Street has two curb cuts which could be examined for Enter Only / Exit Only flow to reduce conflicts in the vicinity of the intersection.

- Advance information /warning signs along Carew Street northeast bound approach and Liberty Street northbound approach to help drivers navigate through Libcar Street will help in reducing sudden maneuvers by drivers to make those movements after they get too close to the intersection

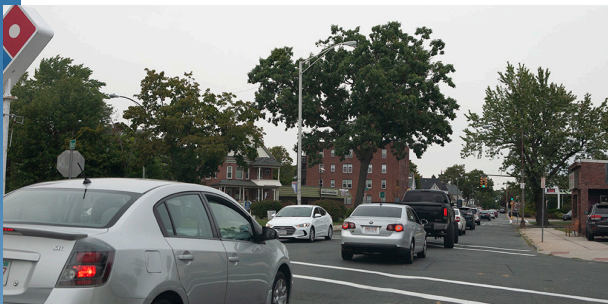
- Few trash barrels were observed to be too close to the travel lanes
- Crosswalk ramps along the intersections are not ADA compliant
- Travel Lanes are narrow

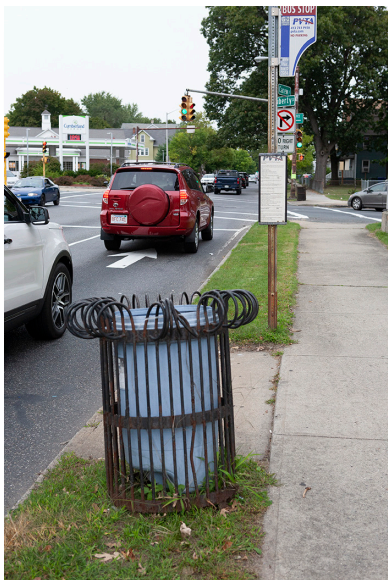
- Exclusive turning lanes do not have advance lane use signs
- Carew Street northeastbound approach did not have separate signal head for exclusive left turn lane which resulted in red light running and driver confusion during overlap

- Long queues along Liberty Street north bound approach block Libcar Street
- This location would greatly benefit by a detailed engineering study or a Roadway Safety Audit
