Riverdale Street (Route 5) / Morgan Road / Dagget Drive

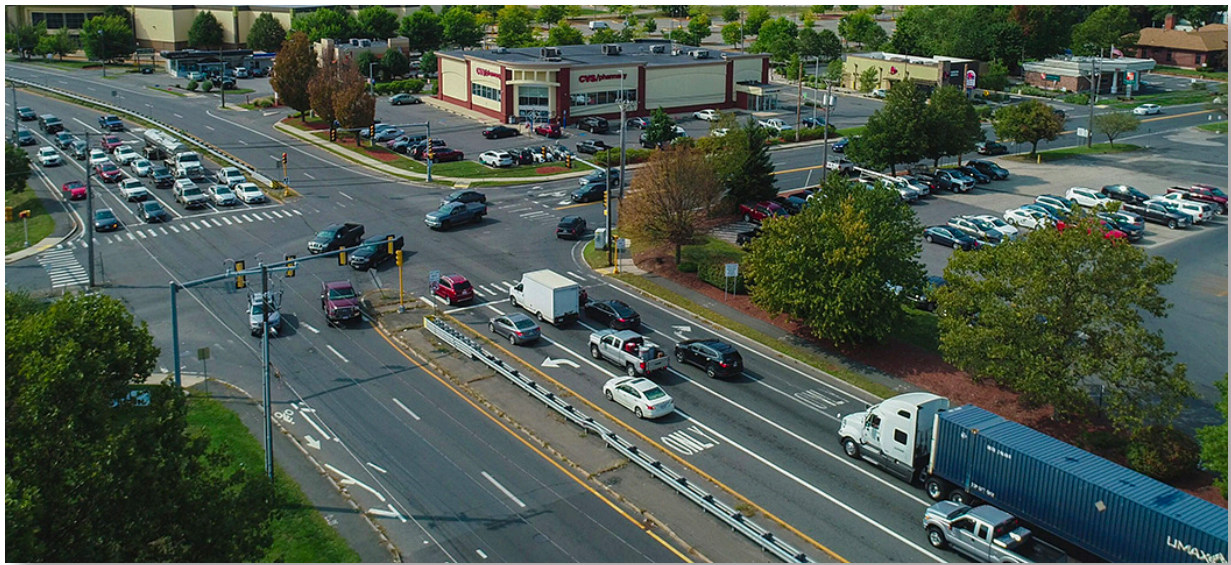
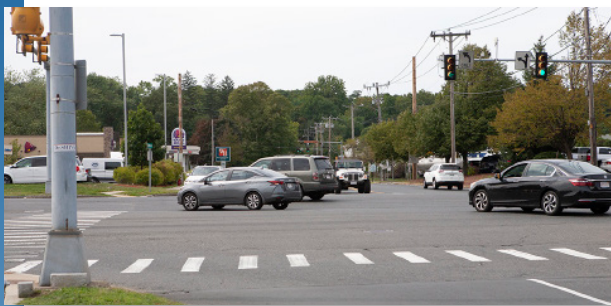
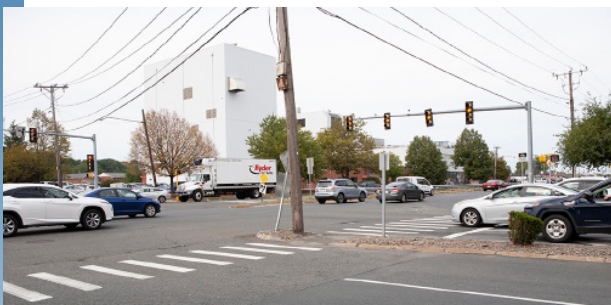
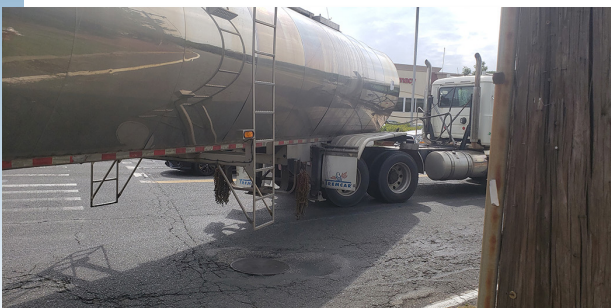
- Aggressive driving, speeding, heavy congestion, and high volumes of commercial vehicle traffic with tight turning radii are some of the factors that could lead to higher probability of crashes along these intersections.

- Several sign posts along the medians seem damaged by collision with motor vehicles
- Dual left turn lanes from the Riverdale Shopping Plaza driveway into Riverdale Street (Route 5) do not have pavement markings through the intersection to guide the vehicles in proper lanes. This created increased possibility of sideswipe crashes

- Red Light running was observed along Riverdale Street (Route 5) northbound approach at the intersection with Morgan Road. Optically programming the two signals could help in addressing this aggressive driving and speeding problem.

- Right turning traffic from Riverdale Street (Route 5) southbound approach into Morgan Road gets backed up behind commercial vehicles entering Agrimark

- Dagget Drive intersection traffic gets backed up all the way to Morgan Road intersection and vice versa
- Lack of optical programming along signals
