FEBRUARY 2019

# AT-GRADE SHARED USE PATH AND ROADWAY INTERSECTIONS IN THE PIONEER VALLEY

Prepared under the direction of the Pioneer  
Valley MPO by:

**PIONEER VALLEY PLANNING COMMISSION**

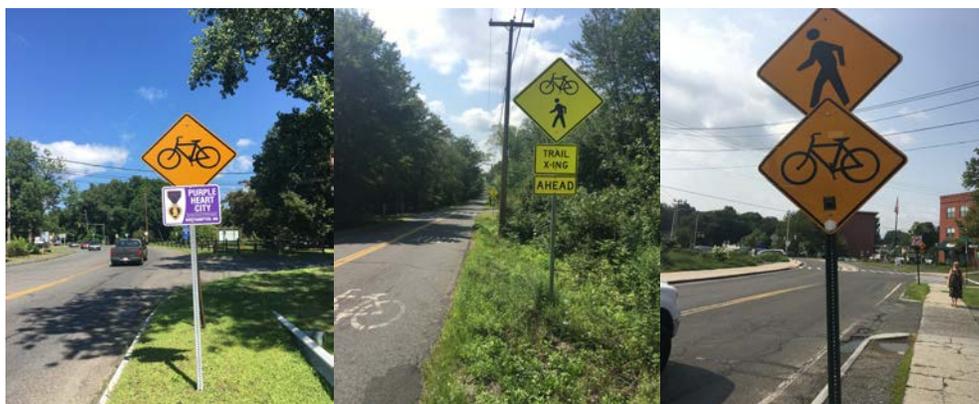
**Figure 2: Some Examples of Advance Warning Signs**

Figure 2 shows examples of different types of advance warning signs that were observed along various roadways. It was noted that many advance warning signs are either Manual on Uniform Traffic Control Devices (MUTCD) 2010 compliant advance pedestrian or bicycle warning sign, but not both. Ideally both pedestrians and bicycles should be displayed on advance warning signs to a shared use path crossing. Supplemental warning plaques displayed on the sign post should also comply with the MUTCD.

Source: PVPC, From Left: Station Road (Amherst), Damon Road (Northampton), Old South Street (Northampton)

**Advance Warning Signs-** Advance warning signs and pavement marking play a significant role in alerting motorists of the possibility of either bicyclists or pedestrians potentially crossing the road. A variety of advance warning signs were observed as a part of this inventory. More than half of the approaches (89 out of 142) to a shared use path crossing did not have any form of advance warning sign. It is recommended that these locations be examined to determine if advance warning signs compliant with the MUTCD guidelines are necessary.

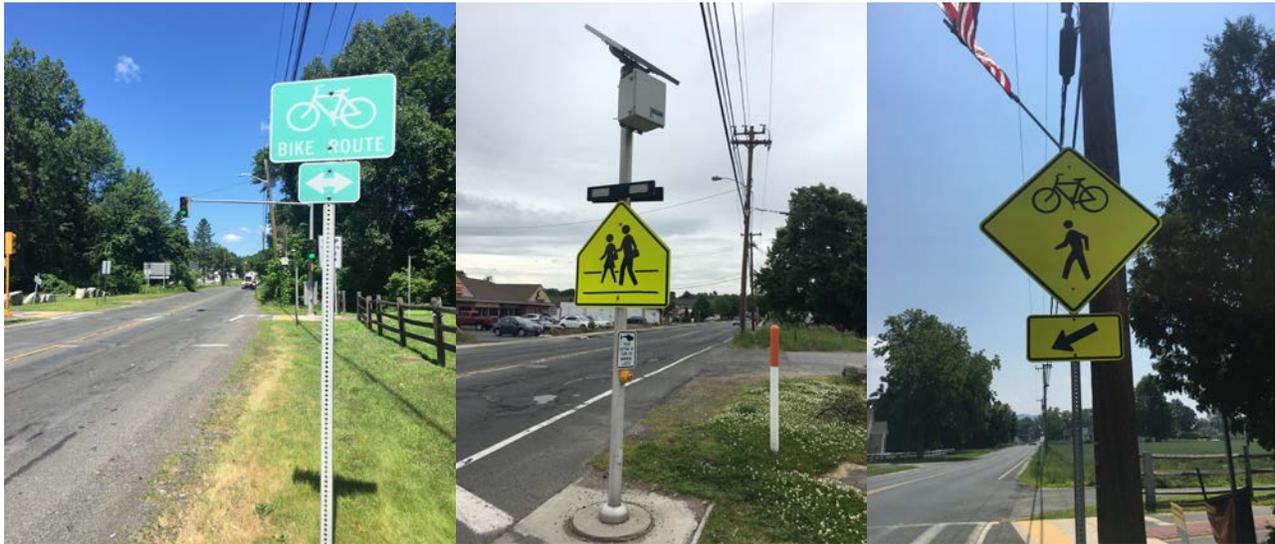
**Figure 3: Shared Use Path Signs at the At-grade Crossings**

Source: PVPC, From Left: Damon Road (Northampton), Maple Street (East Longmeadow), And East Street (Hadley)

types of signs. Most of these shared use path signs were found to be in good condition with optimal visibility. A total of 39 approaches did not have these any signs. Some of the locations summarized in the study are located at a three way intersection so the roadways have a single approach to the crossing. For all other locations it is recommended that an MUTCD complaint warning sign be installed for the approaches with no existing sign.

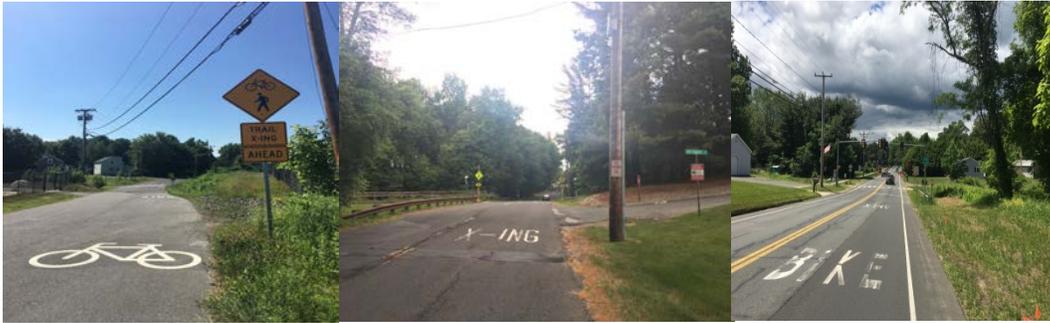
**Figure 4: Types of Pavement Markings**

**Advance Pavement Markings-** Approximately one third of the total number of roadway approaches had advance pavement markings (48 out of 142) to alert motorists of the upcoming crossing. A majority of these existing pavement markings were noted to be in poor condition (29 out of 48) at the time of survey. Advance pavement markings are an important supplemental safety measure to alert the drivers of the potential need to reduce speed or stop. It is recommended that all pavement markings be maintained in good condition and installed along the approaches with higher speeds and traffic volumes.

Source: PVPC, From Left: Woodmont Road (Northampton), Shaker Road (Westfield), Feeding Hills Road (Southwick)

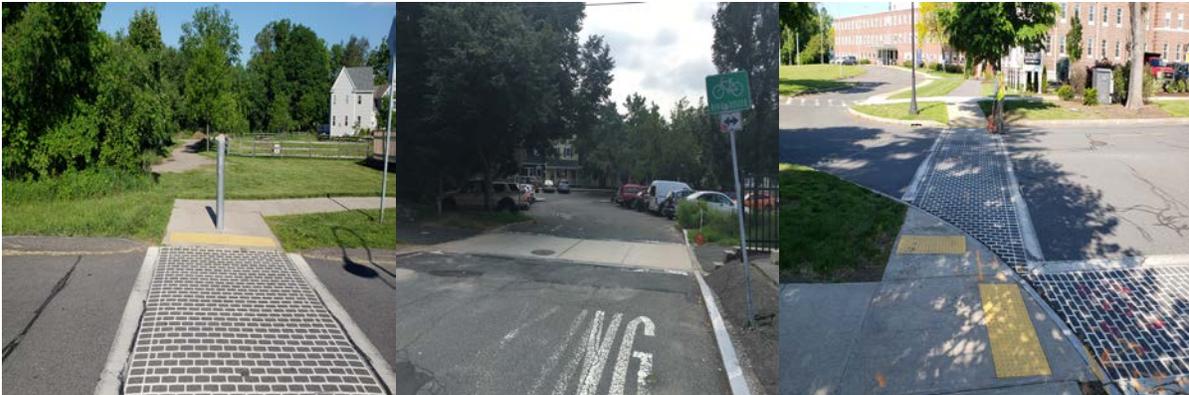
Figure 6: Boutique Style and Concrete Style Crosswalks in Northampton

Source: PVPC, From Left: Musante Drive, Old South Street Parking Lot, And Village Hill Road

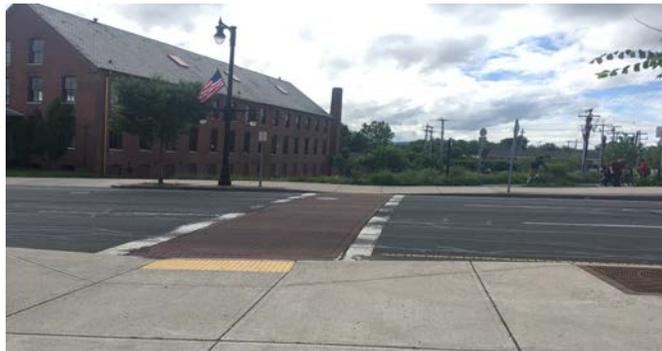
Figure 7: Raised Brick Crosswalk in Westfield

Source: PVPC, North Elm Street (Westfield)

**Crosswalk Markings-** Seven different styles of crosswalk markings were observed to be used for at-grade shared use path crossings. Additional data including the width, crossing distance, and style of crosswalk is presented in **Appendix 3**. A total of 8 locations in the region did not have a crosswalk. They are located within the communities of Amherst, Brimfield, Easthampton, Ludlow, and Northampton. A majority of locations had continental style crosswalk markings. Figure 5 represents the classification of crosswalks. Figure 6 shows pictures of Concrete and Boutique style crosswalks in the City of Northampton. Figure 7 shows a picture of raised brick crosswalk at North Elm Street in Westfield.

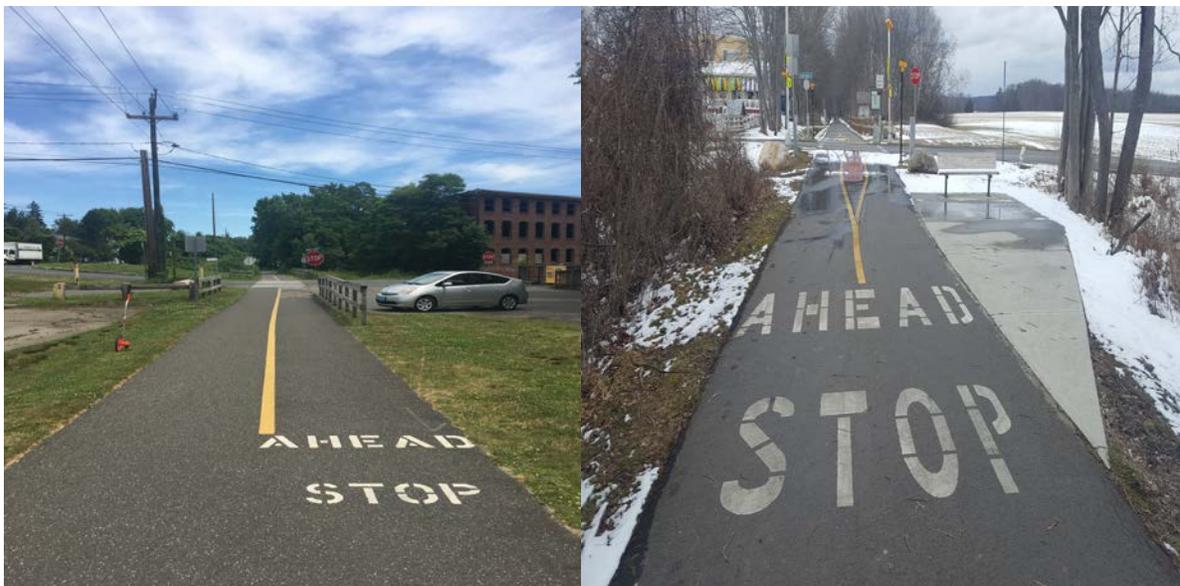
**Figure 8: Pavement Markings along Shared Use Path Approaches**

Source: PVPC, From Left: Manhan Rail Trail approaching Ferry Street (Easthampton), Norwottuck Branch of Mass Central Rail Trail approaching South Maple Street (Hadley)

**Pavement Markings-** Pavement markings are used along shared use paths in advance of at-grade crossings to alert users of the upcoming crossing and increase compliance with existing traffic controls. Recently upgraded shared use paths such as the Norwottuck branch of the Mass Central Rail Trail in Hadley and the Manhan Rail Trail in Easthampton have pavement markings along the shared use paths that are in very good condition. **Appendix 2** summarizes the location of these markings and their condition. It is recommended that all the shared use path approaches to at-grade crossings be upgraded with advance pavement markings.

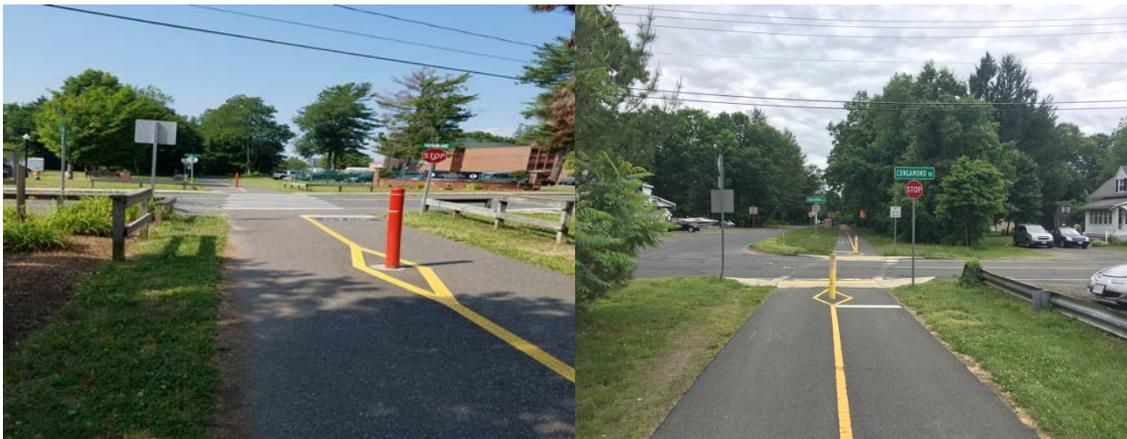
**Figure 9: Bollards at Shared Use Path Approaches**

A total of 56 approaches at 28 crossings have some form of bollard along the shared use path. Bicycle advocate groups have recently discouraged the use of bollards on the shared use paths as they can act as an obstacle and increase the risk of injuries and crashes. It is recommended that local officials develop a policy on the appropriate use of bollards. A preferred method of restricting entry of motor vehicles is to split the entry way into two sections separated by low landscaping. The approach to the split should be delineated with solid line pavement markings to guide the path user around the split. Each section should be half the nominal path width. Emergency vehicles can still enter if necessary by straddling the landscaping. Alternatively it may be more appropriate to designate emergency vehicles access via protected access drives that can be secured.

Source: PVPC, From Left: Manhan Rail Trail approaching Payson Avenue (Easthampton), Southwick Rail Trail approaching Congamond Road (Southwick)

**Bollards**- Bollards are intended to secure the entrances to shared use paths by preventing access by unauthorized vehicles. They also reinforce the need of a user to stay to the right of the path prior to crossing a roadway; however per '***American Association of State Highway and Transportation Officials (AASHTO) 2012 Design Guide, Chapter 5: Restricting Motor Vehicle Traffic***': bollards and other similar physical barriers to restrict motor vehicles are not recommended.

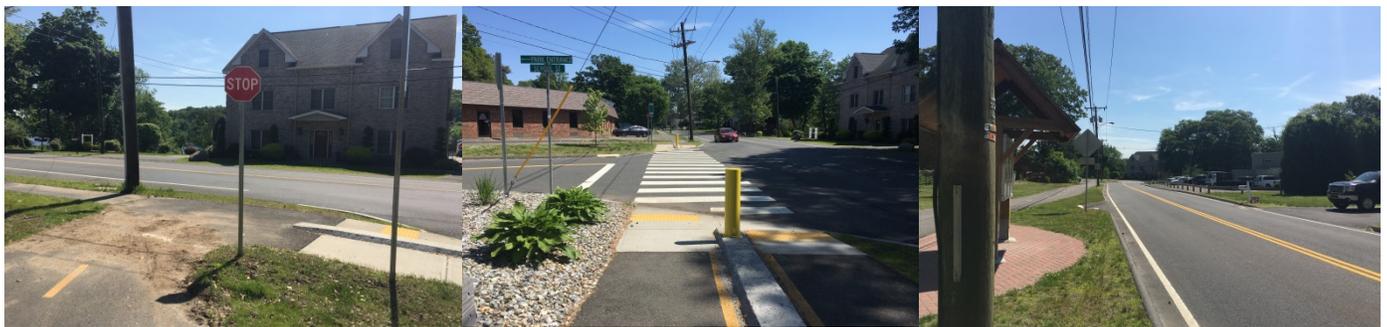
**1. SCHOOL STREET (Urban area crossing with overhead lighting)**

*Starting from left: (i) Eastbound approach of shared use path covered in dirt, (ii) Northbound approach of shared use path with bollards and crosswalk (iii) School Street approach and curved geometry*

The crossing is located at a three way intersection of two roadways. The crosswalk is placed right at the intersection of School Street and River Road. The shared use path follows EB/WB direction towards the west of the crossing and diverts to NB/SB direction at the crosswalk. There is light residential and retail development around the vicinity. The stop line on the EB shared use path has dirt covering it and is in poor condition due to its low visibility and faded shared use path markings.

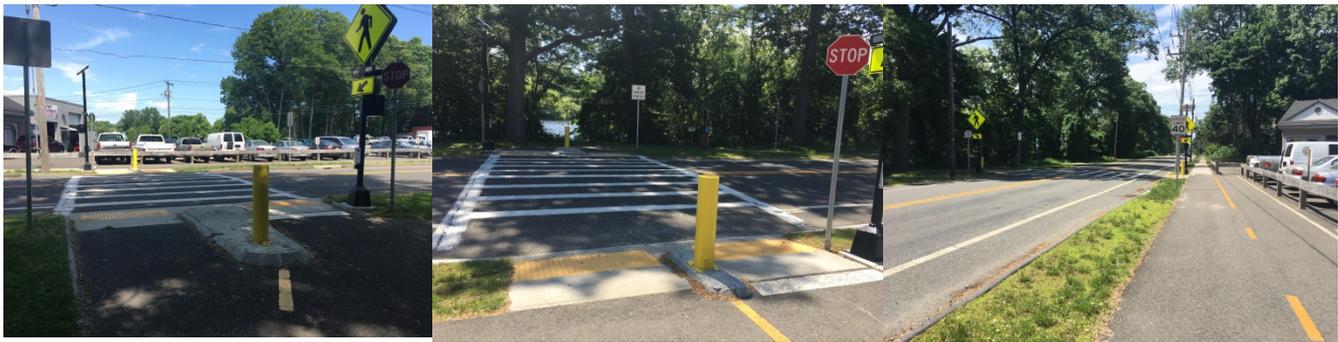
Both approaches of the shared use path had different widths at the crossing.

From Left (i) Westbound approach of shared use path, (ii) Stop sign along eastbound approach of shared use path, (iii) Southbound approach of River Road showing RRFBs under shade

RRFBs are solar powered and are under shade trees in the vicinity. Both approaches of the shared use path have stop signs with clearly defined stop lines. The area in the vicinity of the crossing has a mix of residential and retail development. The RRFBs are supplemented by pedestrian crossing signs and do not specify shared use path crossing or bicycle crossing.

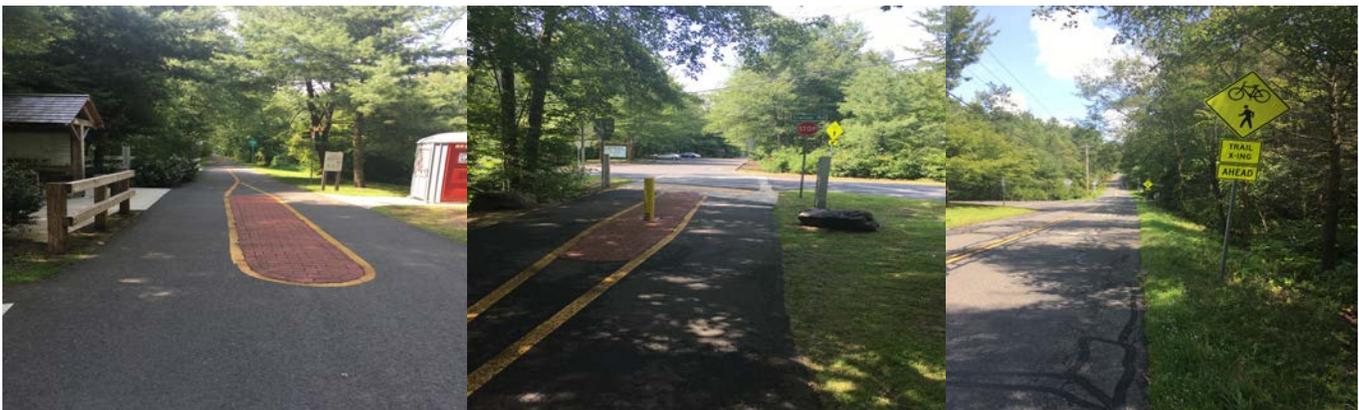
Only the northbound approach has a brick median with a bollard. The Southbound approach of the shared use path is located in the parking lot adjacent to Station Road. The southbound approach to the Station Road crossing does not have a median; however the approach to the parking lot has a median without a bollard.

*From Left (i) Southbound approach of the shared use path within the parking lot with amenities, (ii) Northbound approach of shared use path, (iii)Tilted advance warning sign along eastbound approach of Station Road and thick vegetation along the sides in absence of shoulders*

The crossing is located in a residential area. The shared use path navigates through the parking lot along the southbound approach to the Station Road crossing. The shared use path approach towards the parking lot is highlighted by a brick median. A map of the trail, bike racks, portable restrooms, and benches have been installed in the vicinity of the shared use path approach to the parking lot.

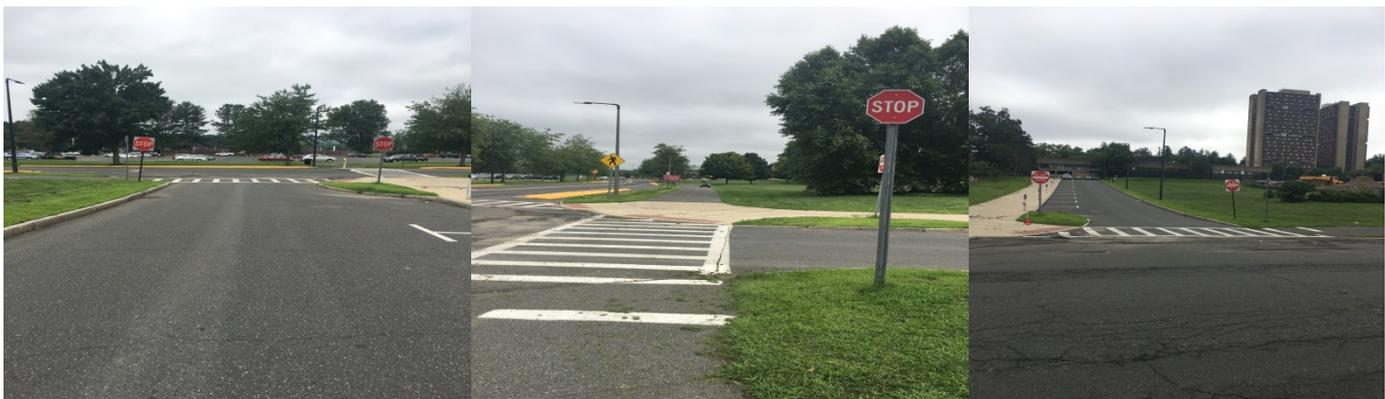
The northbound approach of the shared use path has a stop line which is absent along the southbound approach. The southbound approach has a concrete ramp with divided tactile warning plates providing access to the two crosswalks across Southwest Circle and University Drive.

From Left (i) Southwest Circle driveway Exit, (ii) View from northbound approach of shared use path depicting crosswalk and concrete ramps along the southbound approach, (iii) View form University Drive showing Southwest Circle Exit.

The crossing is located along a one way approach exit from the Southwest Circle driveway. The shared use path approaches are very busy at this location which is situated within the University of Massachusetts campus.

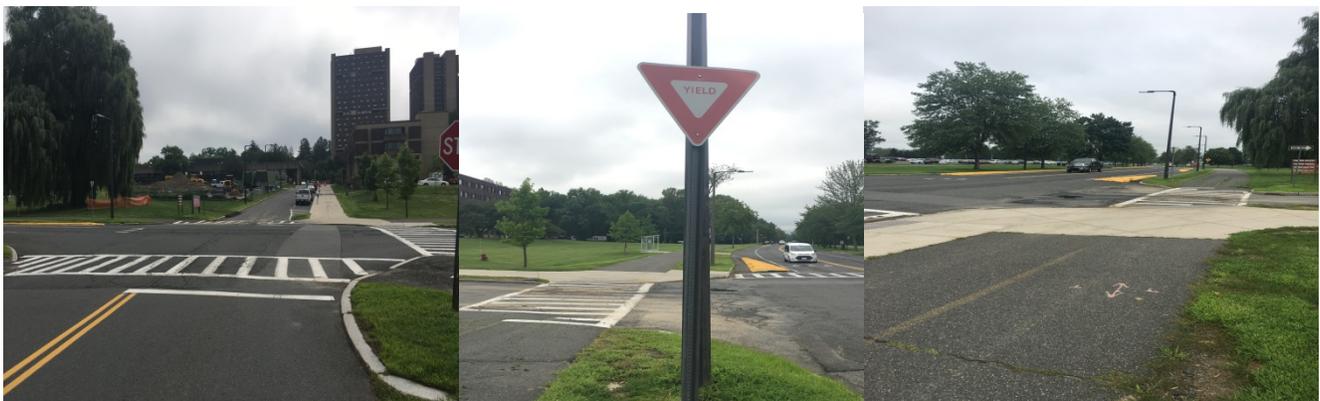
The southbound approach of the shared use path has a yield sign.

*From Left (i) View form UMASS parking lot showing Southwest Circle Entry, (ii) Yield sign along the southbound approach of the shared use path, (iii) Concrete ramp along northbound approach of the shared use path*

The crossing is located across the driveway for the University of Massachusetts Parking lot along the west side of University Drive. The crossing is located along a one way approach entry into Southwest Circle. The shared use path approaches are very busy at this location which is situated within the University of Massachusetts campus.

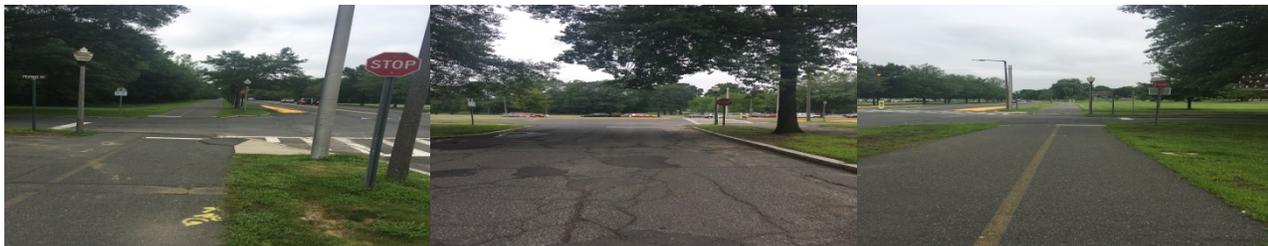
The 'Stop' sign at the southbound approach of the shared use path is placed before the stop line.

Starting from left: (i) Southbound approach of the shared use path, 'Stop' sign installed before the stop line (ii) Fearing Street approach (iii) Northbound approach of the shared use path showing absence of crosswalk

The crossing is located at the intersection of Fearing Street and University Drive. At the time of the site visit no crosswalk markings were installed to mark the shared use path crossing. The crosswalk markings existed across University Drive for pedestrians.

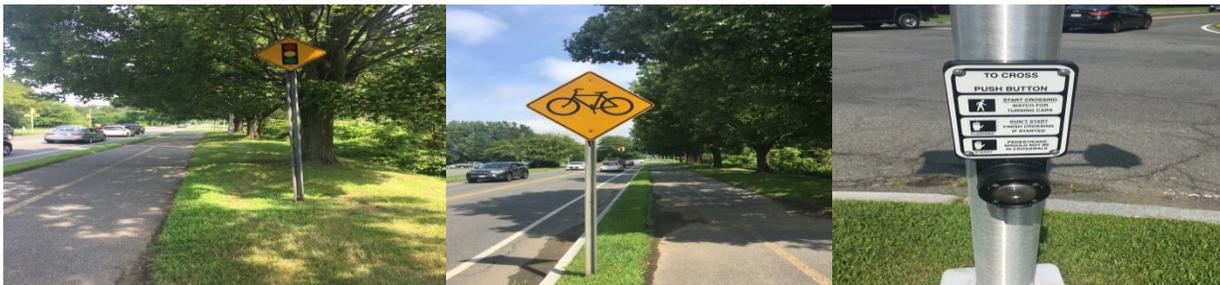
The northbound approach of the shared use path has been recently updated and has an Americans with Disabilities Act (ADA) compliant push button to activate the crosswalk signal.

From Left: (i) 'Signal ahead' sign along the shared use path, (ii) Advance warning sign along eastbound approach of Amity Street (iii) ADA compliant push button along northbound approach of the shared use path

The signal allocates approximately 15 seconds of 'Walk' time for the users of the shared use path to navigate through the cross walk across Amity Street.

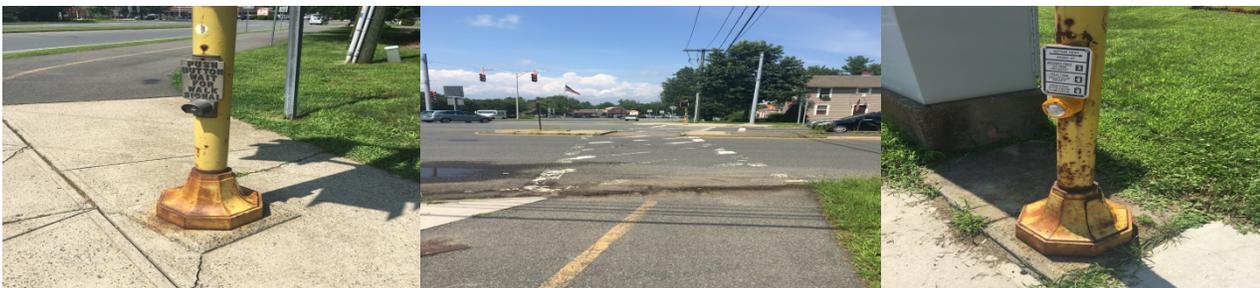
Northbound approach has newly installed ADA compliant push button. Southbound approach does not have an upgraded push button.

*From Left: (i) Push button located at the southbound approach of the shared use path (ii) Faded crosswalk markings (iii) Push button located along northbound approach of the shared use path*

The signal allocates approximately 15 seconds of 'Walk' time for the users of the shared use path to navigate through the cross walk across Northampton Road. The crossing is located in a highly developed area with lot of retail and residential land use.

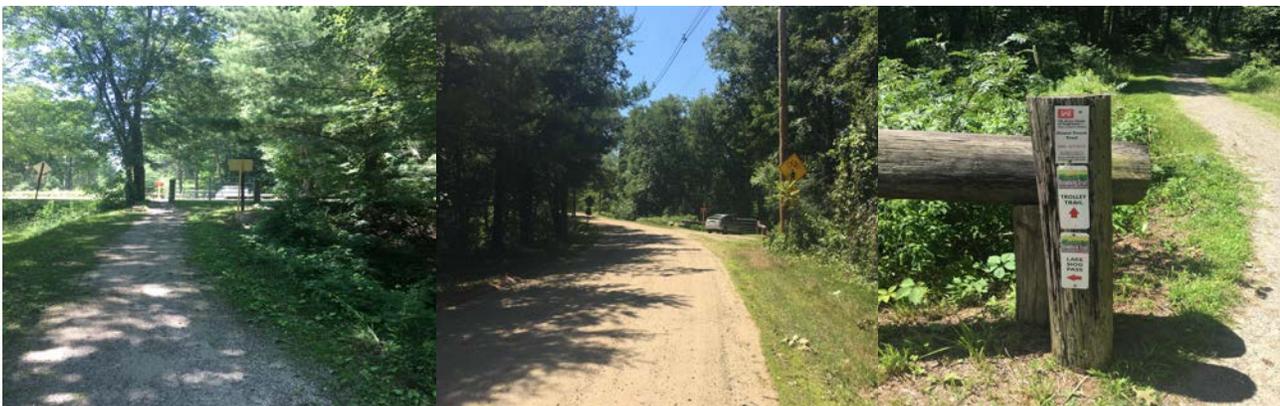
Sight distance along both directions of the eastbound approach is limited because of overgrown vegetation. The approaches of the shared use path are gated to restrict motorized vehicles from entering. Three small information/guide signs are posted along the pole of the gate providing the name and information about the trail and the roadway.

From Left: (i) Gate at the approach of the shared use path, (ii) View from Five Bridge Road approach of shared use path signs covered in vegetation (iii) Signs mounted on a post of a guardrail along the crossing

The crossing is located in very remote rural area with very light traffic. Both the roadway and the shared use path are unpaved. The signs posted along the guardrail posts at the crossing refer to the shared use path as Brimfield Trolley Trail, and U.S. Army Corps. Of Engineers Grand Trunk Trail. The Titanic Rail Trail is the official name as per the website for the shared use path.

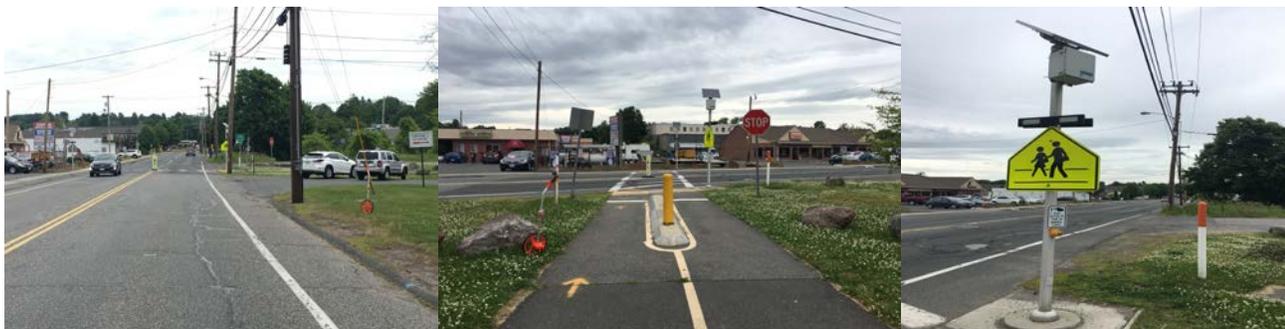
Southbound approach had a RRFB activation switch.

Photos from left: (i) View from Maple Street eastbound approach and temporary sign in the center of crossing, (ii) Shared-use path northbound approach 'Stop' sign and median with bollard (iii) RRFB activation switch

The shared use path ends at the Maple Street crossing. The crossing is located in a commercial area and has more pedestrians on weekdays compared to bicyclists.

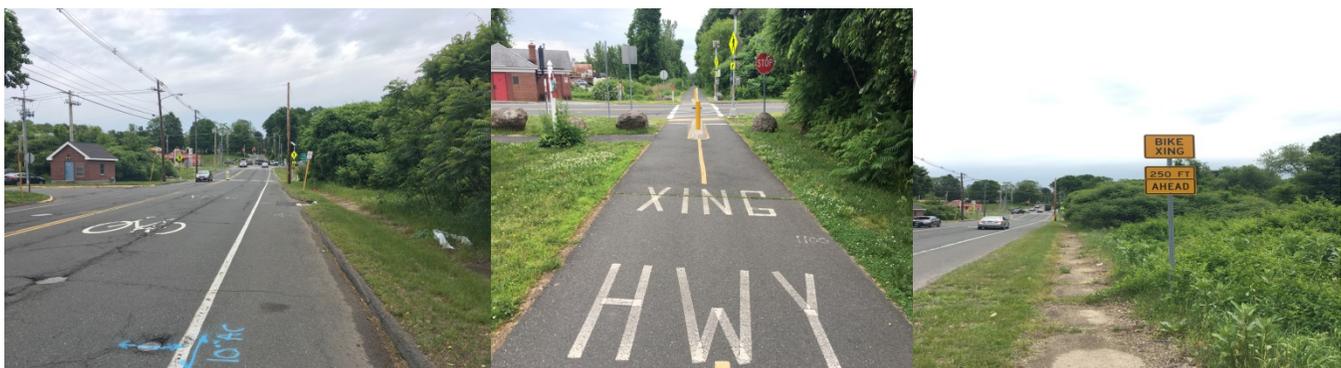
Photos from left: (i) Chestnut Street pavement markings and temporary sign in the center of the crossing, (ii) Shared-use path pavement markings and bollards (iii) Advance warning sign along Chestnut Street approach

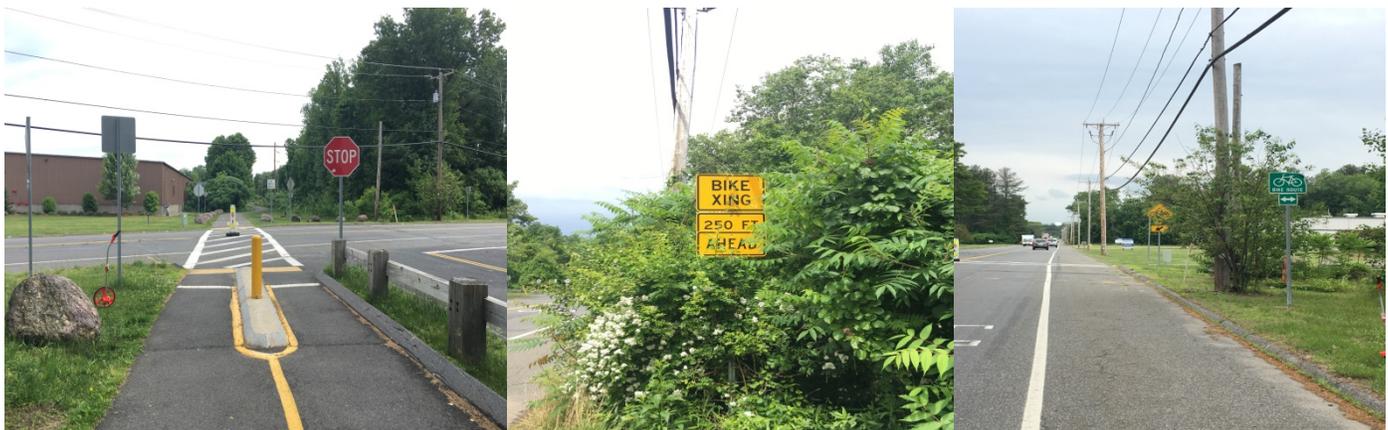
Photos from left: (i) Shared use path approach showing bollards and temporary sign, (ii) Advance warning sign for westbound Industrial Drive approach covered by vegetation (iii) Shared use path sign and additional Bike Route sign along Industrial Drive

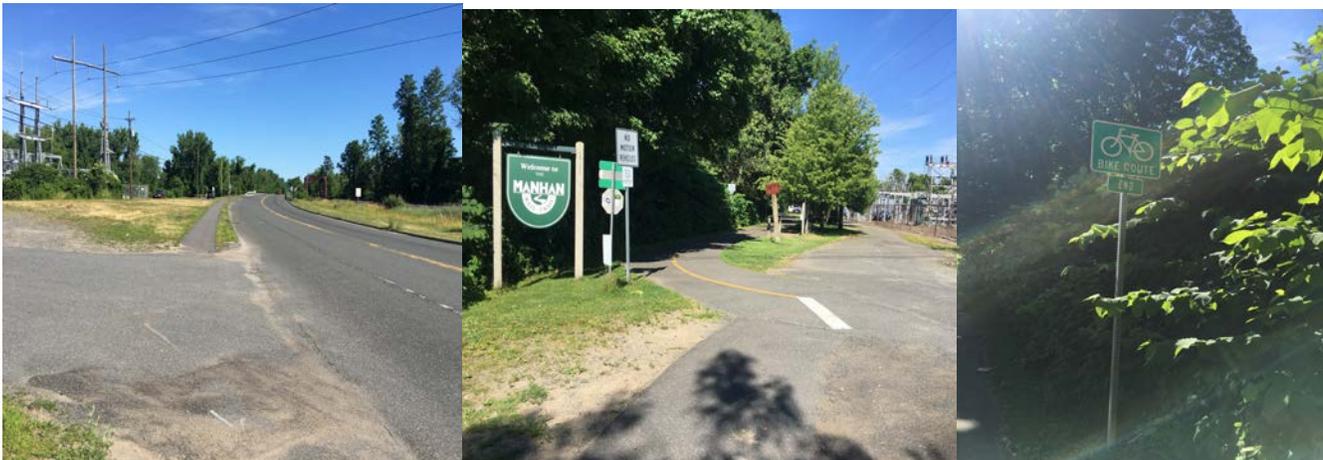
Photos from left: (i) View from North Street northbound approach showing driveway to the shared use path parking lot (ii) Shared-use path 'entrance within the parking lot (iii) 'Bike Route Ends' sign along the shared use path eastbound approach.

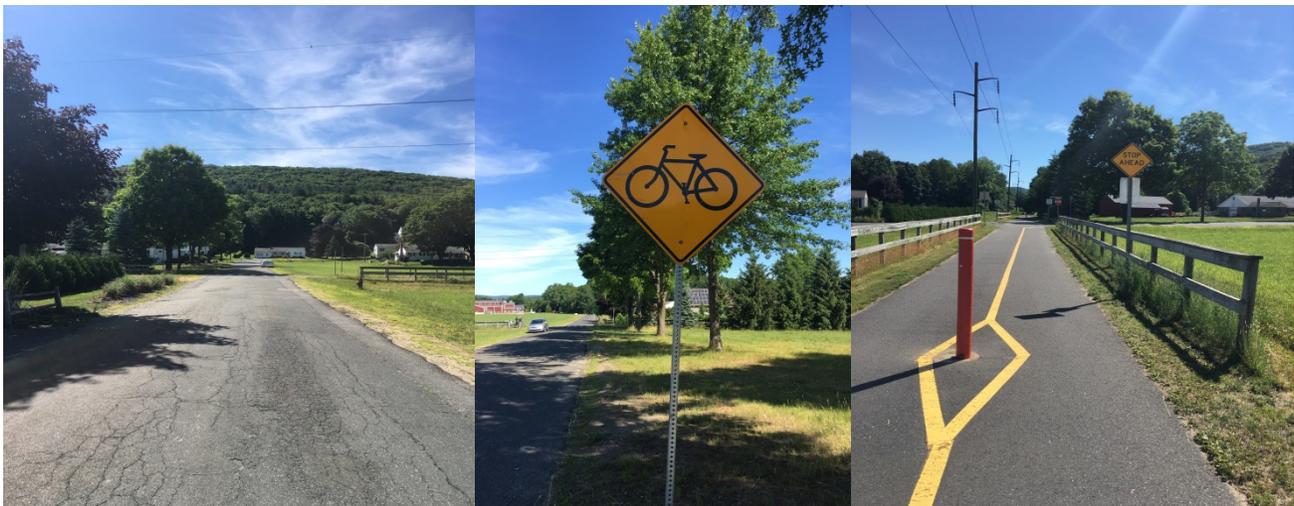
Photos from left: (i) View from Fort Hill Road approach, (ii) Advance warning sign along Fort Hill Road (iii) Shared use path approach

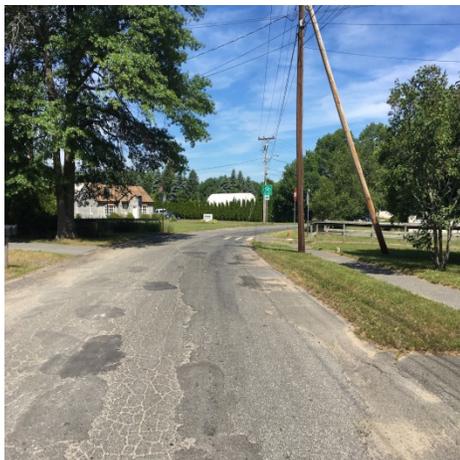
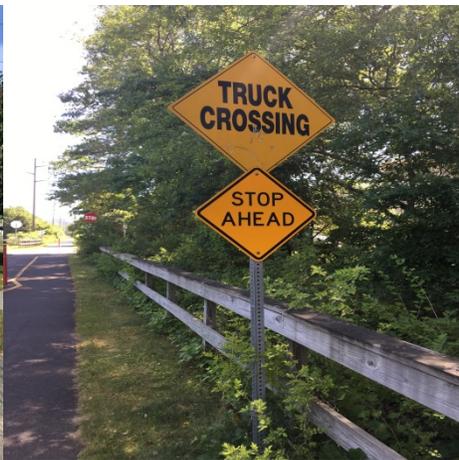
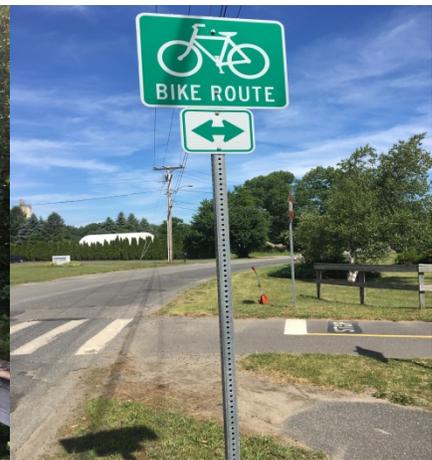
The sight distance along both approaches of the Manhan Rail Trail is limited because of over grown vegetation.

Photos from left: (i) View from Arthur Street approach showing shared use path sign, (ii) Advance Warning sign along shared-use path approach (iii) Shared use path sign along the crossing

The advance warning sign along both approaches of the shared use path alerts non-motorists of the upcoming 'Stop' sign and about truck traffic on Arthur Street.

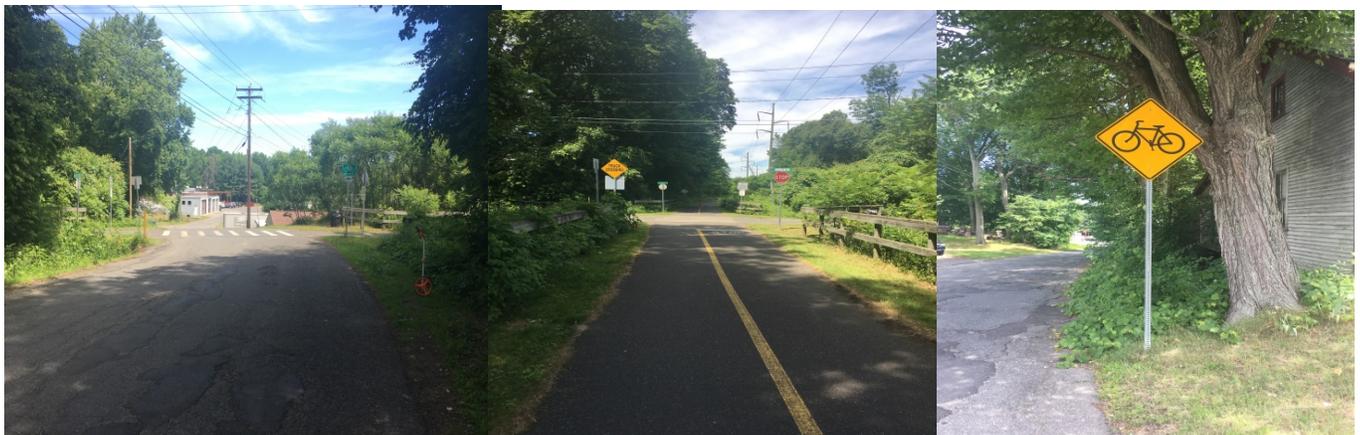
Photos from left (i) View from Gosselin Drive approach, (ii) Shared-use path approach (iii) Shared use path sign along the roadway

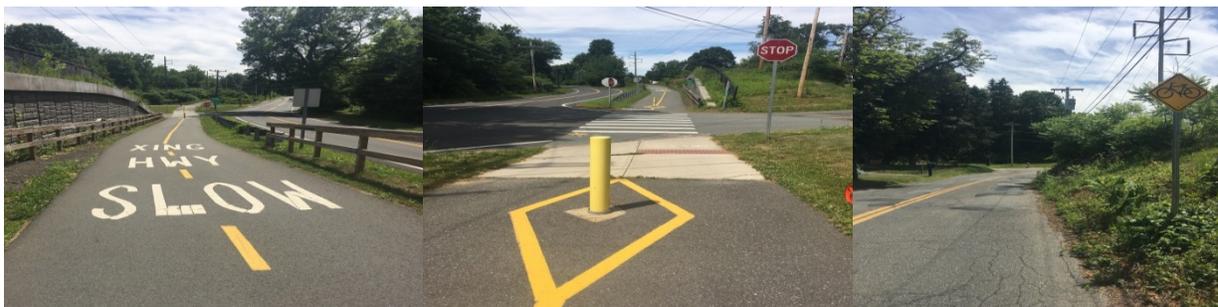
The northbound approach of the shared use path has a ramp and a tactile warning plate which is absent on the southbound approach. The northbound approach stop line is faded.

*Photos from left (i) Southbound approach of shared use path and embankment along Lovefield Street, (ii) Northbound approach of shares use path with ramp and tactile warning plate (iii) Lovefield Street southbound/westbound approach before the curvature*

**Remarks:** The crossing is located at the three-way intersection of Lovefield Street and O’Neil Street in a residential area with a low volume of traffic. The geometry of the roadway creates sight distance issues for shared use path and roadway users.

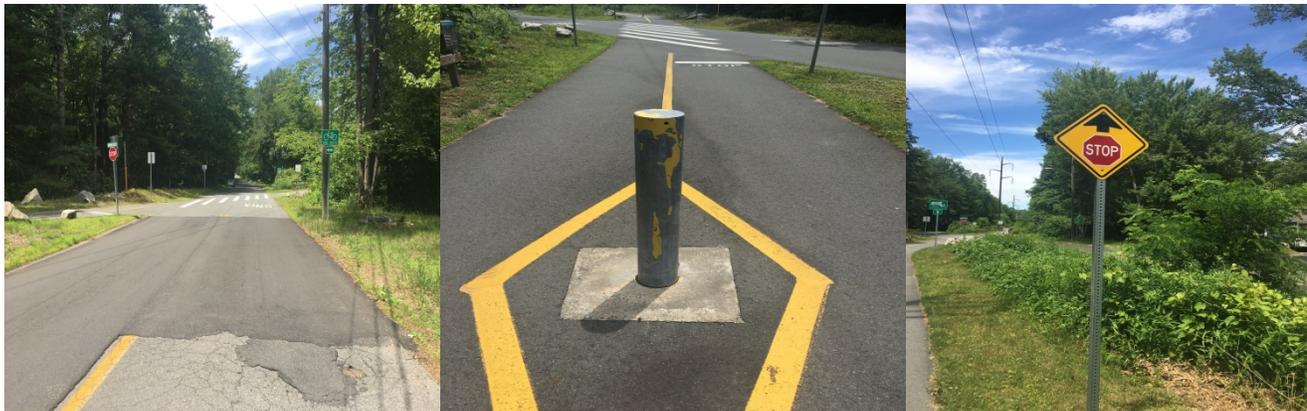
*Photos from left: (i) View from Lovefield Street approach with faded pavement markings, (ii) Bollard losing paint color (iii) Advance warning sign along shared use path northbound approach.*

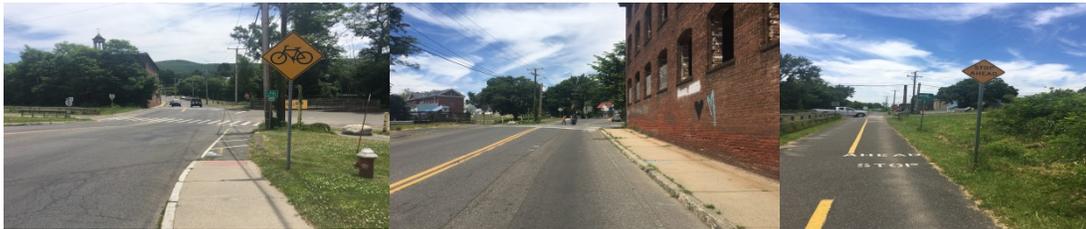
Photos from left: (i) View from eastbound approach of Ferry Street (ii) View from westbound approach of Ferry Street and building located in the northeast corner of the crossing, (iii) Southbound approach of the shared use path

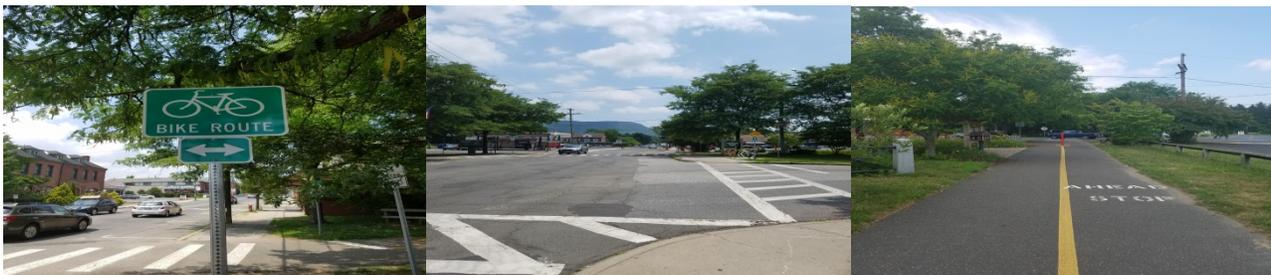
There are supplemental pavement markings including the legend 'Stop Ahead' in advance of the shared use path crossing.

*Photos from left: (i) Shared use path sign at the crossing, (ii) View from northbound approach of Union Street in the vicinity of its intersection with Liberty Street, (iii) Shared use path approach with bollard and pavement markings.*

**Remarks:** The crossing is located in the vicinity of the intersection of Union Street and Liberty Street in a commercial business district.

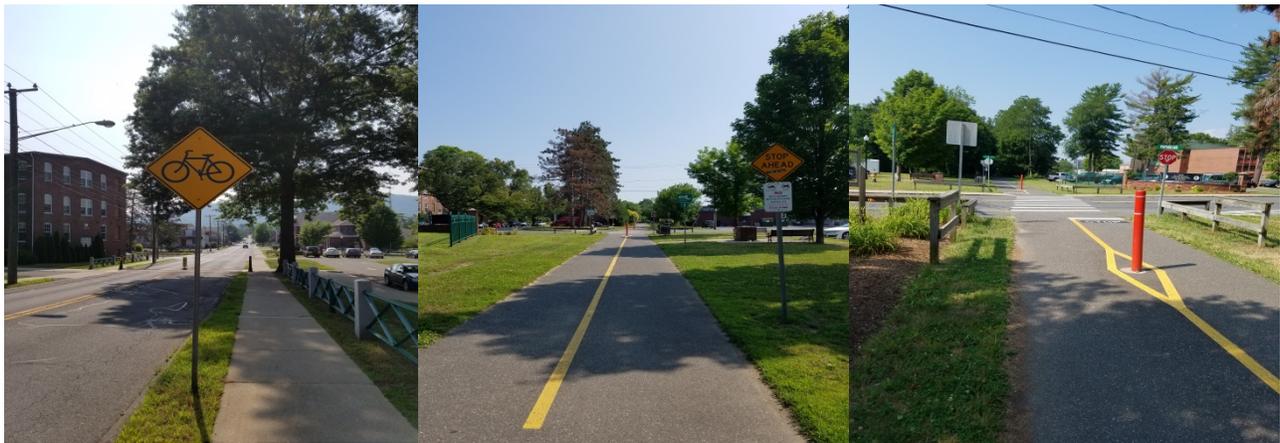
Photos to capture (i) View from Payson Avenue approach, (ii) View from northbound approach of the shared use path showing advance warning sign (iii) Red bollard along the shared use path approach

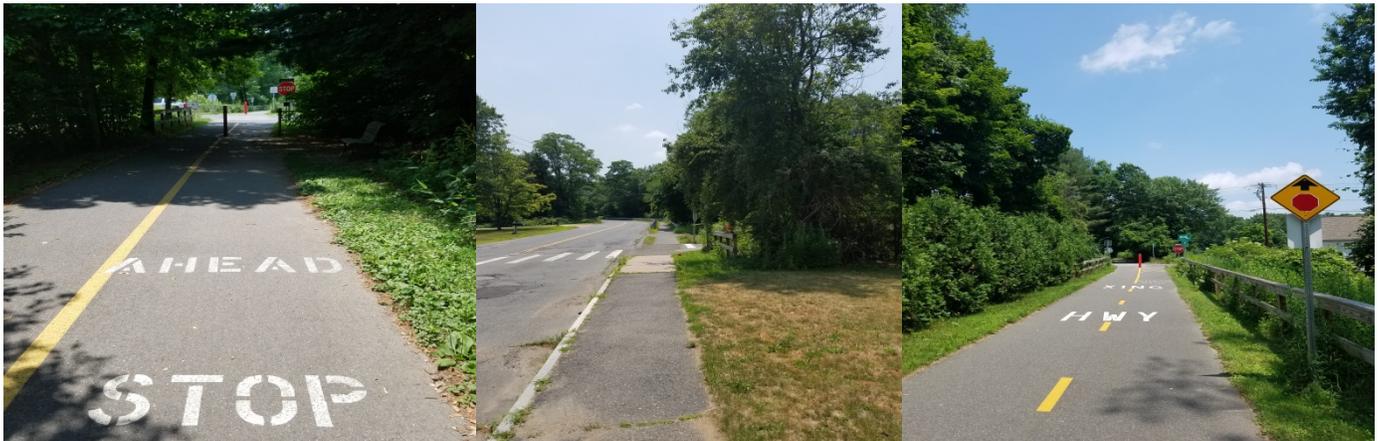
Photos to capture (i) View from shared use path approach showing advance pavement markings, (ii) View from South Street approach, (iii) Advance warning sign and supplemental pavement markings along shared use path approach

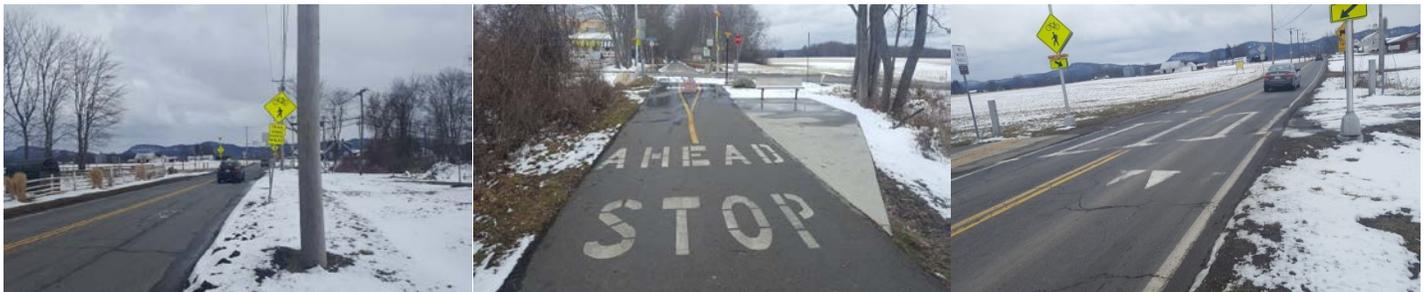
Both approaches of the shared use path have 'Stop' signs and 'Stop Ahead' pavement markings. Maps of the Mass Central/Norwottuck Rail Trail and benches have been installed along both sides of the shared use path.

From left: (i) View from South Maple Street southbound approach showing advance warning signs, RRFB, faded pavement markings, (ii) Pavement markings and Stop sign along Mass Central / Norwottuck Rail Trail East bound approach, (iii) Faded crosswalk markings and shark teeth yield markings

**Remarks:** Advance pavement markings along both directions of South Maple Street have completely faded. Shark Teeth Yield lines and cross walk markings at the intersection have also faded. This location has retail development in the immediate vicinity; however there are no sidewalks to connect the intersection with the retail establishments on both sides of South Maple Street.

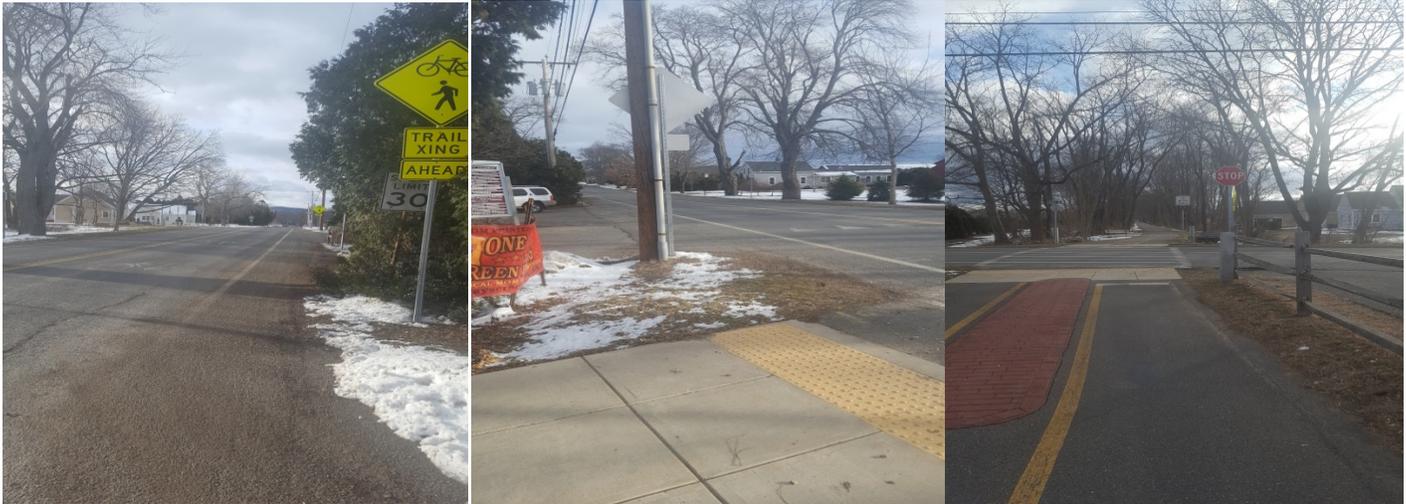
From left: (i) View from South East Street southbound approach showing advance warning signs partially covered by vegetation and faded pavement markings, (ii) Sight distance north of Mass Central / Norwottuck Rail Trail east bound approach, (iii) Shared-use path 'Stop' sign and crosswalk markings

**Remarks:** The existing pavement markings have faded and the advance warning sign for East Street south bound approach is partially covered by vegetation. The sight distance to the north for the eastbound approach of the shared use path is limited because of the road geometry, existing vegetation and utility poles. The advance warning sign for the shared use path crossing along the southbound approach of East Street is partially covered by vegetation.

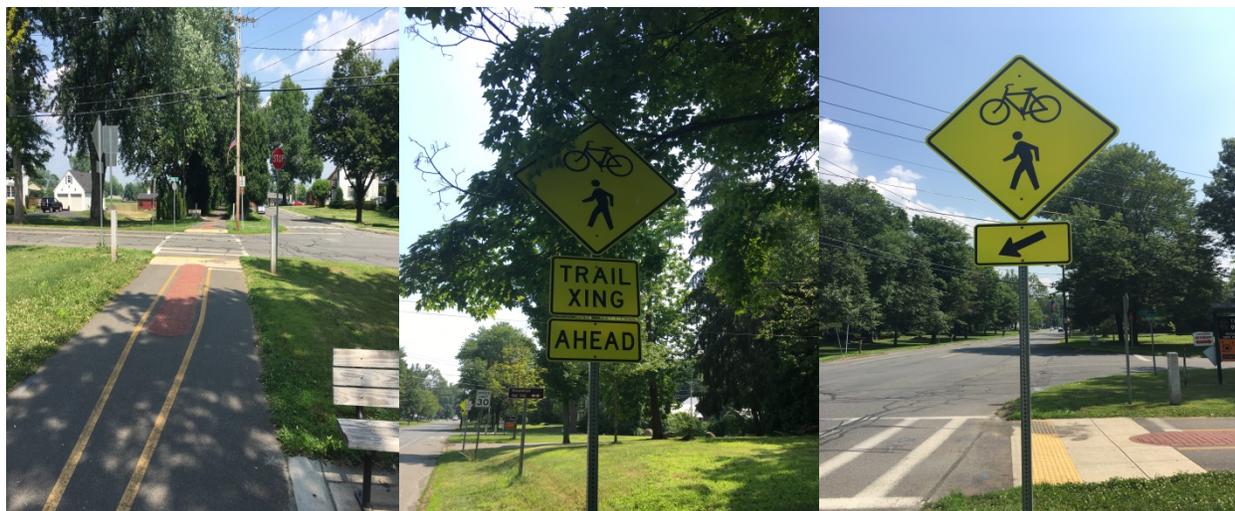
Photos from left: (i) View from shared use path approach, (ii) Advance warning signs along Middle Street, (iii) Shared use path signs at the crossing.

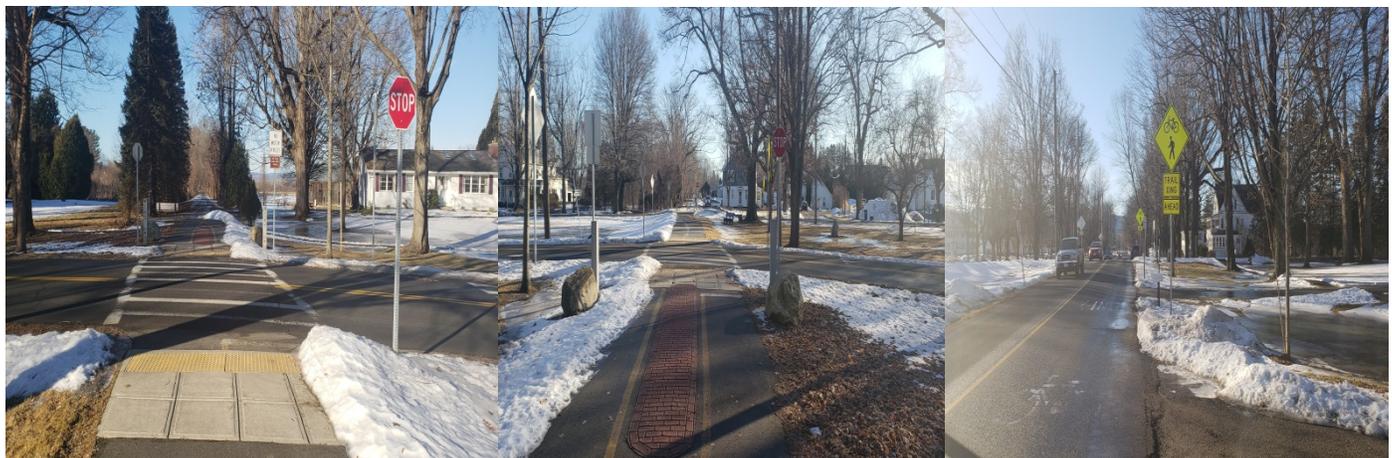
Photos from left: (i) View from shared use path approach, (ii) Shared-use path 'Stop' sign and crosswalk markings, (iii) West Street northbound approach.

**Remarks:** At the time of the field visit, West Street was being repaved. As a result, the condition of the pavement and crosswalk markings should improve to 'Excellent'.

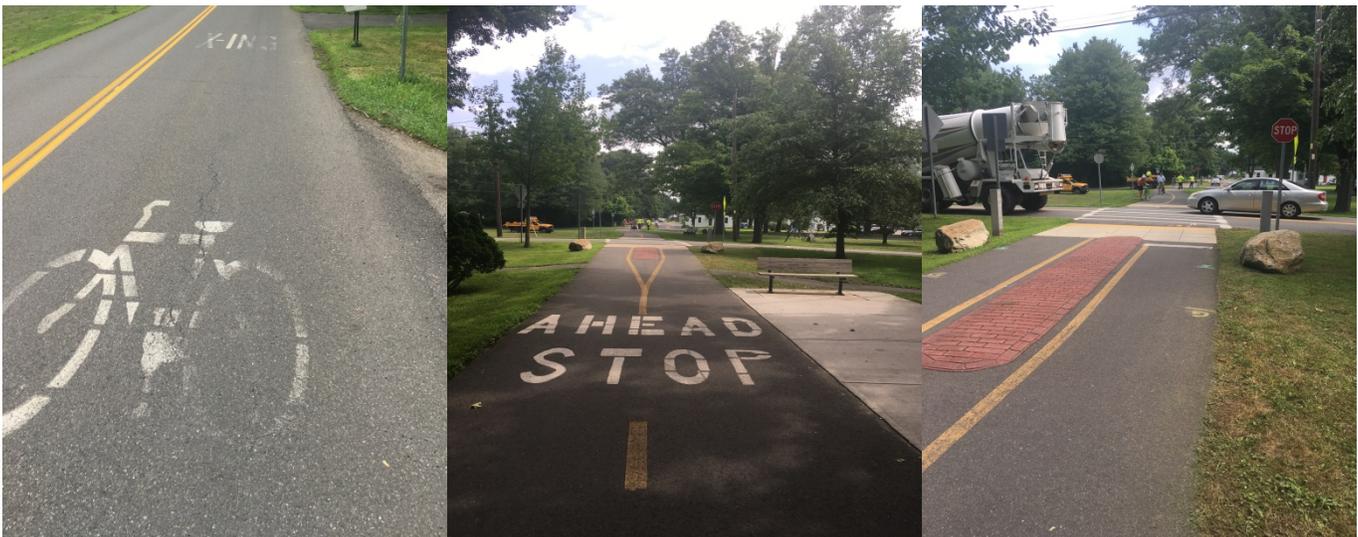
Photos from left: (i) Pavement markings along the roadway (ii) Shared-use path pavement markings (iii) Westbound approach of shared use path with median
