FEBRUARY 2019

# AT-GRADE SHARED USE PATH AND ROADWAY INTERSECTIONS IN THE PIONEER VALLEY

Prepared under the direction of the Pioneer  
Valley MPO by:

**PIONEER VALLEY PLANNING COMMISSION**

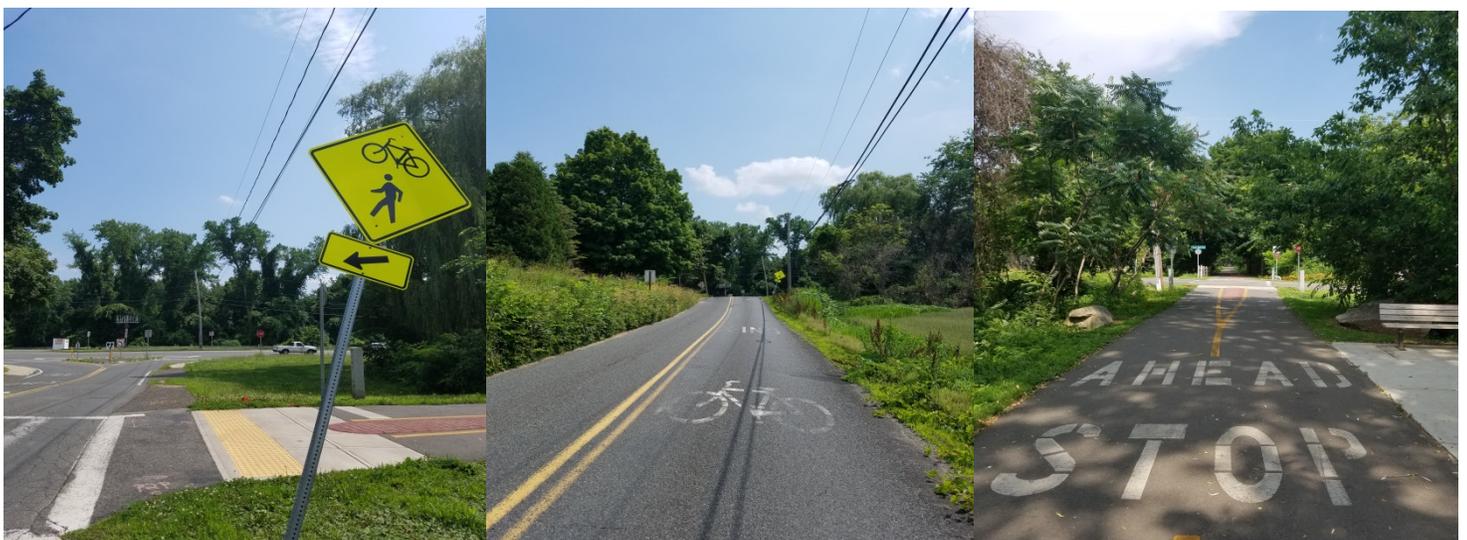
Photos from left: (i) Tilted sign post along southbound approach of Cross Path Road, (ii) Pavement markings along the roadway, (iii) Pavement markings along shared use path

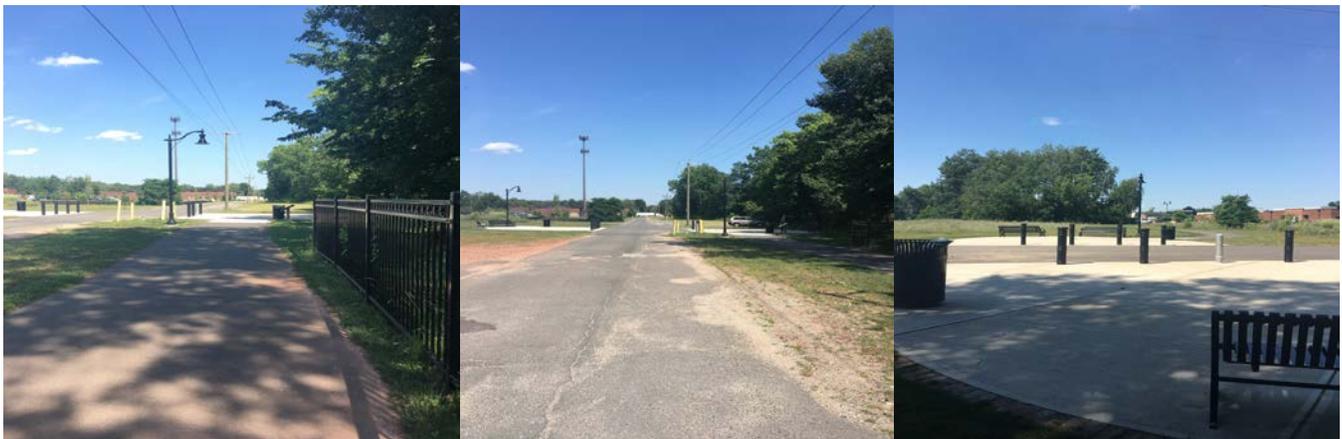
Both approaches of the shared use path have multiple bollards to restrict motor vehicles from entering the path.

*Photos from left: (i) Bollards and overhead lighting along shared use path approach, (ii) View from First Avenue, (iii) Benches and trash cans along shared use path approaches.*

**Remarks:** The crossing is located in an area with low volume of traffic. Benches have been installed along both approaches of the shared use path along with trash cans and overhead lights.

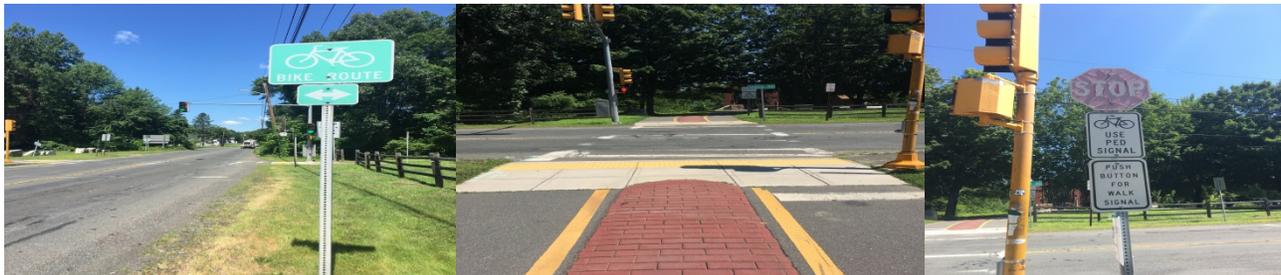
Photos from left (i) View from Street approach showing shared use path sign (ii) View from shared use path approach showing faded crosswalk markings (iii) Stop sign along northbound approach of shared use path

**Remarks:** The crossing is located on a high traffic volume corridor. There is a parking lot on Damon Road in the vicinity of the crossing. The crossing has a push button activated signal which allocates approximately 13 seconds of crossing time. The pavement markings and crosswalk markings need to be repainted at this crossing.

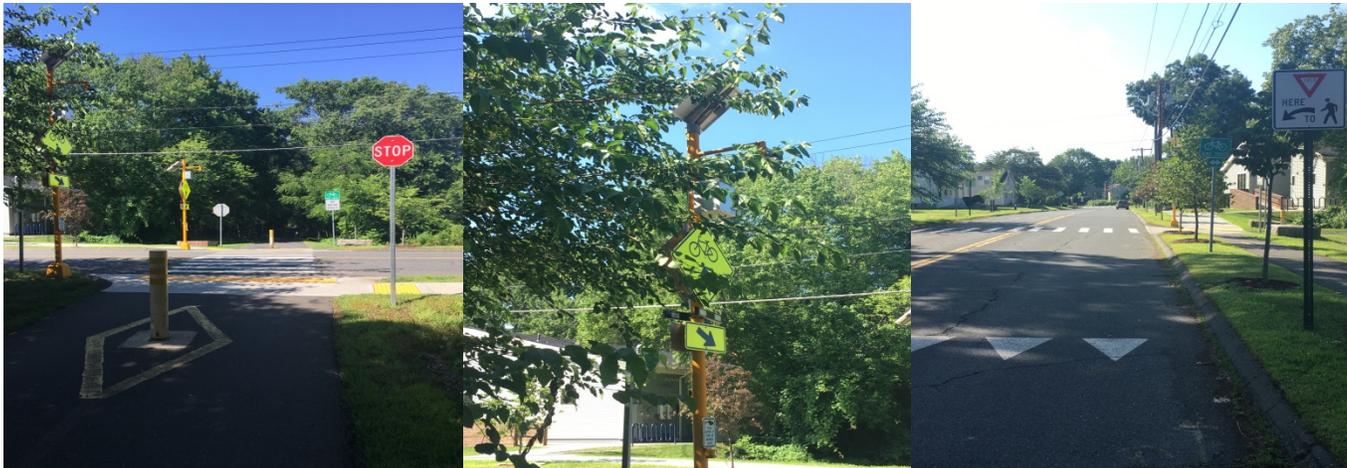
Photos from left: (i) View from the shared use path approach (ii) RRFB partially covered by vegetation (iii) View from Bates Street approach showing 'Yield to Pedestrians' sign and crosswalk

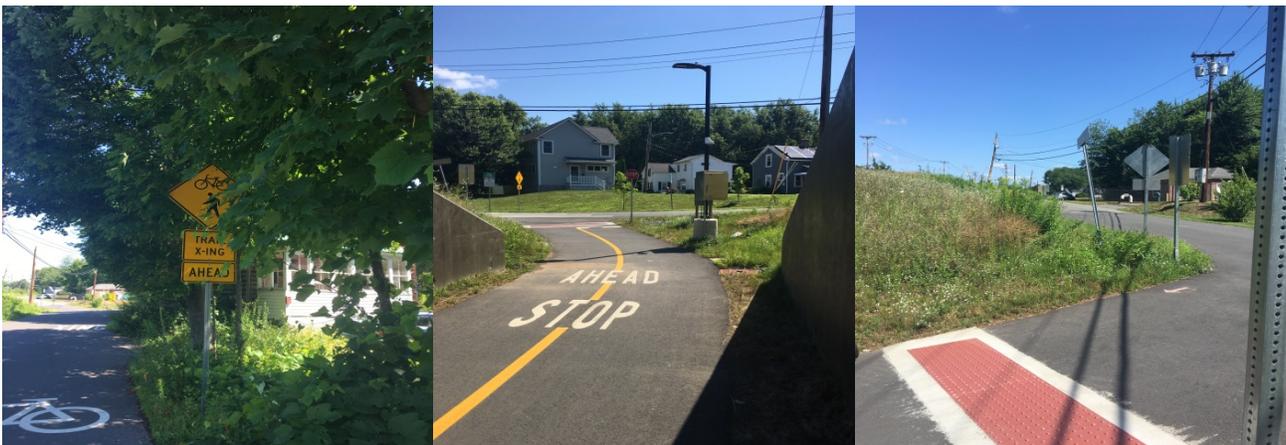
The westbound approach of the shared use path has an advance warning sign to inform users about the approaching stop. The sight distance to the south from the eastbound approach at the stop line is restricted by overgrown vegetation and geometry.

Photos from left : (i) View from northbound approach of Woodmont Road showing advance warning sign partially covered by vegetation, (ii) Eastbound approach of the shared use path going through the tunnel (iii) Restricted sight distance from the stop line of the eastbound approach of the shared use

The crossing is located in a residential area with a very low volume of traffic. The eastbound approach of the shared use path goes through a tunnel under the railroad in the immediate vicinity of the crossing.

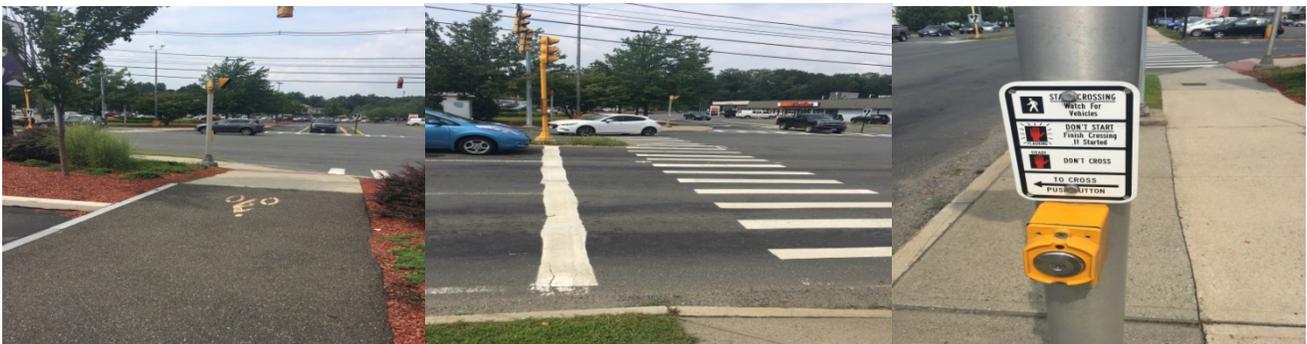
Photos from left (i) Shared use path approach, (ii) Crosswalk without median (iii) ADA compliant push button

**Remarks:** The crossing is located at a four way intersection of King Street with the Shopping Center. The shared use path signs and advance warning signs along the roadway are missing. It is recommended that a median be considered for the King Street crosswalk to allow for pedestrian refuge area while crossing multiple lanes of traffic.

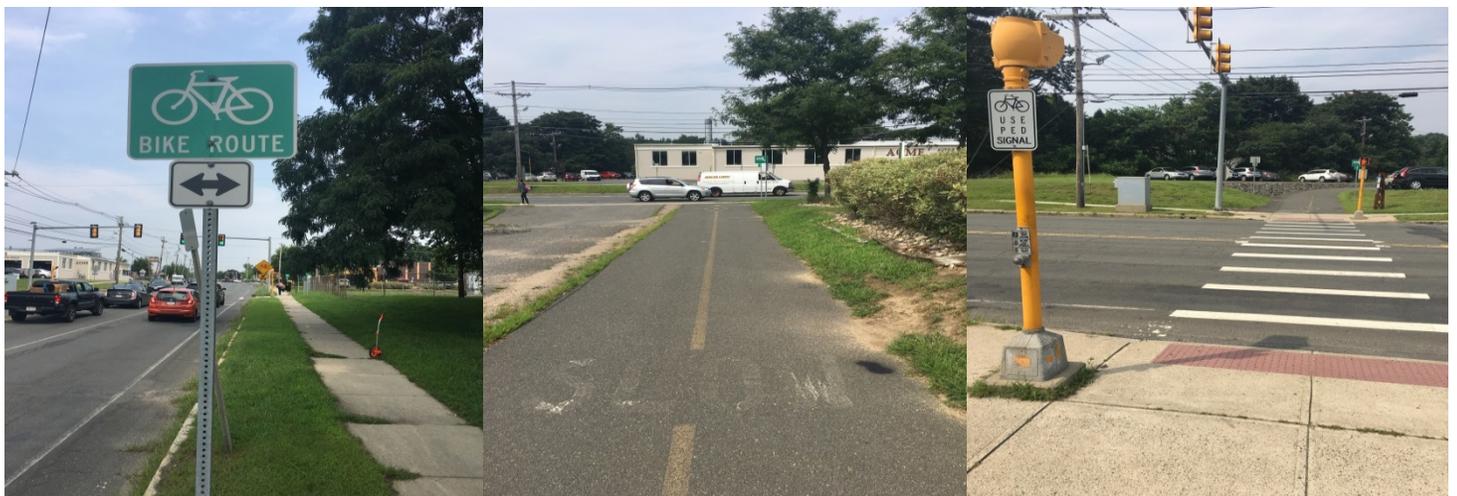
Photos from left (i) Green bike route signs along the crossing, (ii) Faded pavement markings along the shared use path approach, (iii) Push button activated signal and crosswalk at the crossing

**Remarks:** The crossing is located in commercial area with a high volume of traffic and shared use path users. The shared use path connects to the sidewalks in the vicinity of the shopping center. The signal allocates approximately 20 seconds of walk time to cross King Street. Proposed King Street Reconstruction project is currently at 75% design stage which proposes narrowing down of King Street south of the crossing to accommodate bike lanes.

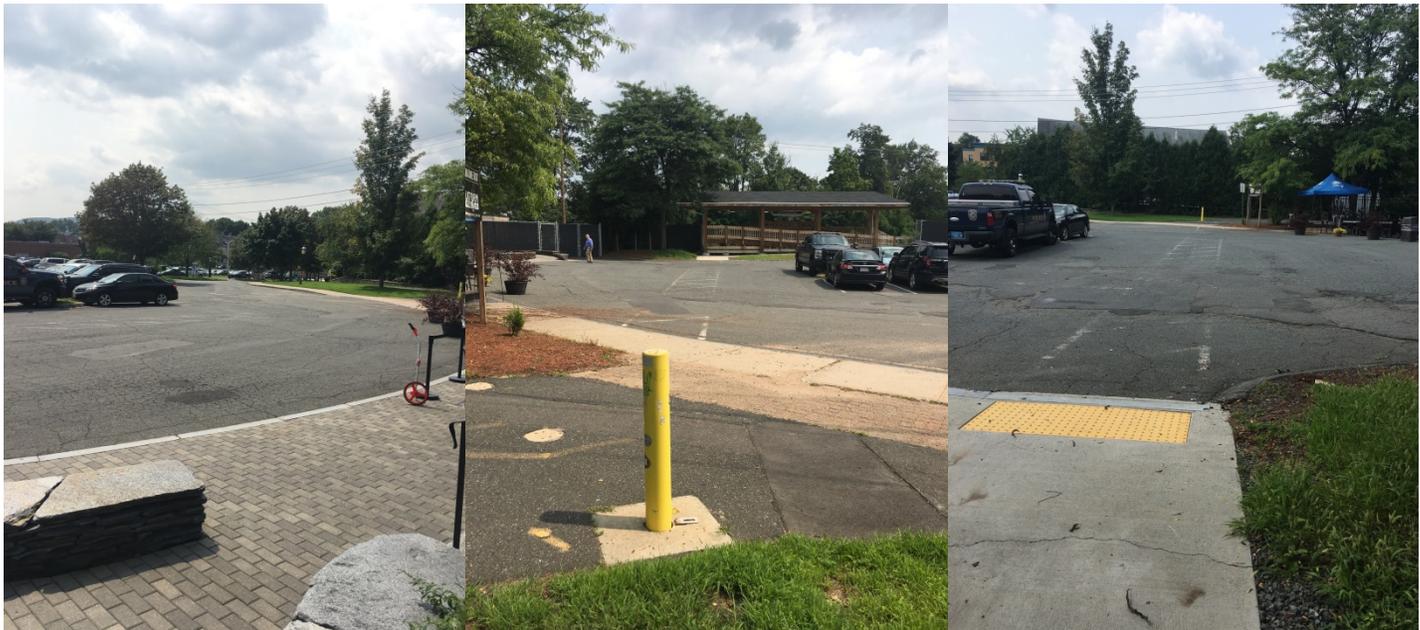
**Remarks:** This crossing is located within the Northampton Union Station parking lot. The crosswalk markings are faded at several locations. It is recommended this crosswalk be repainted.

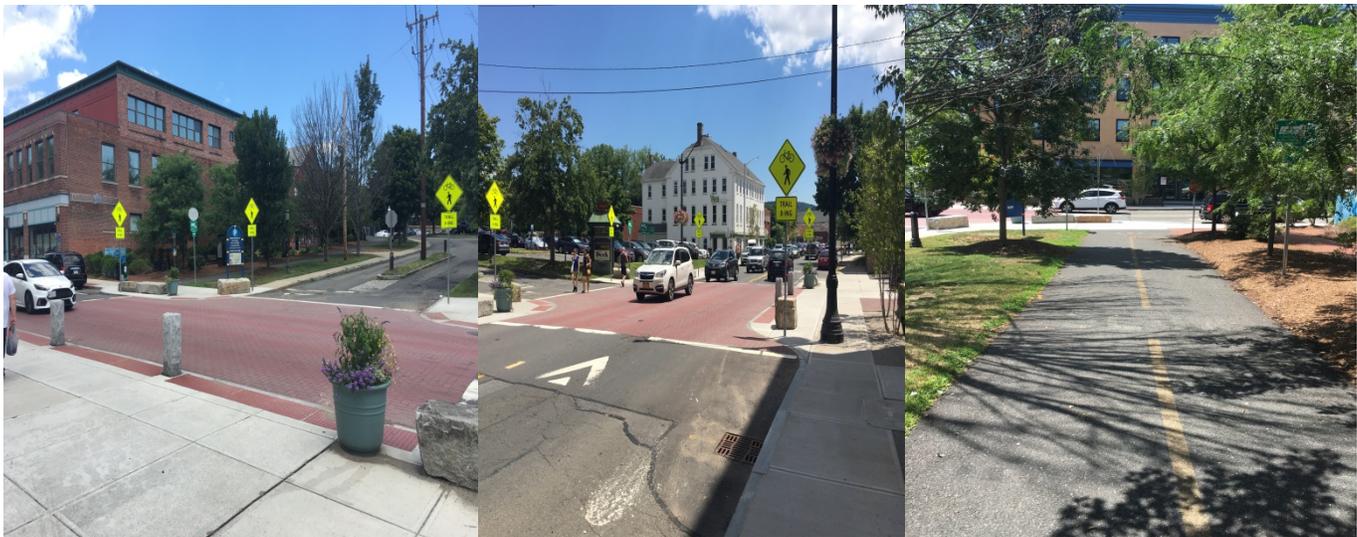
Pavement markings along both approaches of the shared use path have faded in several locations. The 'Stop' sign for the westbound approach is partially covered by vegetation. The eastbound approach of the shared use path has granite bollards.

*Photos from left (i) View from eastbound approach of the shared use path showing rock bollards and raised brick crosswalk platform, (ii) View from Pleasant Street approach, (iii) Westbound approach of shared use path showing faded pavement markings and Stop sign covered by vegetation*

**Remarks:** The crossing is a wide raised brick crosswalk.

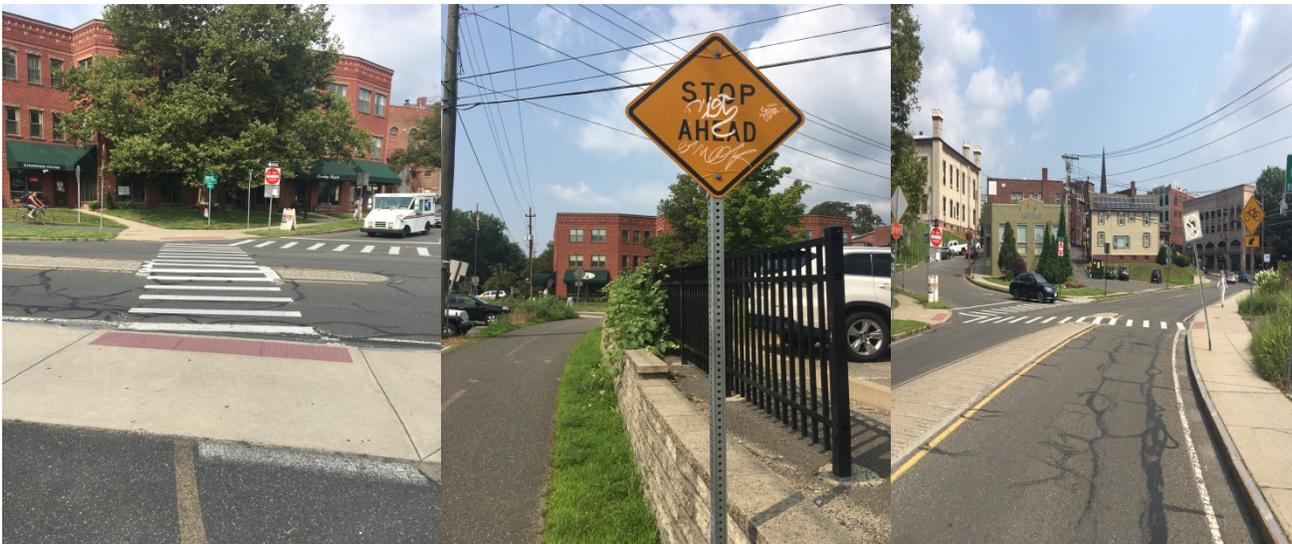
The advance warning sign for the westbound approach is partially covered by graffiti. Pavement markings along the westbound approach have faded in several locations. The eastbound approach does not have pavement markings.

*Photos from left: (i) View from westbound approach of the shared use path, (ii) Advance warning sign for the westbound approach of the shared use path partially damaged by graffiti, (iii) View from southbound approach of Old South Street.*

**Remarks:** The northbound approach of Old South Street has a center median.

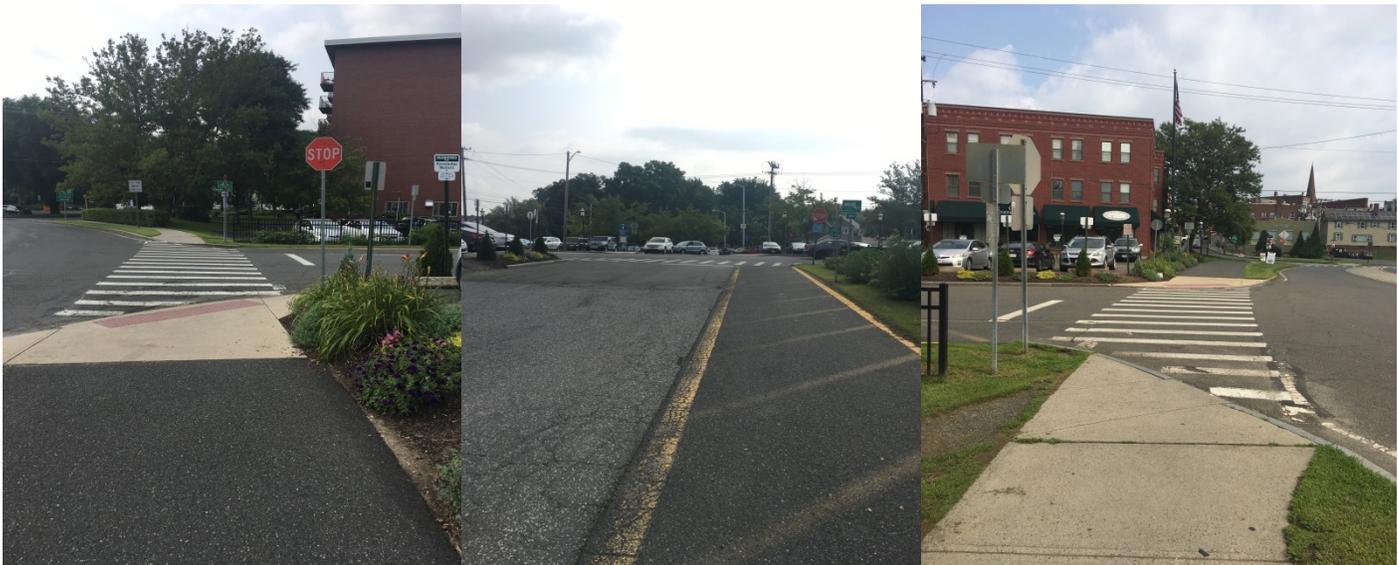
The eastbound approaches of the shared use path and the roadway have a common 'Stop' sign.

*Photos from left: (i) View from southbound approach of shared use path, (ii) View from eastbound approach of Roundhouse Plaza adjacent to the eastbound approach of shared use path, (iii) View of crosswalk from northbound approach of shared use path.*

**Remarks:** The crossing is located at a three way intersection of Roundhouse Plaza and Old South Street. The shared use path approach direction changes from eastbound to northbound at the crossing.

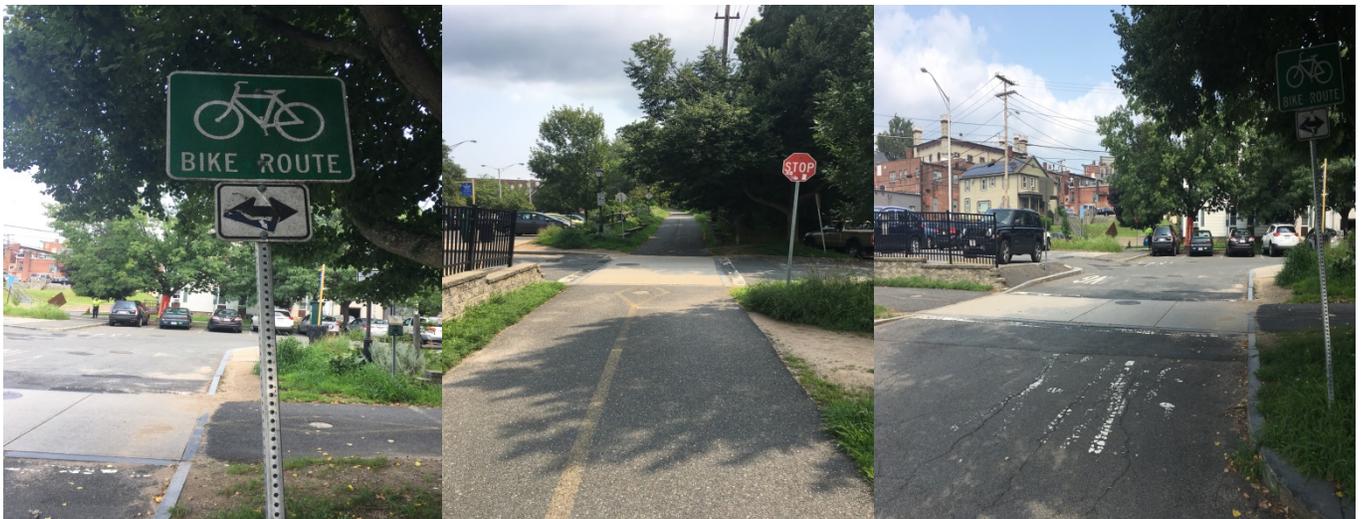
Pavement markings along both approaches of the shared use path have faded in several locations. 'Stop' Signs for both approaches are partially covered in graffiti.

Photos from left: (i) Green bike path signs, (ii) 'Stop' sign along the shared use path approach partially covered by graffiti (iii) Faded pavement markings along the driveway approach

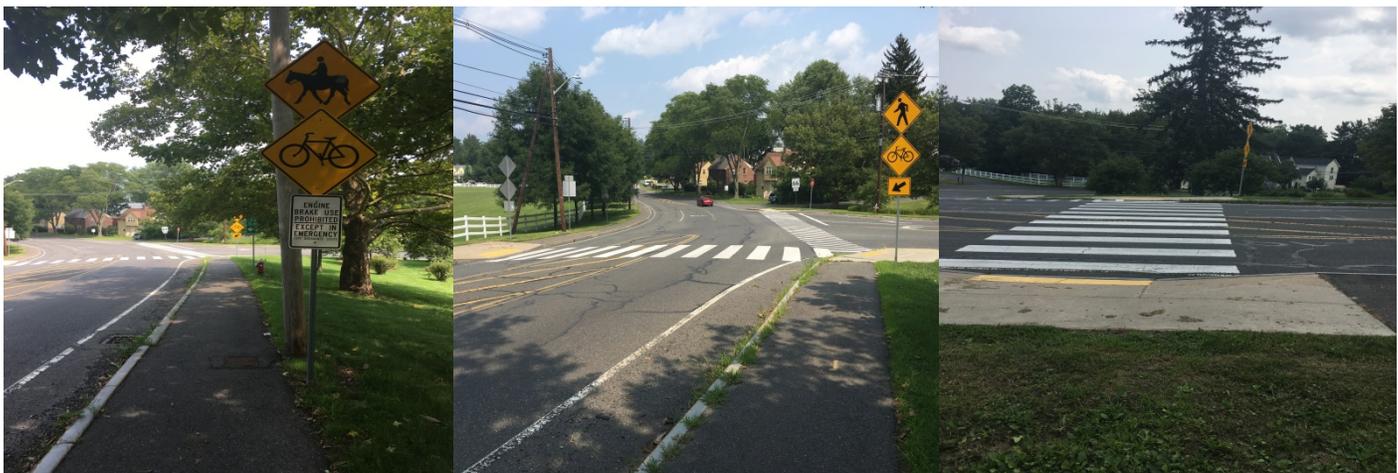
**40. PRINCE STREET / WEST STREET (Urban area crossing with overhead lighting)**

The shared use path provides a connection to another minor trail to the north.

Photos from left: (i) Equestrian sign along roadway, (ii) View from Prince Street approach (iii) Crosswalk viewed from northbound approach of the shared use path

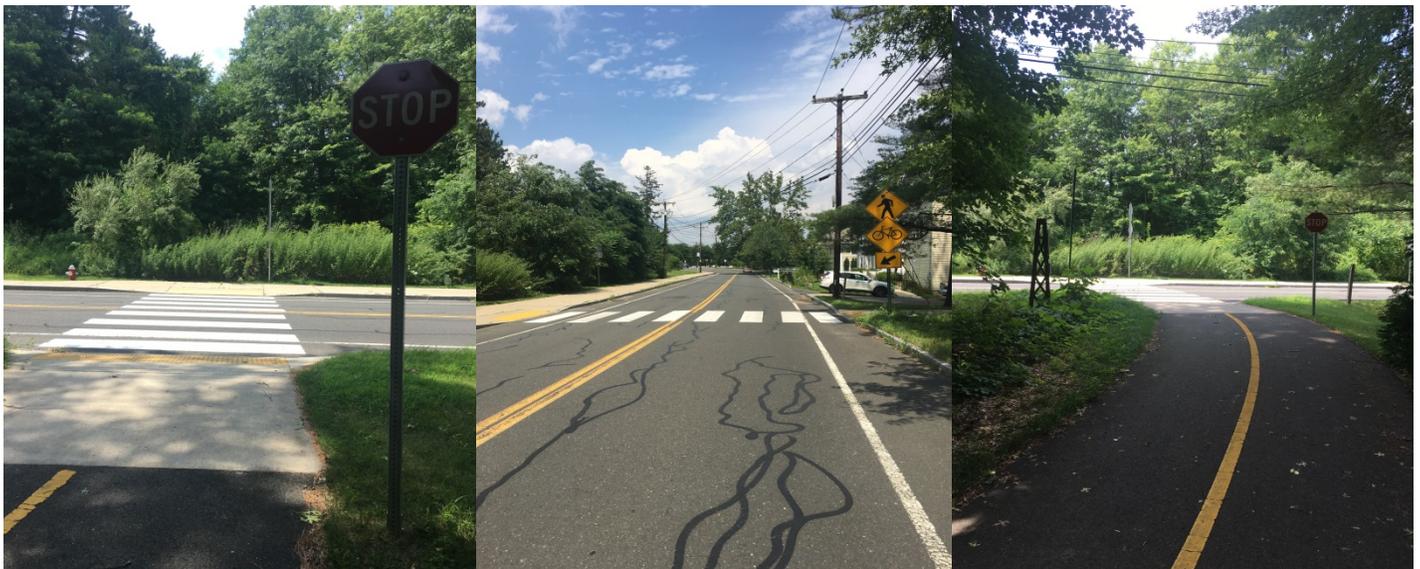
**41. EARLE STREET (Urban area crossing without overhead lighting)**

The shared use path ends at the eastbound approach of the crossing.

Photos from left: (i) View of crosswalk from westbound approach of shared use path, (ii) View from roadway approach,, (iii) Westbound approach of the shared use path.

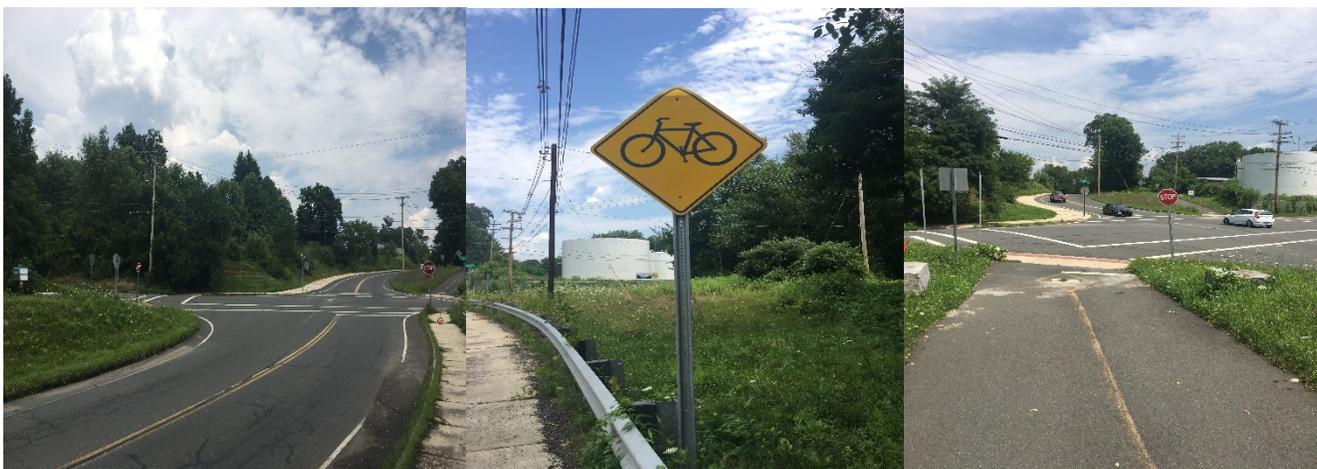
**42. EARLE STREET (At intersection with Grove Street) Urban area crossing with overhead lighting)**

Bollards along both approaches have been removed.

*Photos from left: (i) View from Earle Street depicting the crossing (ii) Shared use path sign at a distance from crossing (iii) Shared use path approach.*

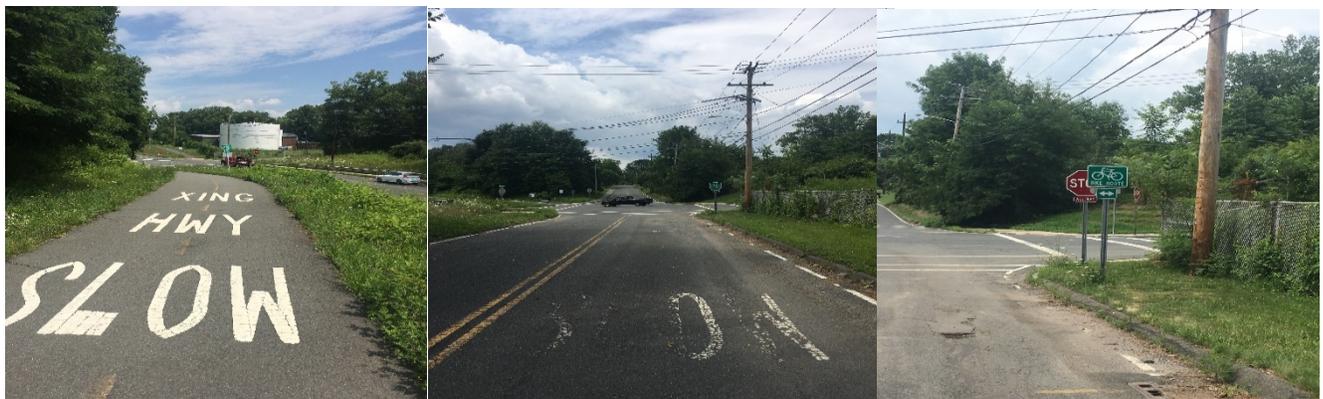
**43. GROVE STREET** (Urban area crossing with overhead lighting)

The bollards have been removed from both approaches of the shared use path.

Photos from left: (i) View from the shared use path approach, (ii) Faded pavement markings along Grove Street, (iii) 'Stop' sign along Gove Street partially blocked by shared use path sign.

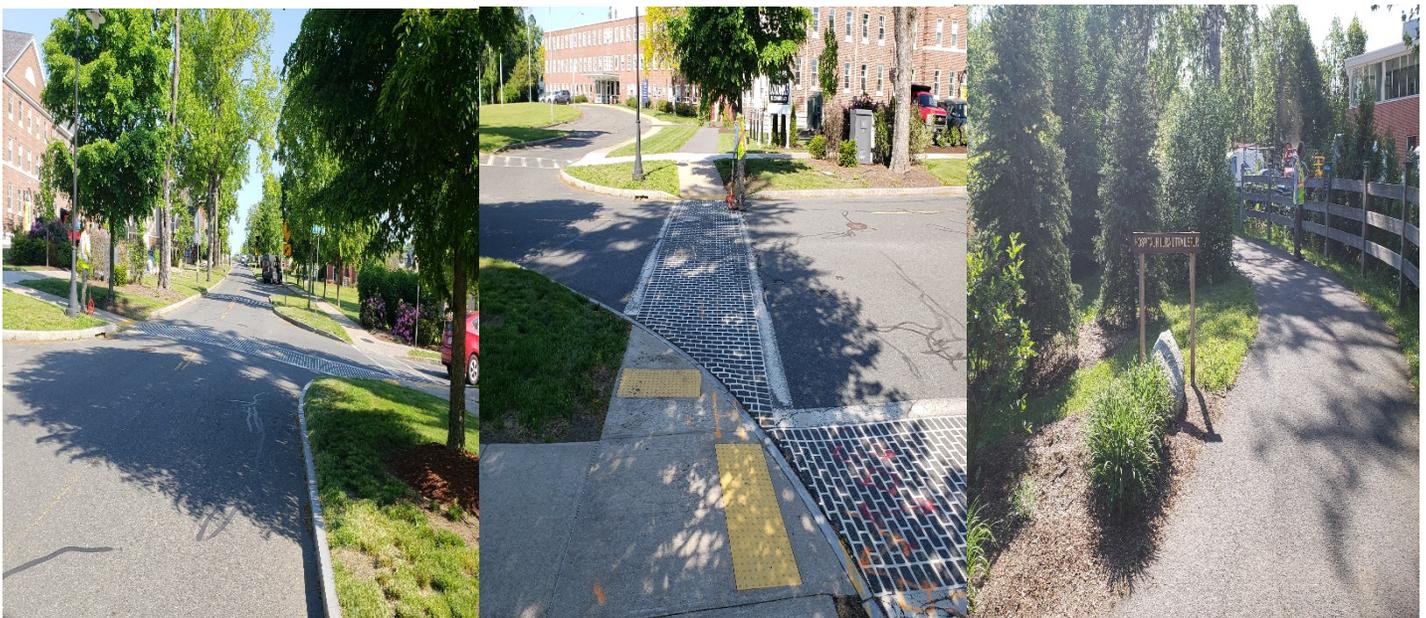
**44. VILLAGE HILL ROAD (Urban area crossing with overhead lighting)**

The shared use path has bituminous pavement west of the crossing and has concrete pavement east of the crossing.

Photos from left: (i) View from Village Hill Road northbound approach, (ii) View from shared use path westbound approach, (iii) Shared use path

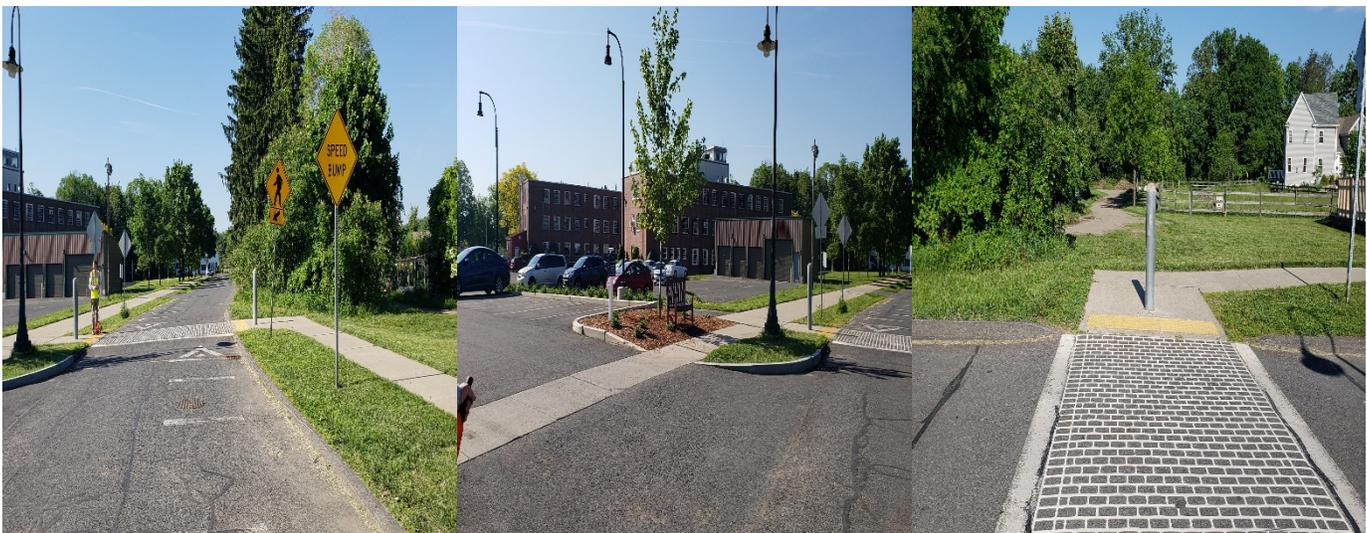
**45. MUSANTE DRIVE** (Urban area crossing with overhead lighting)

Hospital Hill Rail Trail Spur has two sections. The section in the east is composed of bituminous and concrete pavements. West of the crossing the trail provides an access to the community gardens.

*Photos from left: (i) View from Musante Drive southbound approach, (ii) Shared use path along east of the crossing, (iii) Shared use path extension in the west of the crossing proving access to community garden*

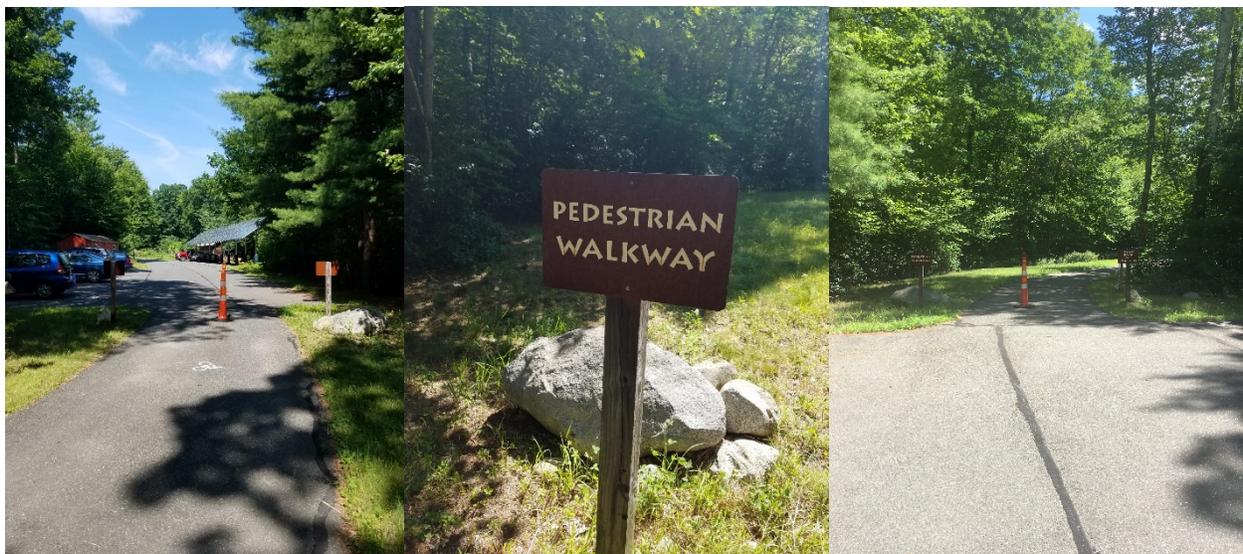
**46. BLACK BIRCH TRAIL (1) (Urban area crossing without overhead lighting)**

The shared use path ends in the parking lot.

Photos from left: (i) View from shared use path depicting parking lot, (ii) Walkway sign along the shared use path approach, (iii) Temporary traffic cone along the shared use path approach to restrict vehicles from the parking

**Remarks:** At the time of the field visit a temporary traffic cone was placed at the approach of the shared use path to restrict vehicles in the parking lot from entering the path.

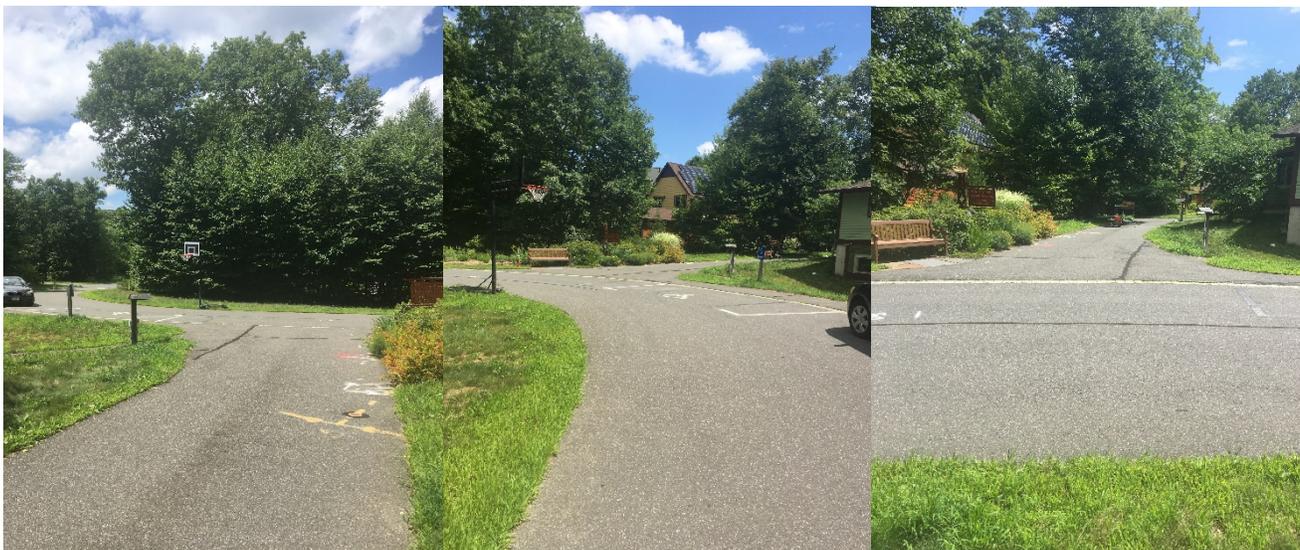
**47. BLACK BIRCH TRAIL (2) (Urban area crossing without overhead lighting)**

The shared use path does not have a southbound approach.

*Photos from left: (i) View from shared use path approach, (ii) View from Black Birch Trail, (iii) Shared use path.*

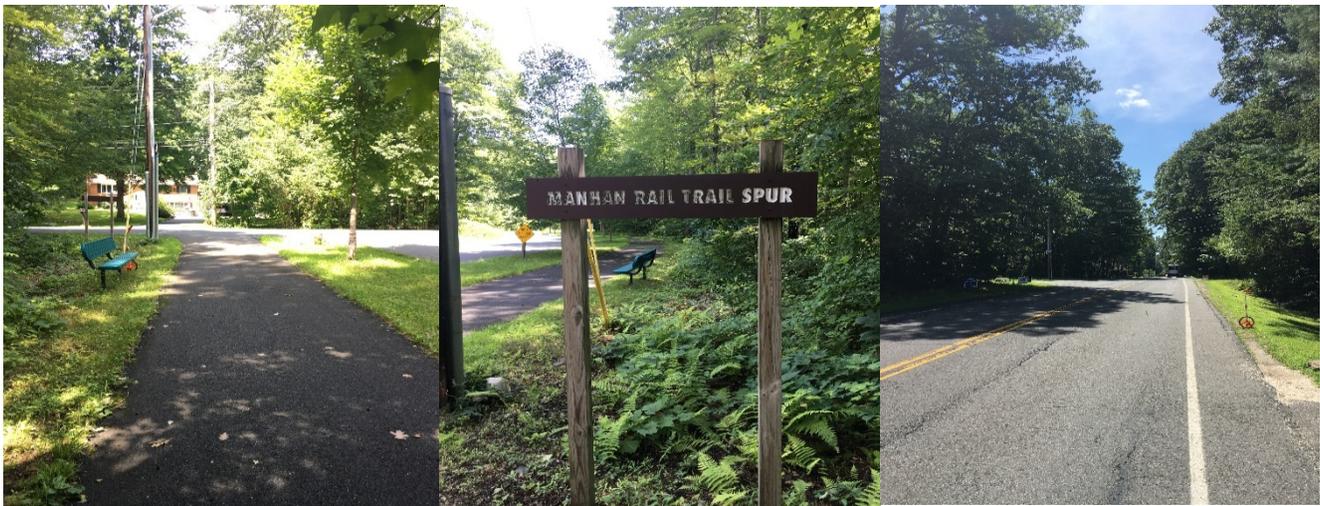
**48. FLORENCE ROAD (Urban area crossing with overhead lighting)**

The shared use path ends at the crossing.

*Photos from left: (i) View from shared use path approach, (ii) Sign along shared use path, (iii) View from Florence Road approach.*

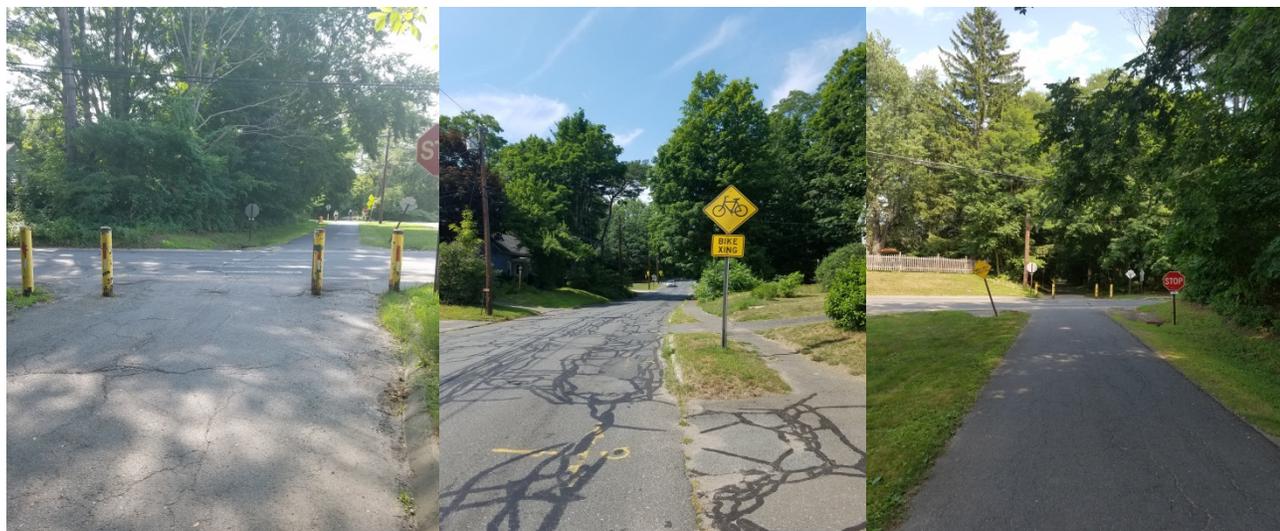
The westbound approach of the shared use path has four bollards installed to restrict motor vehicles from entering the path.

Photos from left: (i) View from westbound approach of the shared use path, (ii) View from North Elm Street approach, (iii) View from eastbound approach of the shared use path

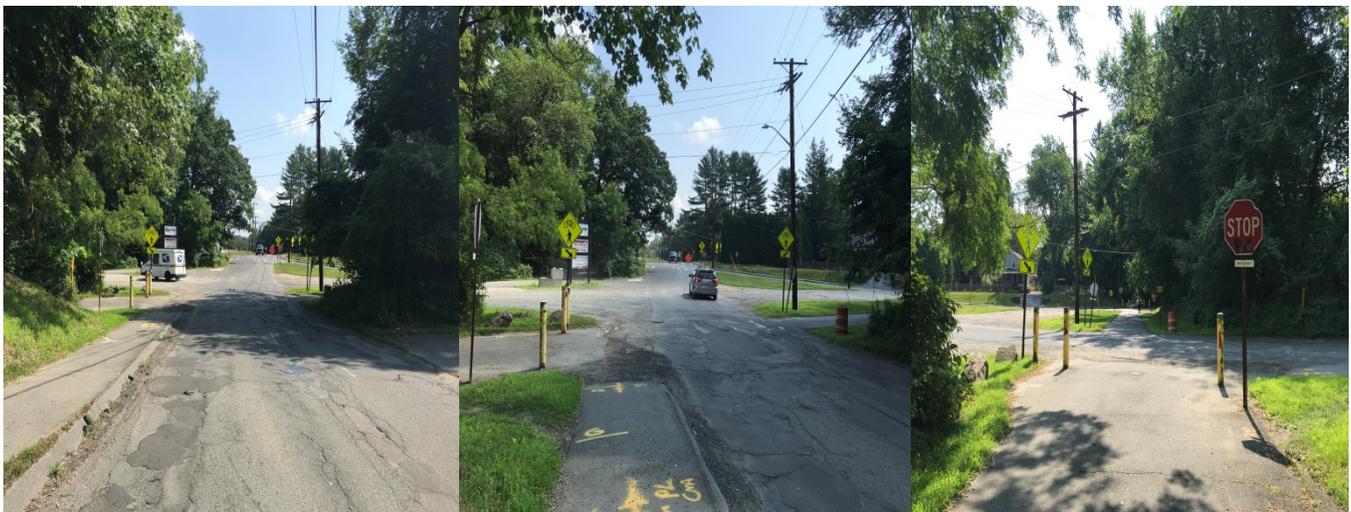
**Remarks:** The crosswalk needs to be repainted at this location.

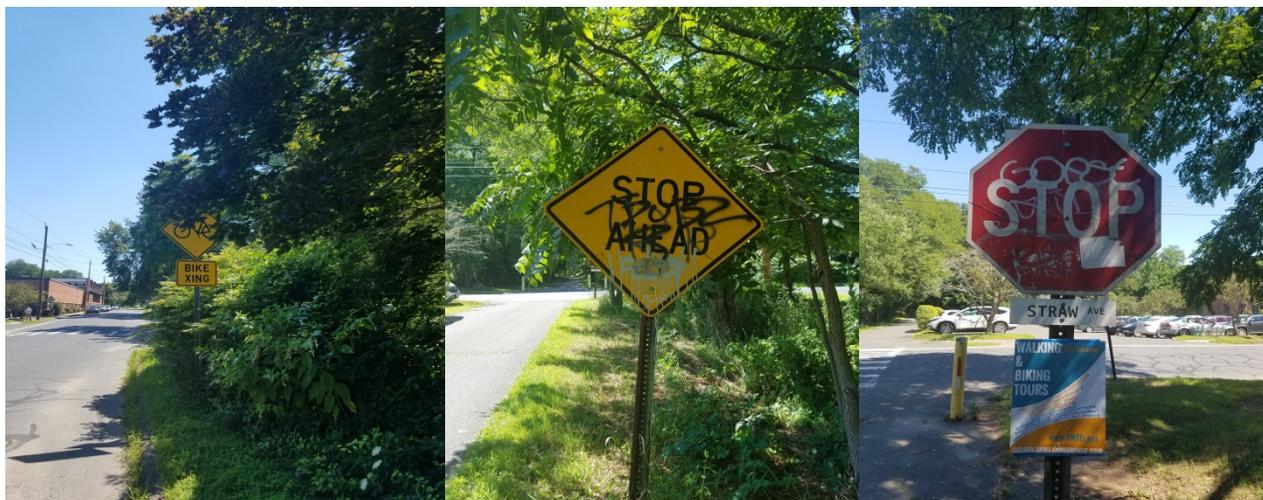
Signs along both approaches of the shared use path are partially covered with graffiti. The sight distance from the westbound approach is restricted by overgrown vegetation.

Photos from left: (i) View from southbound approach of the roadway showing partially blocked shared use sign, (ii) Advance warning sign along shared use path covered in graffiti, (iii) 'Stop' sign along shared use path approach partially covered in graffiti.

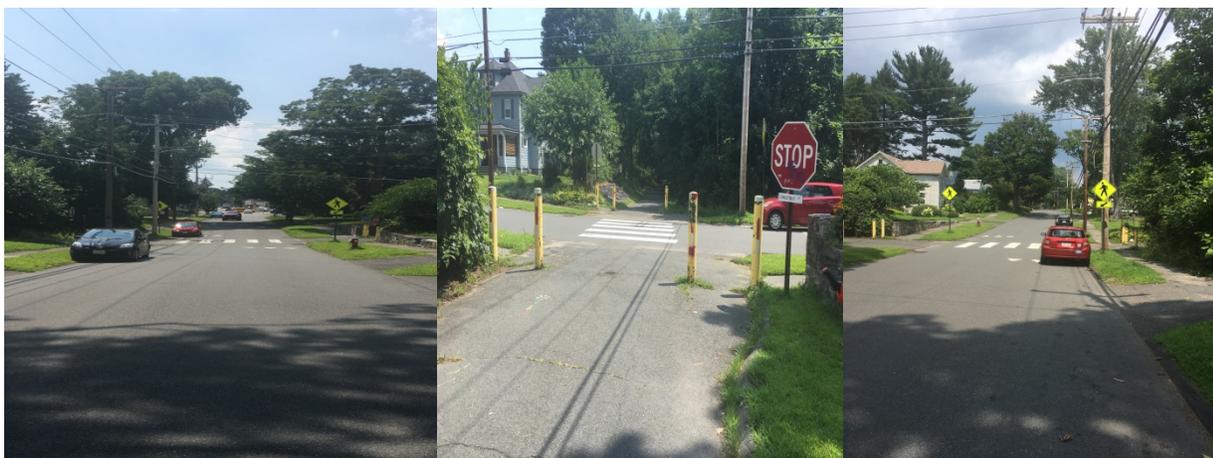
**Remarks:** The paint is wearing off all bollards. At the time of the field visit cars were parked in the immediate vicinity of the crossing which restricted the view of the westbound approach of the shared use path. It is recommended that no parking be allowed in the immediate vicinity of this crosswalk.

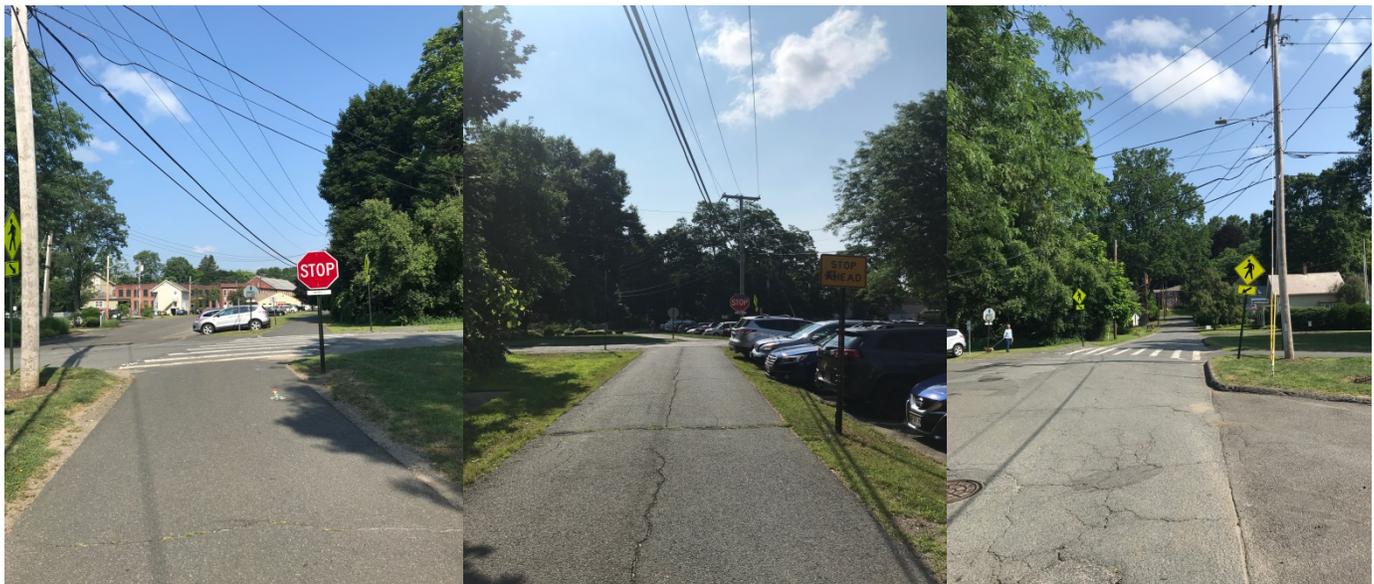
The eastbound approach has an advance warning sign.

Photos from left: (i) View from shared use path approach, (ii) Advance warning sign along eastbound approach of shared use path, (iii) View from Keyes Street approach

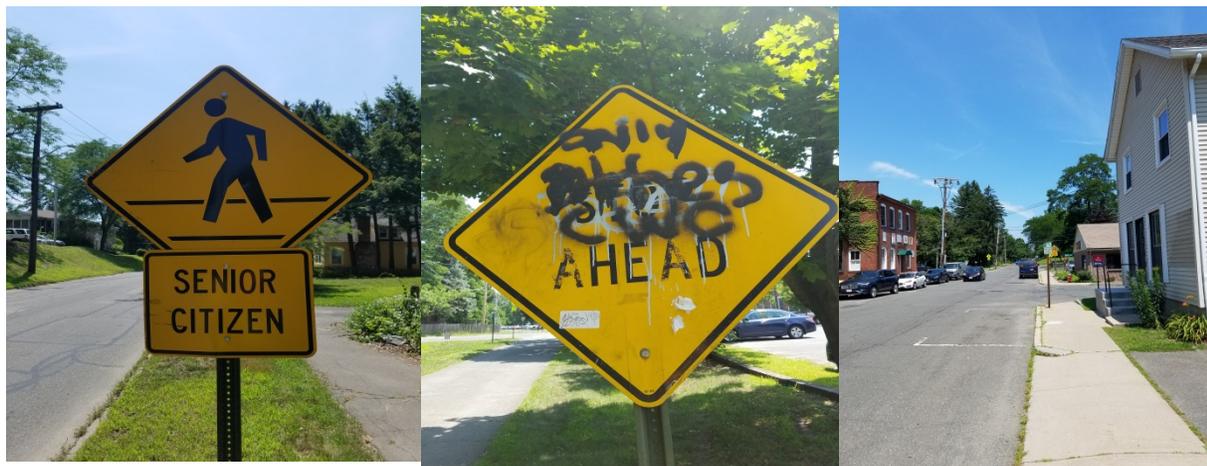
**55. NORTH MAPLE STREET (Urban area crossing with overhead lighting)**

Signs along both approaches of the shared use path are partially covered by graffiti.

Photos from left: (i) Senior citizen sign along the roadway,, (ii) Advance warning sign along shared use path partially covered by graffiti, (iii) Building in the southeast corner of the crossing along North Maple Street

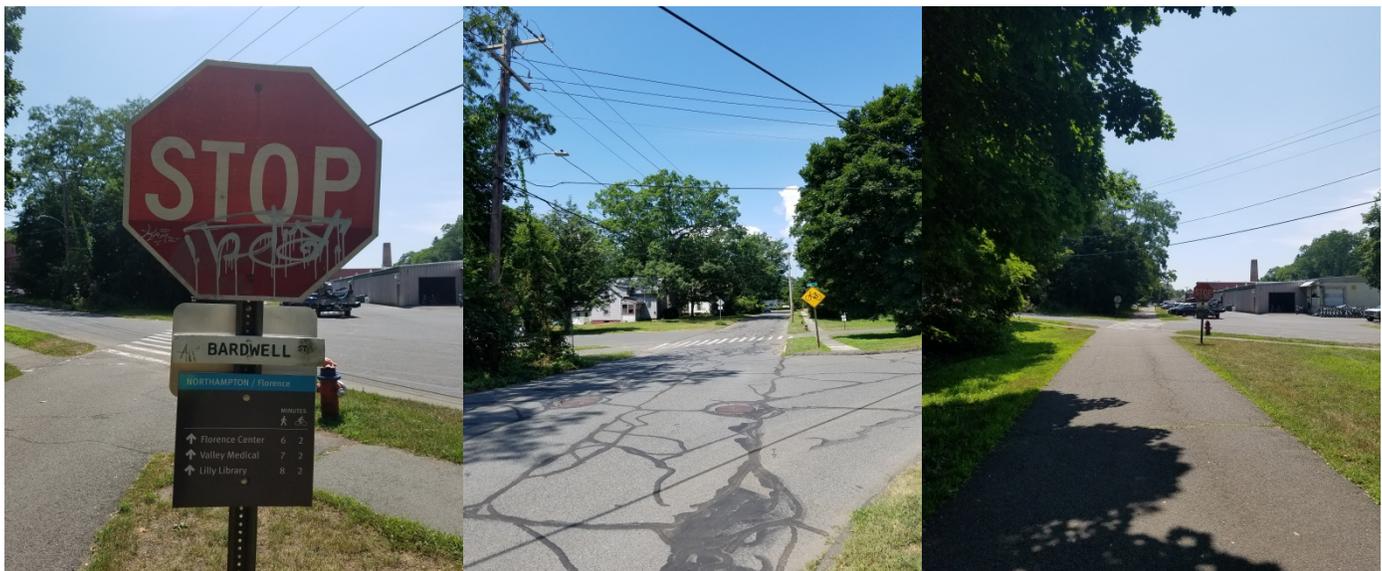
**56. BARDWELL STREET** (Urban area crossing with overhead lighting)

Signs along both approaches are damaged by graffiti and are faded.

Photos from left: (i) 'Stop' sign at shared use path approach partially covered by graffiti, (ii) View from Bardwell street approach, (iii) View from shared use path approach

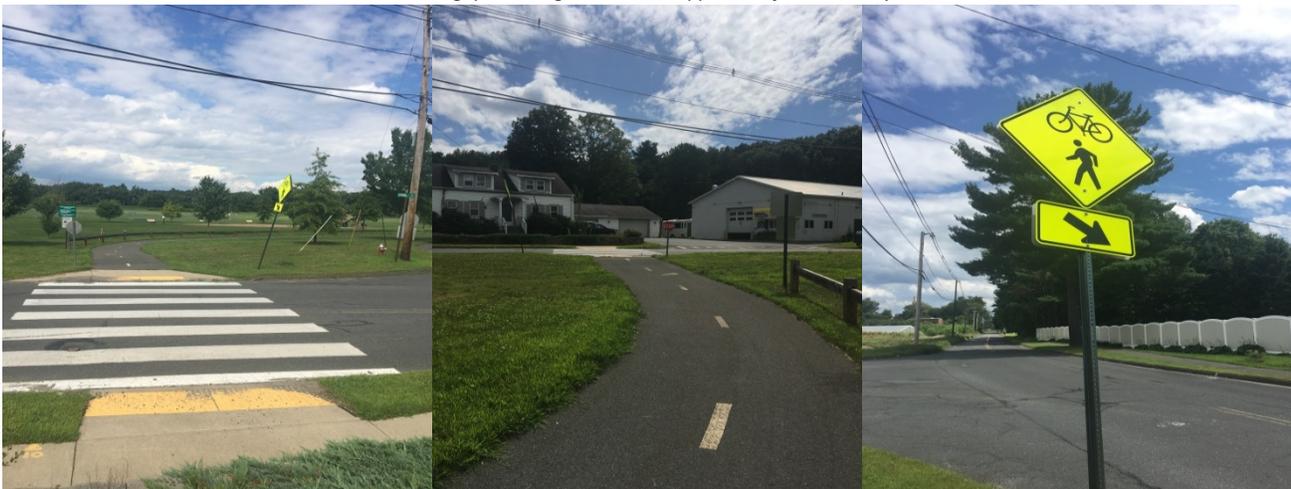
The shared use path ends at this crossing and connects to a sidewalk along the eastbound approach.

Photos from left: (i) Crosswalk and tilted sign post along northbound approach of Spring Street, (ii) View from westbound approach of the shared use path. (iii) Tilted signpost along southbound approach of the roadway
