FEBRUARY 2019

# AT-GRADE SHARED USE PATH AND ROADWAY INTERSECTIONS IN THE PIONEER VALLEY

Prepared under the direction of the Pioneer  
Valley MPO by:

**PIONEER VALLEY PLANNING COMMISSION**

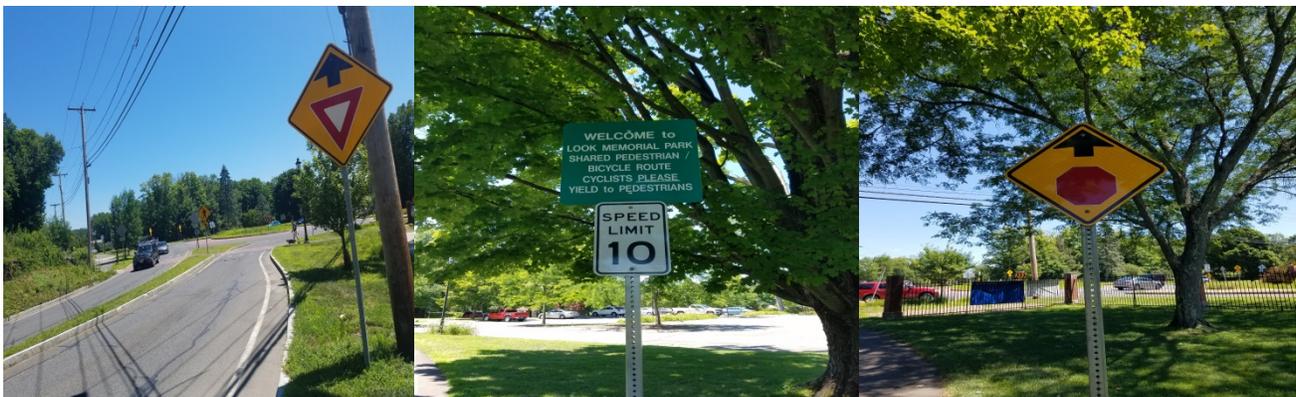
The eastbound approach of the shared use path has a 'Stop Ahead' advance warning sign but there is no 'Stop' sign at the approach in the vicinity of the crosswalk. There is a '10 mph' speed limit sign posted for the westbound direction leading into Look Park.

Photos from left: (i) North Main Street approach entering the roundabout, (ii) Speed limit sign along the eastbound approach of the shared use path, (iii) Advance 'Stop Ahead' sign along eastbound approach of shared use path

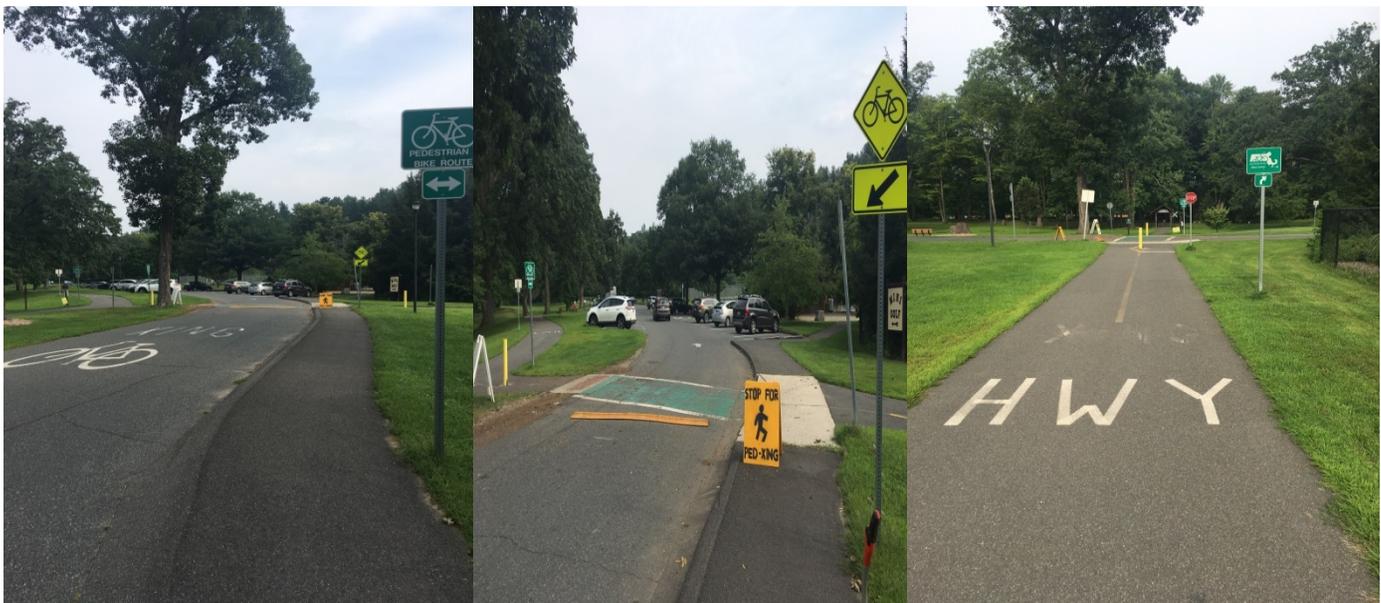
**61. LOWER POOL ROAD (Urban area crossing with overhead lighting)**

The shared use path is located inside Look Park.

Photos from left (i) View from northbound approach of Lower Pool Road, (ii) Crosswalk and temporary pedestrian crossing sign at the crossing, (iii) Shared use path approach.

**Remarks:** This crossing is located along a one way internal road inside Look Park. The pavement markings are faded at several locations along the roadway.

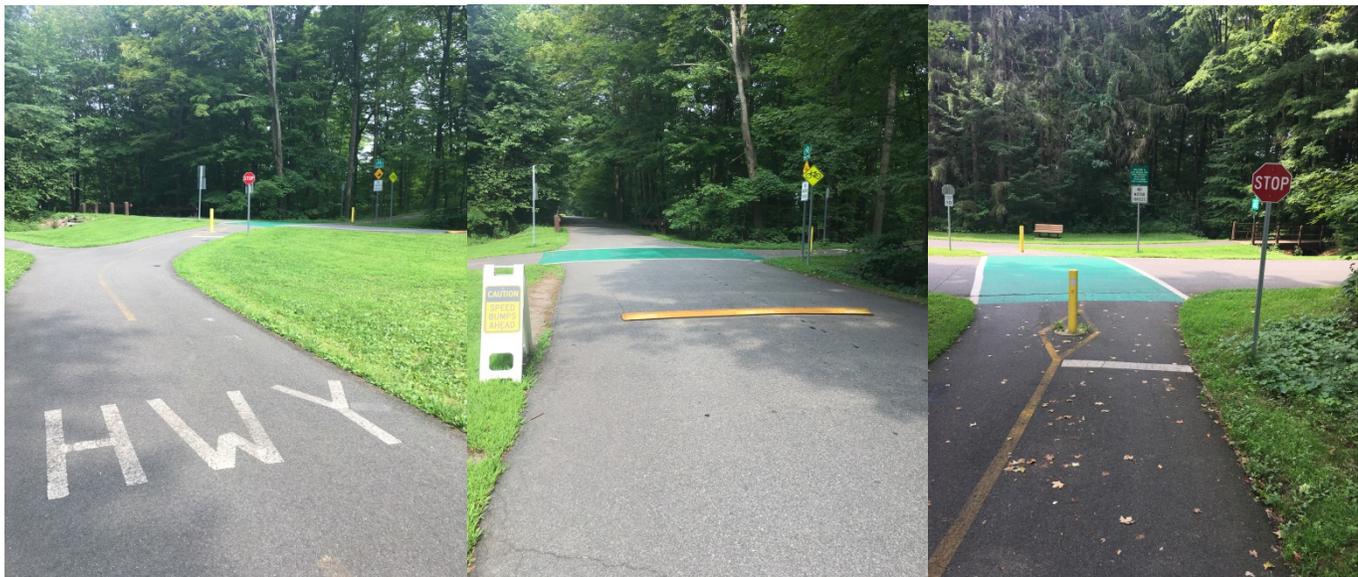
**62. OLD TROLLEY ROAD (Urban area crossing without overhead lighting)**

Photos from left: (i) View from shared use path approach depicting pavement markings, (ii) View from Old Trolley Road approach, (iii) View from shared use path approach depicting 'Stop' sign, crosswalk and bollards

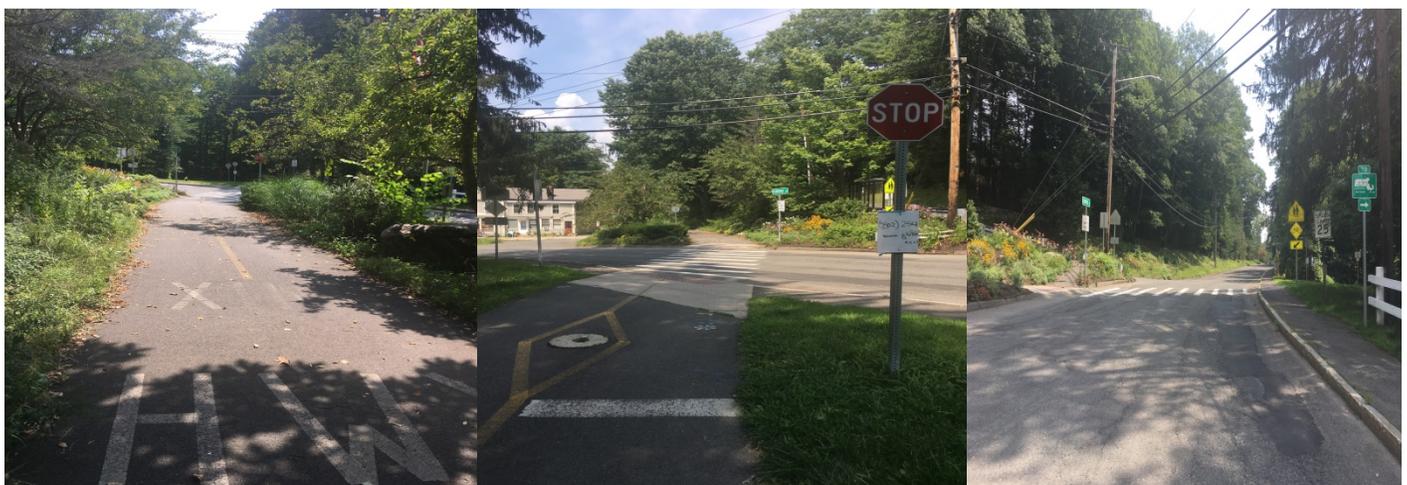
**63. MULBERRY STREET (Urban area crossing with overhead lighting)**

Pavement markings along both approaches have faded in several locations.

Photos from left: (i) Faded pavement markings along shared use path, (ii) Southbound approach of the shared use path, (iii) View from Mulberry Street approach.

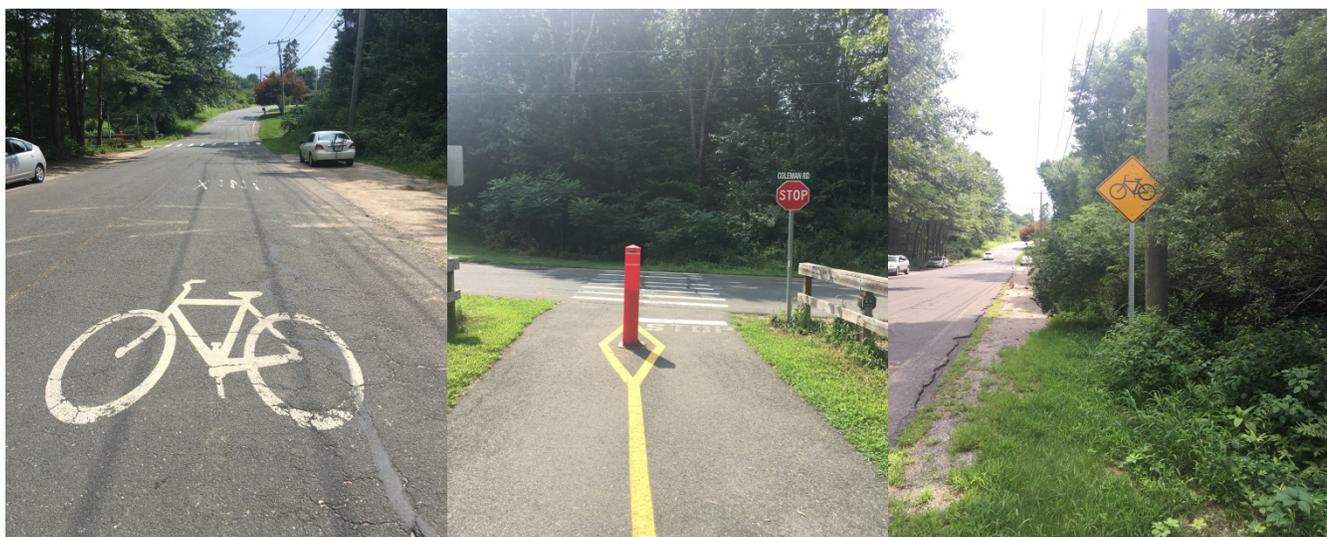
The advance warning sign along the westbound approach of the shared use path is partially blocked by overgrown vegetation.

Photos from left: (i) View from Coleman Road approach showing pavement markings, (ii) View from shared use path westbound approach, (iii) Advance warning sign along westbound approach of the roadway partially covered by vegetation

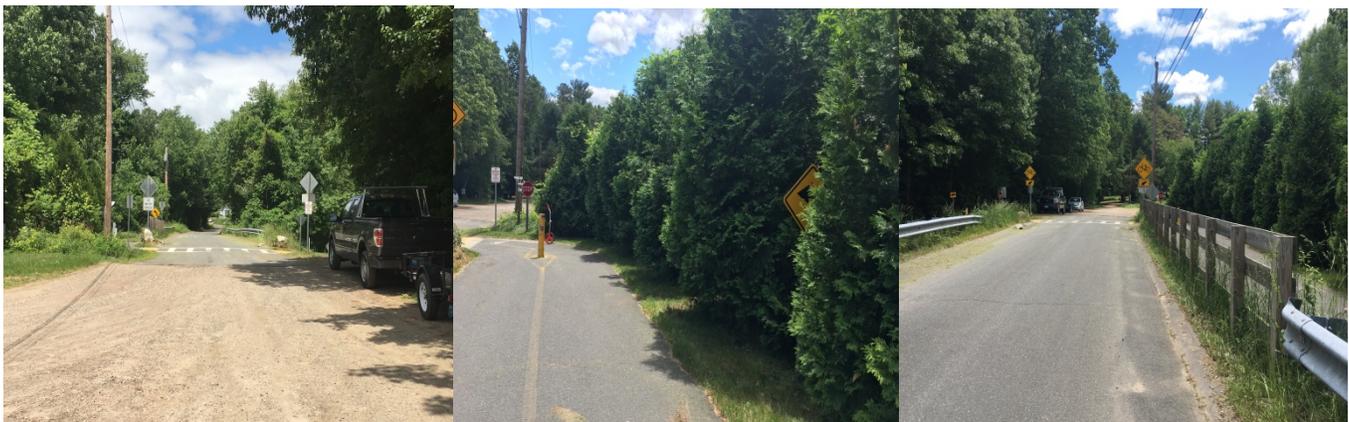
The advance warning sign along northbound approach is partially blocked by overgrown vegetation.

*Photos from left: (i) View from westbound approach of Sam West Road, (ii) Overgrown vegetation along northbound approach of shared use path, (iii) View from eastbound approach of the roadway*

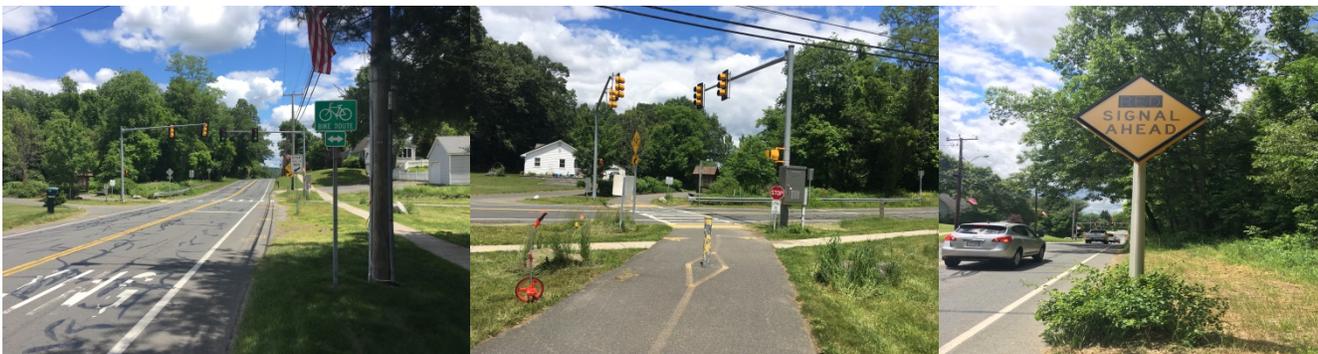
**66. FEEDING HILLS ROAD** (Urban area crossing with overhead lighting)**Crash History in the Vicinity of the Crossing:**

Both approaches of the shared use path have push button activated pedestrian signals.

Photos from left: (i) View from Feeding Hills Road approach, (ii) View from shared use path approach, (iii) Advance warning sign along the roadway.

**Remarks:** The signal at this crossing allocates approximately 15 seconds of walk time.

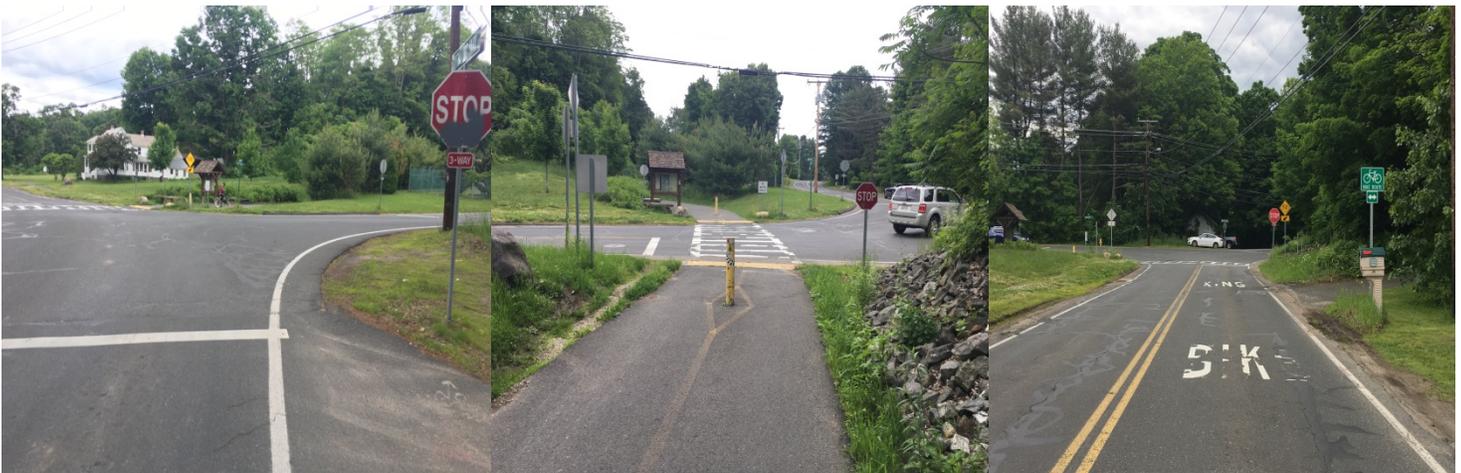
**67. DEPOT STREET (Urban area crossing with overhead lighting)**

Overgrown vegetation along northbound approach of the shared use path partially covers the advance warning sign.

Photos from left: (i) View from westbound approach of the roadway, (ii) Shared use path approach, (iii) View from eastbound approach of Depot Street.

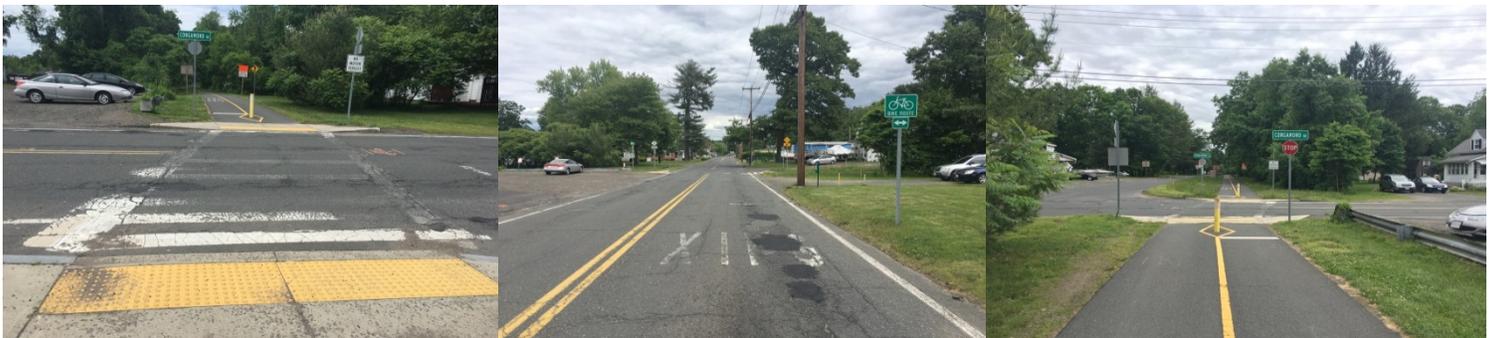
**68. CONGAMOND ROAD** (Urban area crossing with overhead lighting)**Crash History in the Vicinity of the Crossing:**

Photos from left: (i) Faded crosswalk markings, (ii) View from Congamond Road approach showing shared use path signs at a distance, (iii) Shared use path approach

**Remarks:** The crossing is located in a residential area with moderate volume of traffic. This crossing is currently undergoing improvements as a part of Congamond Road Reconstruction Project which is proposed to be completed by Fall of 2019. The proposed improvements include a new signalized crossing similar to the Feeding Hills Road location.

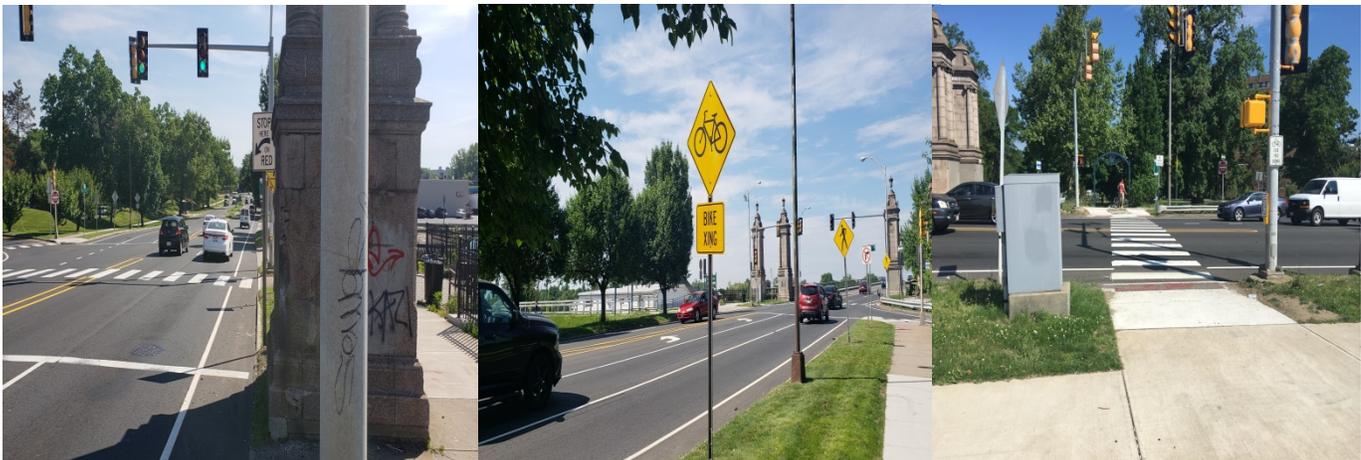
**Remarks:** The signal allocates approximately 16 seconds of walk time. It is recommended that the MassDOT consider increasing this time. The driveway for the Pioneer Valley Riverfront Club is located on the southwest side of the crossing.

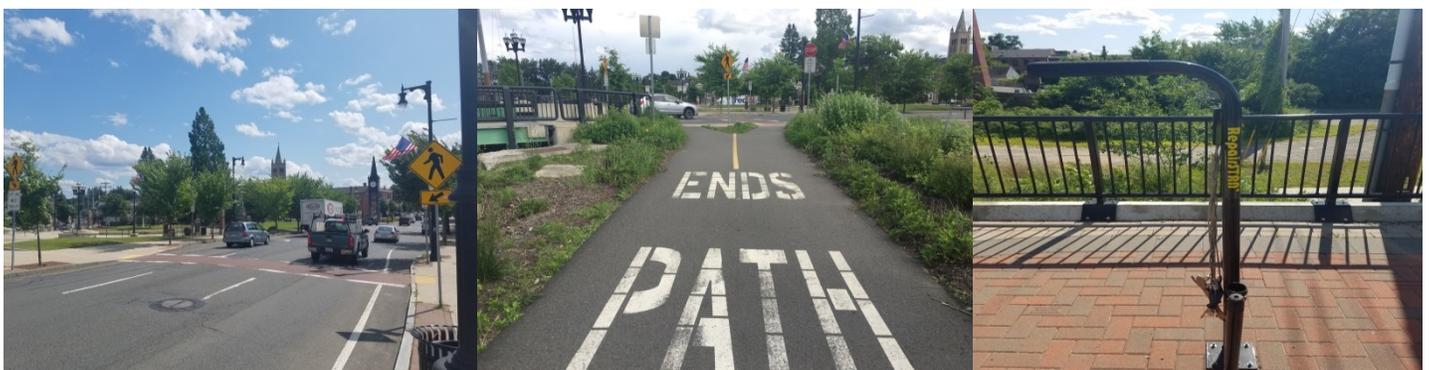
**70. NORTH ELM STREET** (Urban area crossing with overhead lighting)

The shared use path ends at the crossing and there are 'Path Ends' pavement markings along the eastbound approach. A bike repair stand is located along the eastbound approach which provides basic tools for quick bicycle repairs.

Photos from left: (i) View from southbound approach of North Elm Street, (ii) Pavement markings along eastbound approach of the shared use path, (iii) Bike repair stand installed along the shared use path approach

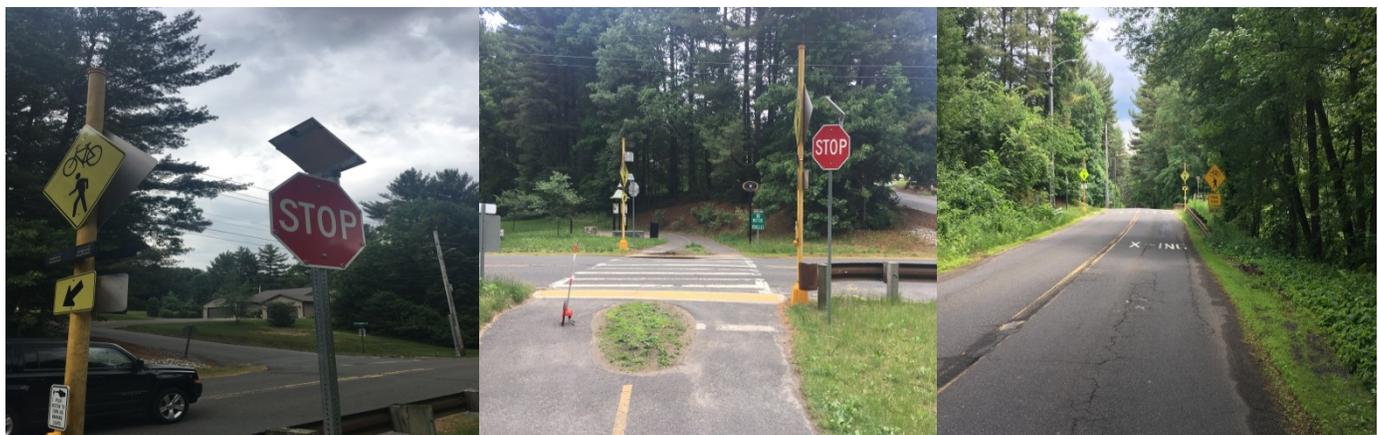
Stop signs for both approaches of the shared use path have flashing LED lights. Push buttons to activate Rectangular Rapid Flashing Beacons (RRFBs) are installed for both approaches of the shared use path.

*Photos from left: (i) RRFB and 'Stop' sign with LED lights along the shared use path approach, (ii) View from the shared use path approach (iii) View from Shaker Road Approach*

**Remarks:** The crossing is located in a residential area with low traffic volumes.
