Beech Street (Route 202) / Cherry Street (Route 202) / Northampton Street (Route 5)

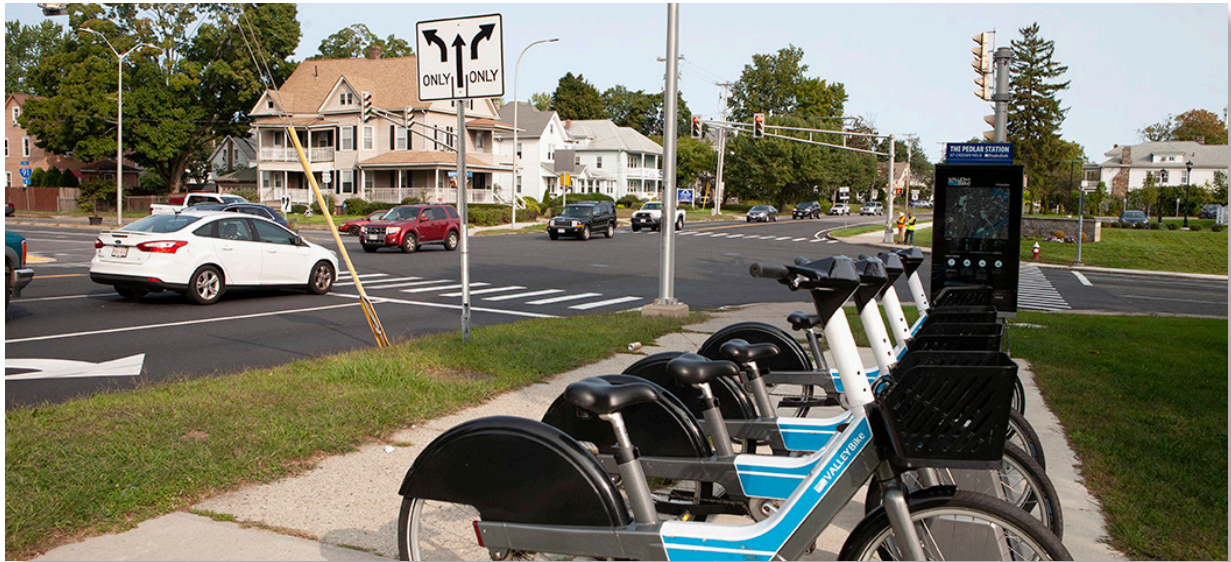
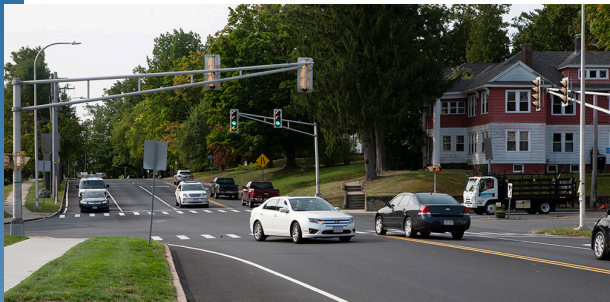
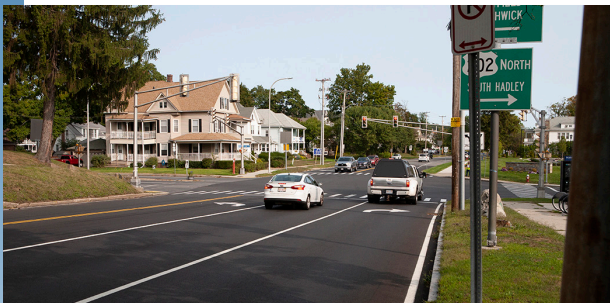
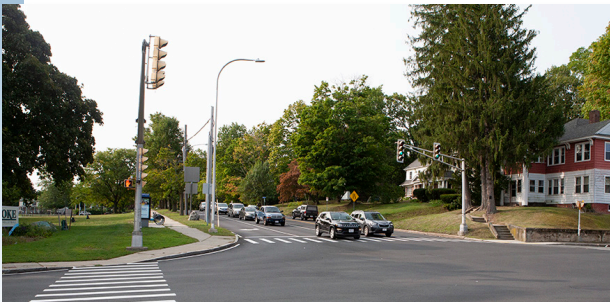
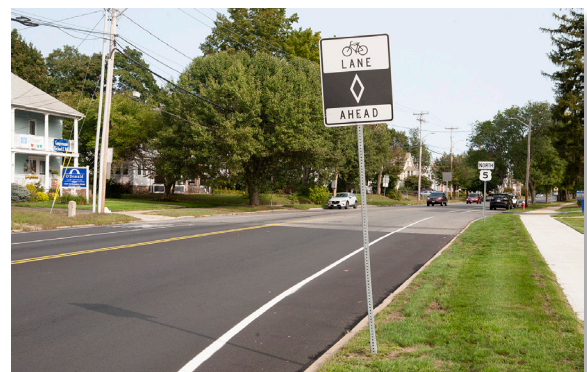
- Bike Share rental station is located along southeast corner of the intersection. Bike lanes are located to the north of the intersection along Northampton Road (Route 5) however there are no bike provisions at the intersection or along other approaches.
- The signal head back plates are old and need new retroreflective stipes.
- Pedestrian signal heads are dated and do not provide countdown.
- All approaches do not have enough signal heads per lane
- Left turn yield on green warning sign is needed for Northampton Street (Route 5) southbound approach
- Pavement markings along several locations at this intersection were observed to be faded
- Northampton Street northbound approach has exclusive left turn lane but does not have a separate signal head or phase dedicated to left turning traffic
- The turn lanes and shared lanes are not marked by appropriate pavement markings
