## Boston Road (Route 20) / Stony Hill Road

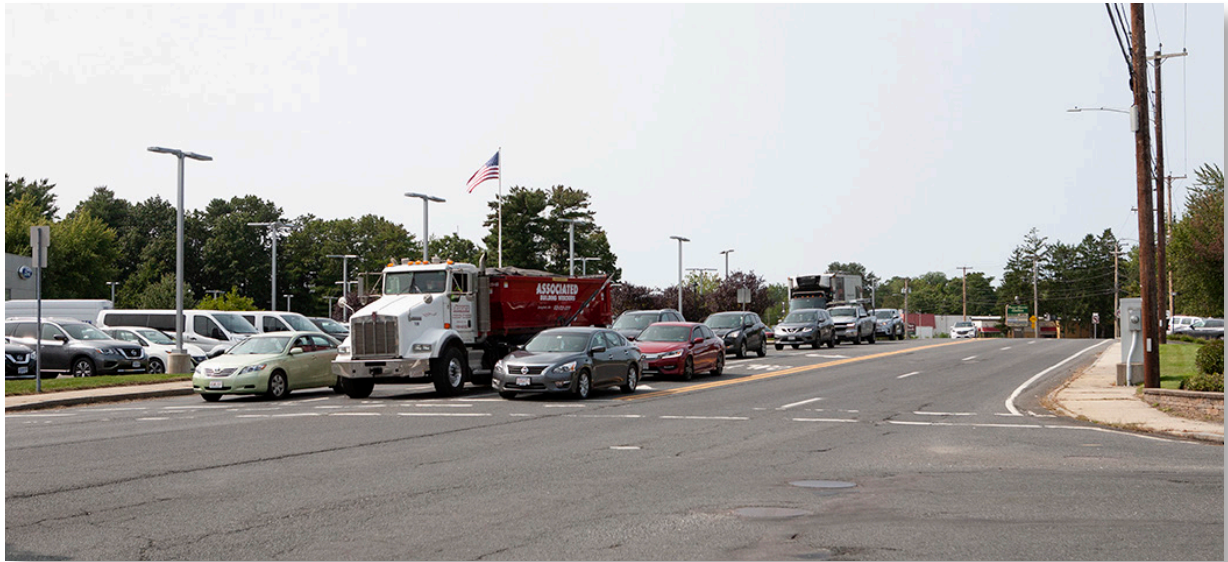
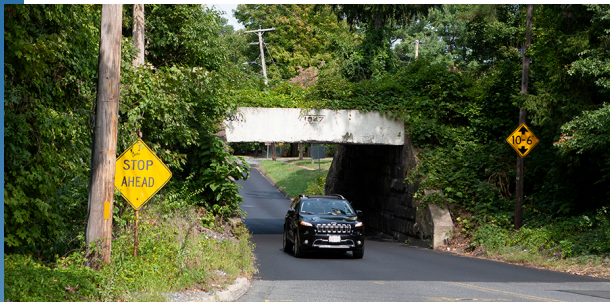
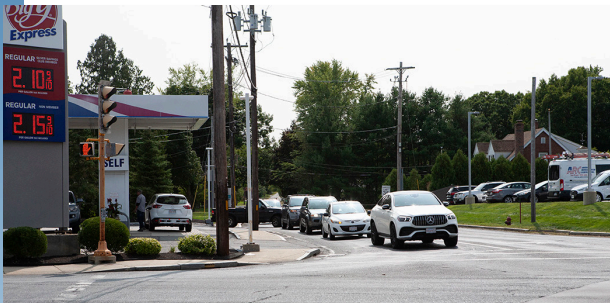
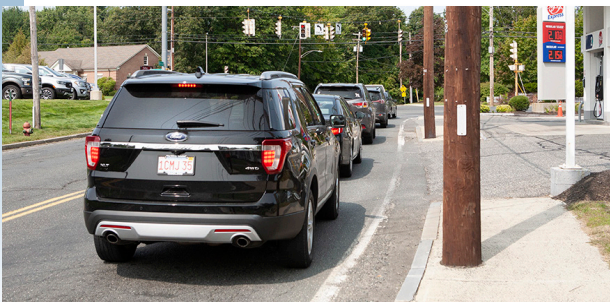
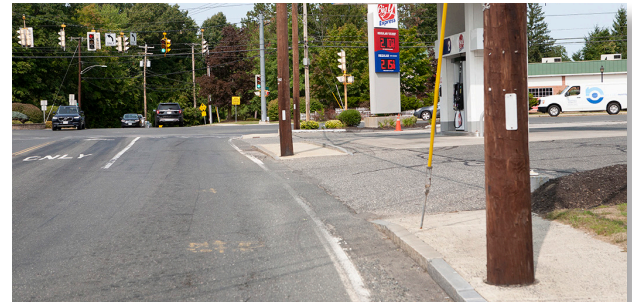
- Heavy congestion, long delays during peak hours, aggressive driving, following too closely, potential red light running, and weather conditions could be some of the factors contributing to higher crashes at this intersection.
- The low clearance underpass located to the north of the intersection along Stony Hill Road has narrow travel lanes
- The left turn lane along Boston Road (Route 20) eastbound approach is short and vehicles have to often cross double yellow center line because of tight turning radii
- Residents along Stony Hill Road get their driveways blocked by heavy traffic queues during peak hours
- The curb openings for the Big Y Express gas station are too close to the intersection
- Faded Pavement Markings
